Failure paths for levees

February 2022

PREPARED BY
Technical Committee on
Geotechnical Aspects of Dikes and Levees
(TC201)

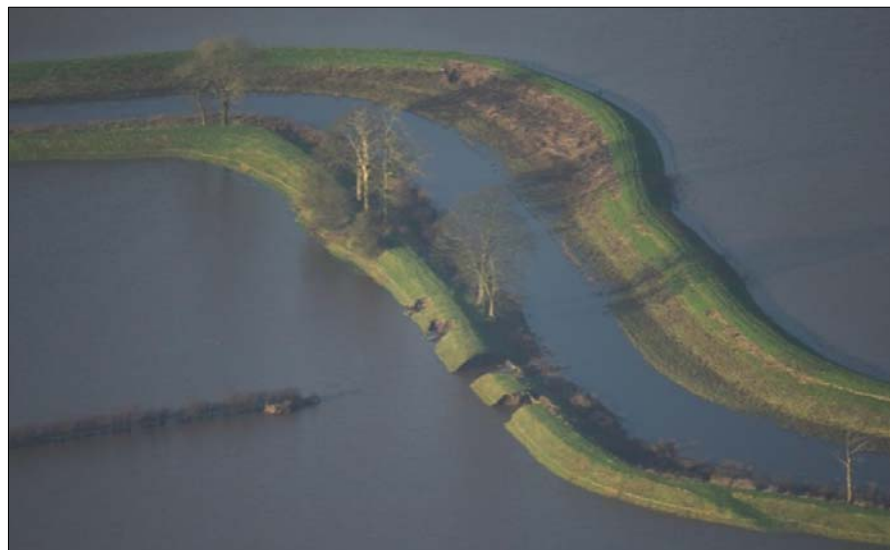
The breach occurred in the UK in 2015 following a period of heavy rain during a named storm event.

Figure 3.2 Photograph of the situation.

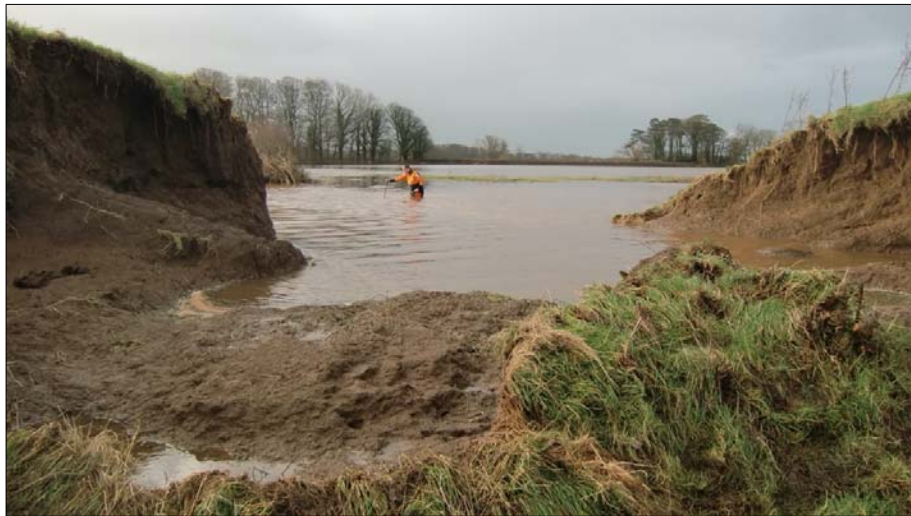
The flooding resulting from the breach, affected approximately sixteen properties and a large area of agricultural land. A scour hole of up to 10 m depth was caused by the flow through the breach.

Figure 3.3 Photograph of the breach.

A forensic review of recent LiDAR images showed that the original crest level at the location of the breach was up to 100 mm lower than at surrounding areas. Furthermore, the location of the breach was underlain by both an in-filled historical meander and an old field drain. It is likely that the localized settlement of the crest in the vicinity of the breach was originally caused by consolidation of the in-fill material in the old meander. This meant that the crest level at this location was lower than at surrounding areas; overflow at this location caused rapid external erosion of the levee because of the steepness of the landward slope, about 30 degrees, the quality of the levee fill material (erodibility) and the lack of a landward berm.

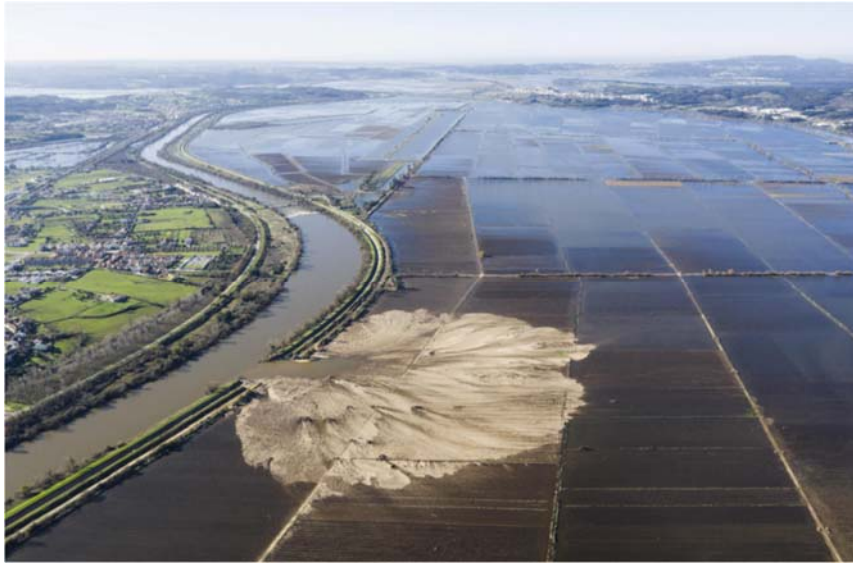
The collapse led to the flooding of the fields in the Central Valley of the Lower Mondego and the cutting of communication routes. Infrastructure was severely damaged, not only the embankment but also the road and the conducting channel at the right bank, for the water supply of agriculture and industries.

Figure 3.20 View of Santo Varão shortly after collapse of the embankment ⁴.

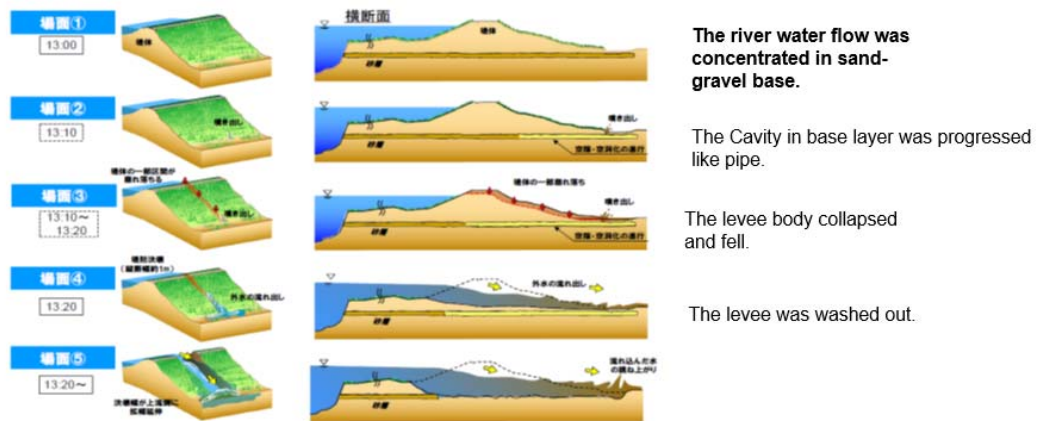
An example of levee failure due to piping erosion is illustrated below for a case on the Yabe river in 2012. In this example the high-water event caused erosion in a sand gravel layer at the base of the levee, which resulted in an eroded ‘pipe’ below the levee base. This resulted in collapse of the levee body and washing out of the levee, see Figure 3.27.

Figure 3.27 Example of piping erosion from the presentation ‘Picture-Card Show Project’ in JGS-JCES’, contribution by K. Maeda, M. Ishihara and H. Mori, using materials from the Ministry of Land, Infrastructure, Transport and Tourism in Japan.

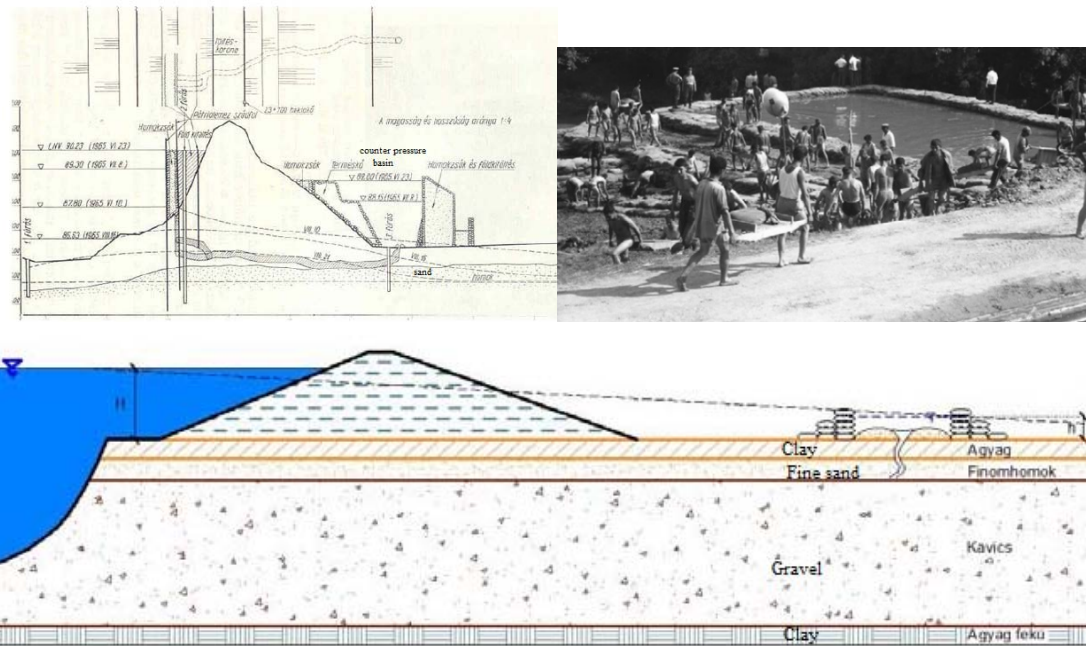
Figure 3.36 Danube, Margitta Island sand boil counter-pressure (top right) and diaphragm walls at the waterside (top left), the cause was the vicinity of an old meander (Garai, 2016). Water level of the counter-pressure basin (bottom).

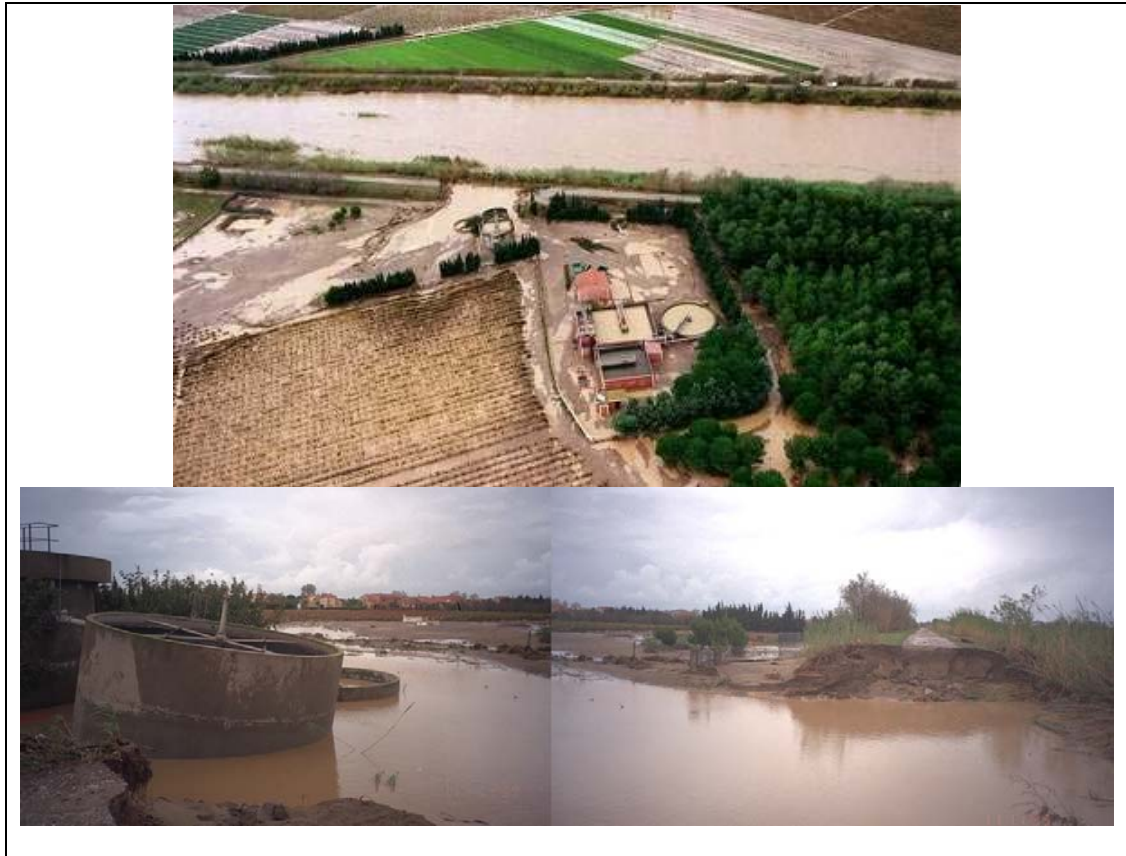
Figure 3.49 Breach in 1999 at St-Laurent-de-la-Salanque.

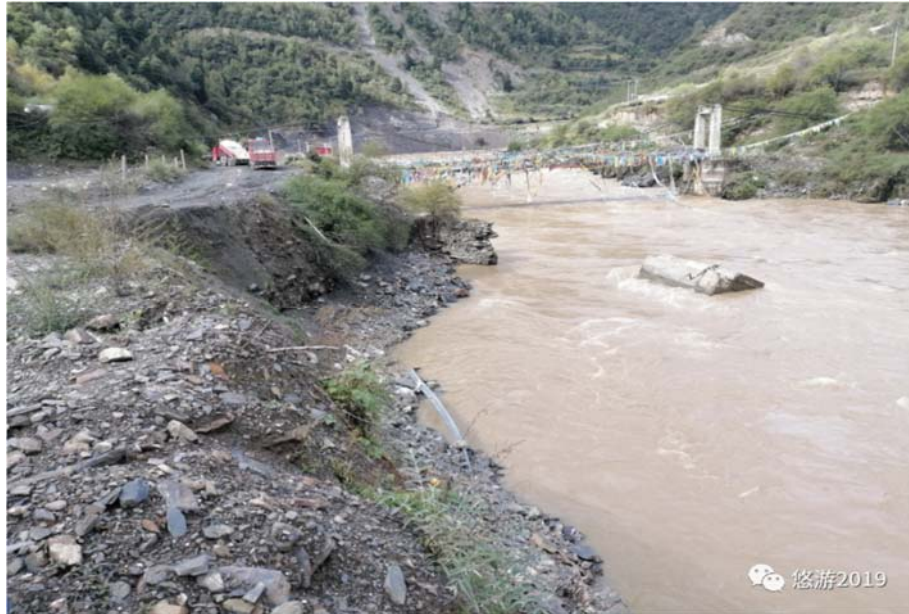
Figure 3.60 Riverbank morphology in the damaged section of retaining wall.

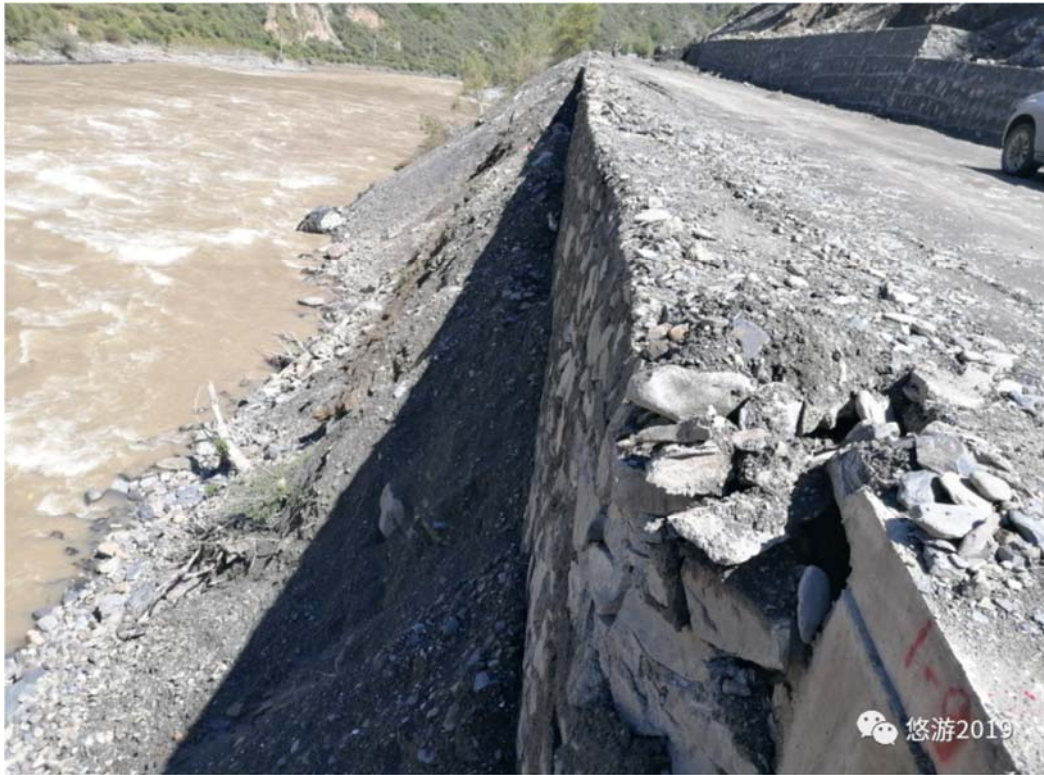
Figure 3.61 Outwards displacement of the bank slope and retaining wall.

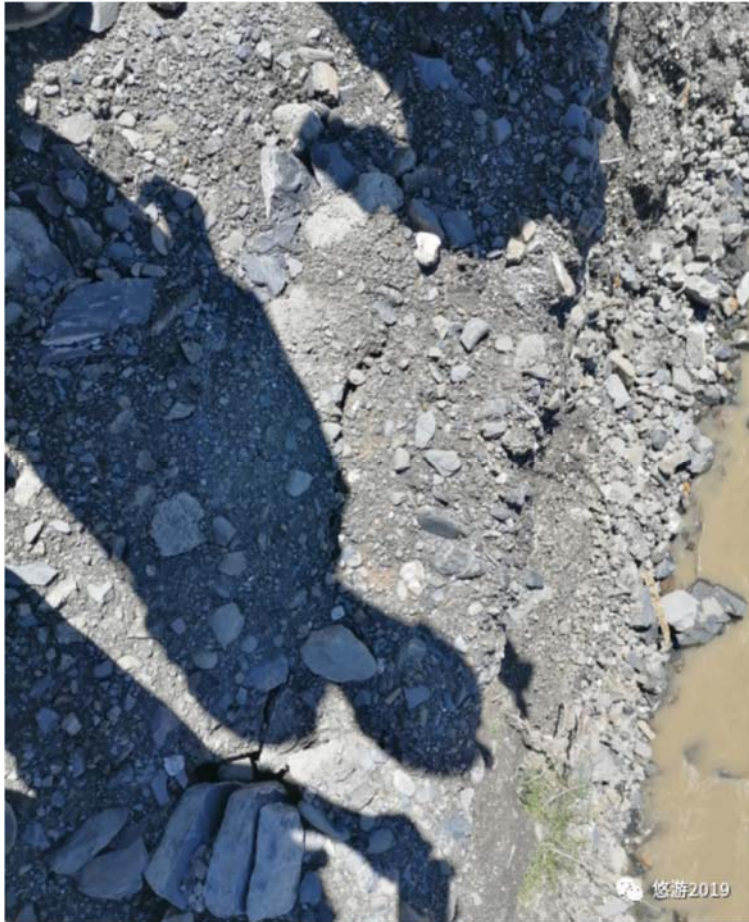
Figure 3.62 Cracking morphology of retaining wall body.
