Failure paths for levees

Meindert Van, Esther Rosenbrand, Rémy Tourment, Philip Smith, Cor
Zwanenburg

February 2022

PREPARED BY
Technical Committee on
Geotechnical Aspects of Dikes and Levees
(TC201)

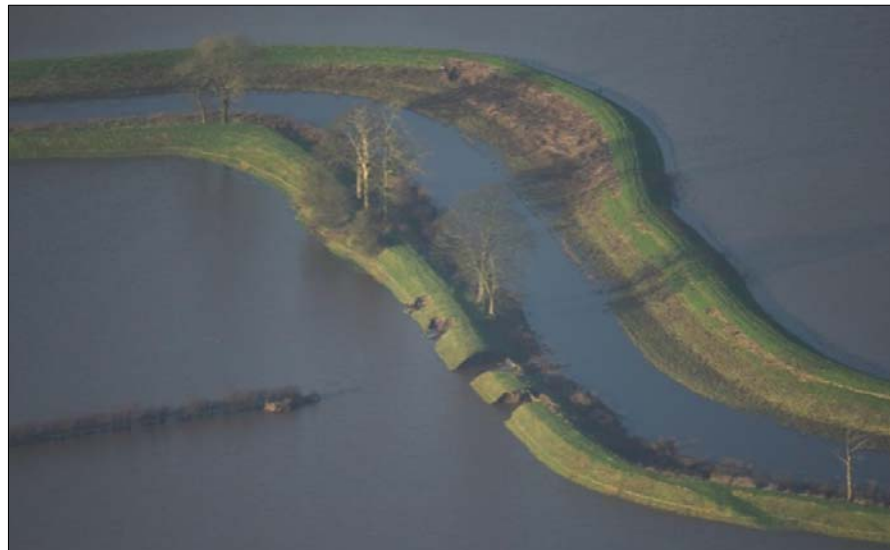
The breach occurred in the UK in 2015 following a period of heavy rain during a named storm event.

Figure 3.2 Photograph of the situation.

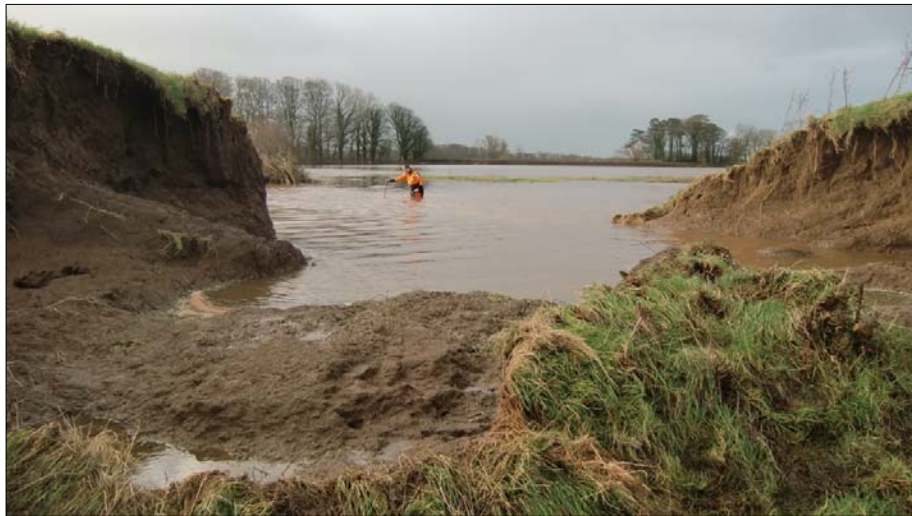
The flooding resulting from the breach, affected approximately sixteen properties and a large area of agricultural land. A scour hole of up to 10 m depth was caused by the flow through the breach.

Figure 3.3 Photograph of the breach.

A forensic review of recent LiDAR images showed that the original crest level at the location of the breach was up to 100 mm lower than at surrounding areas. Furthermore, the location of the breach was underlain by both an in-filled historical meander and an old field drain. It is likely that the localized settlement of the crest in the vicinity of the breach was originally caused by consolidation of the in-fill material in the old meander. This meant that the crest level at this location was lower than at surrounding areas; overflow at this location caused rapid external erosion of the levee because of the steepness of the landward slope, about 30 degrees, the quality of the levee fill material (erodibility) and the lack of a landward berm.

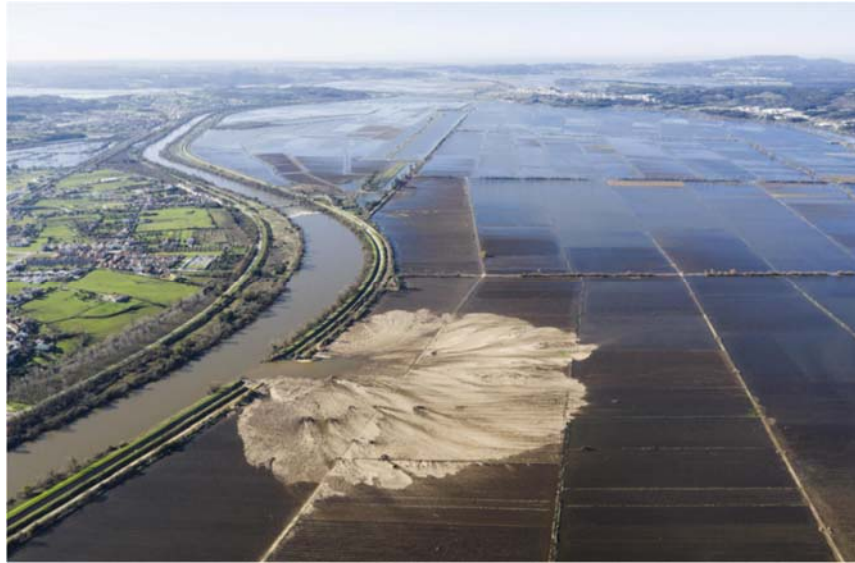
The collapse led to the flooding of the fields in the Central Valley of the Lower Mondego and the cutting of communication routes. Infrastructure was severely damaged, not only the embankment but also the road and the conducting channel at the right bank, for the water supply of agriculture and industries.

Figure 3.20 View of Santo Varão shortly after collapse of the embankment ⁴.

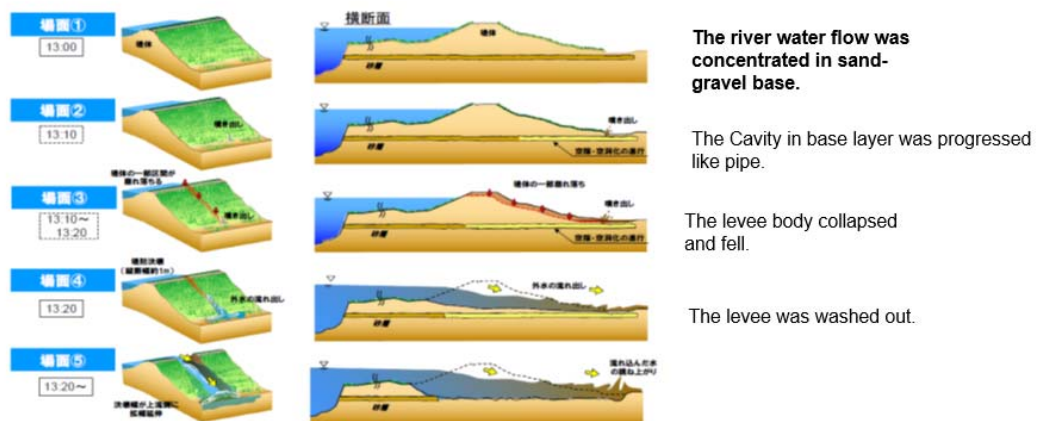
An example of levee failure due to piping erosion is illustrated below for a case on the Yabe river in 2012. In this example the high-water event caused erosion in a sand gravel layer at the base of the levee, which resulted in an eroded ‘pipe’ below the levee base. This resulted in collapse of the levee body and washing out of the levee, see Figure 3.27.

Figure 3.27 Example of piping erosion from the presentation ‘Picture-Card Show Project’ in JGS-JCES’, contribution by K. Maeda, M. Ishihara and H. Mori, using materials from the Ministry of Land, Infrastructure, Transport and Tourism in Japan.

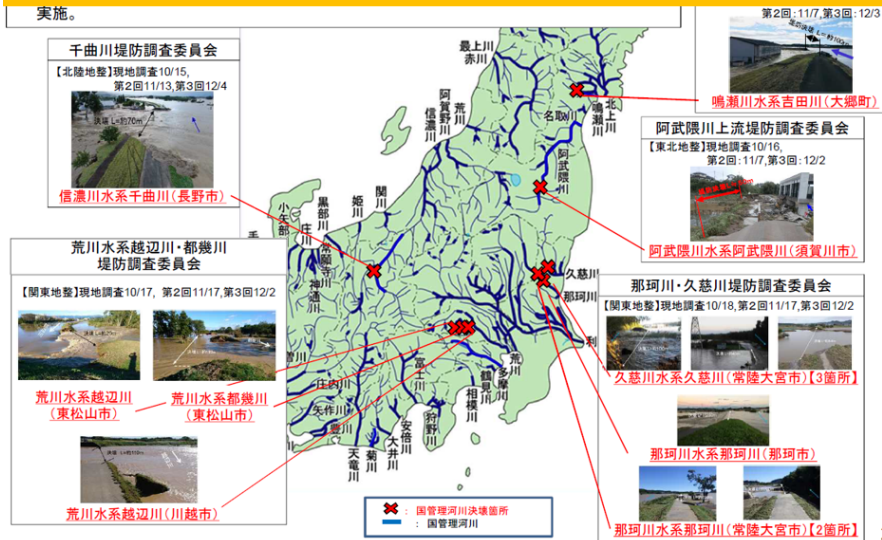
Figure 3.30 Location of overtopping from the presentation 'Picture-Card Show Project' in JGS-JCES', contribution by K. Maeda, M. Ishihara and H. Mori, using materials from the Ministry of Land, Infrastructure, Transport and Tourism in Japan.

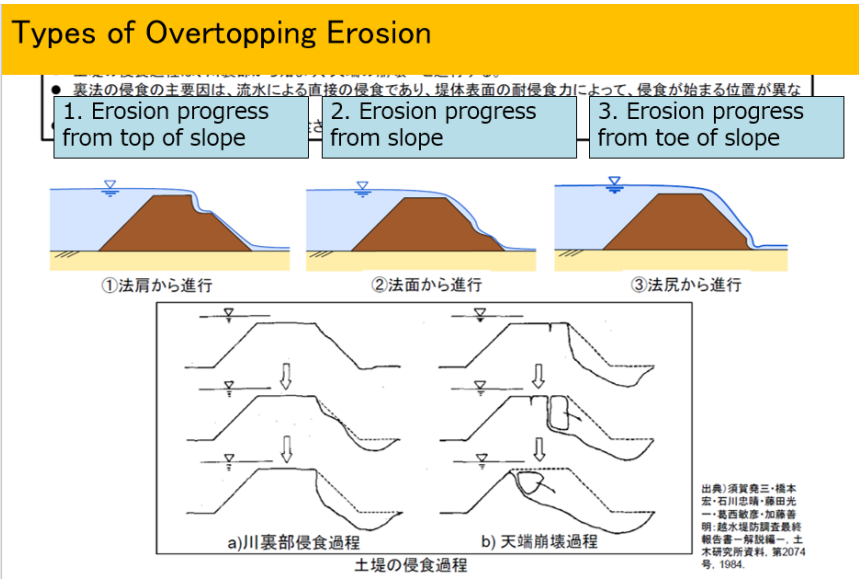
Figure 3.31 Type of overtopping from the presentation 'Picture-Card Show Project' in JGS-JCES', contribution by K. Maeda, M. Ishihara and H. Mori, using materials from the Ministry of Land, Infrastructure, Transport and Tourism in Japan.

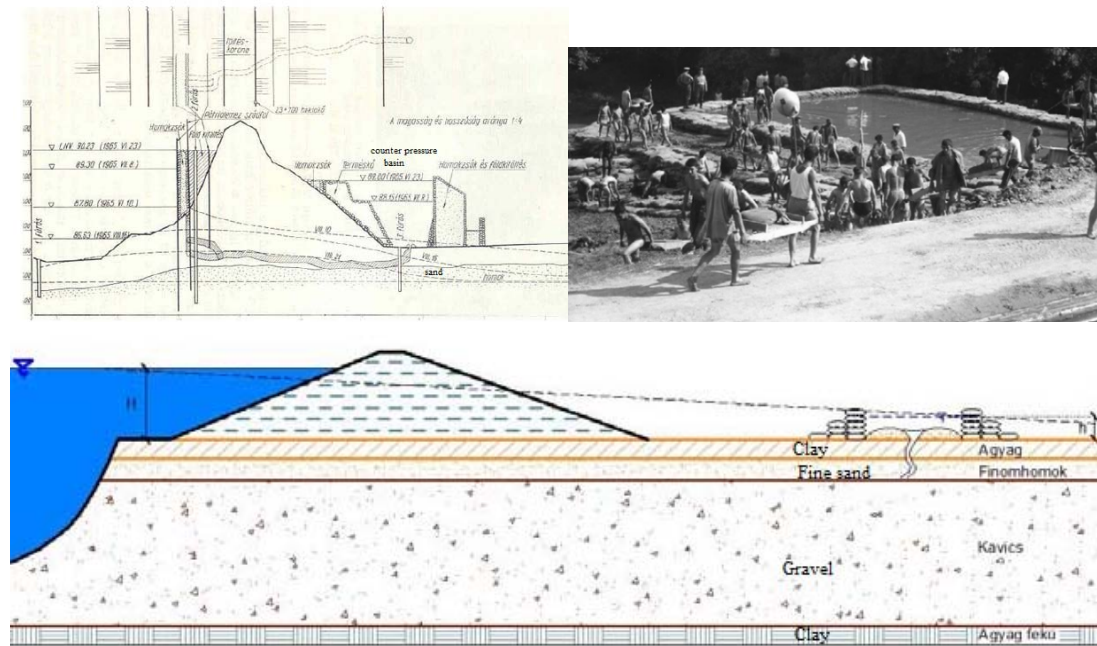
Figure 3.36 Danube, Margitta Island sand boil counter-pressure (top right) and diaphragm walls at the waterside (top left), the cause was the vicinity of an old meander (Garai, 2016). Water level of the counter-pressure basin (bottom).

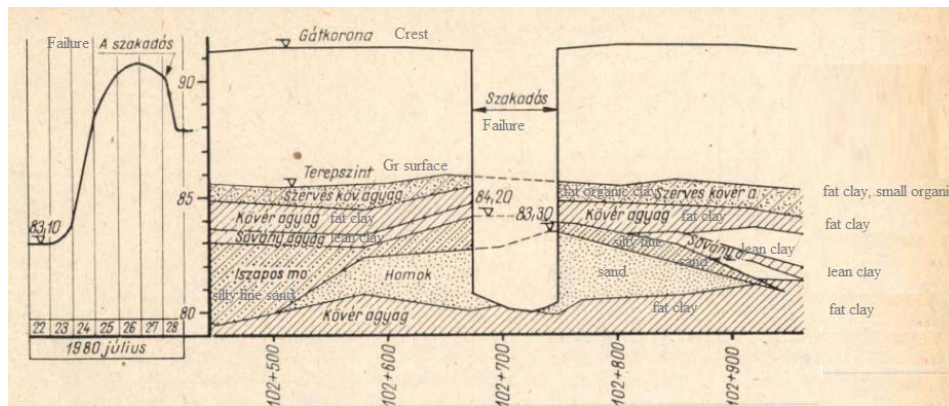
Figure 3.43 Kettős Körös, Hosszúfok in 1980, fast piping failure, failure location at top from (Szepessy, J.(1983)), with time history of flood. Bottom: grading curves, indicating the very loose sand inclusion with $3 < C_u$ and $e \sim 0.8$.

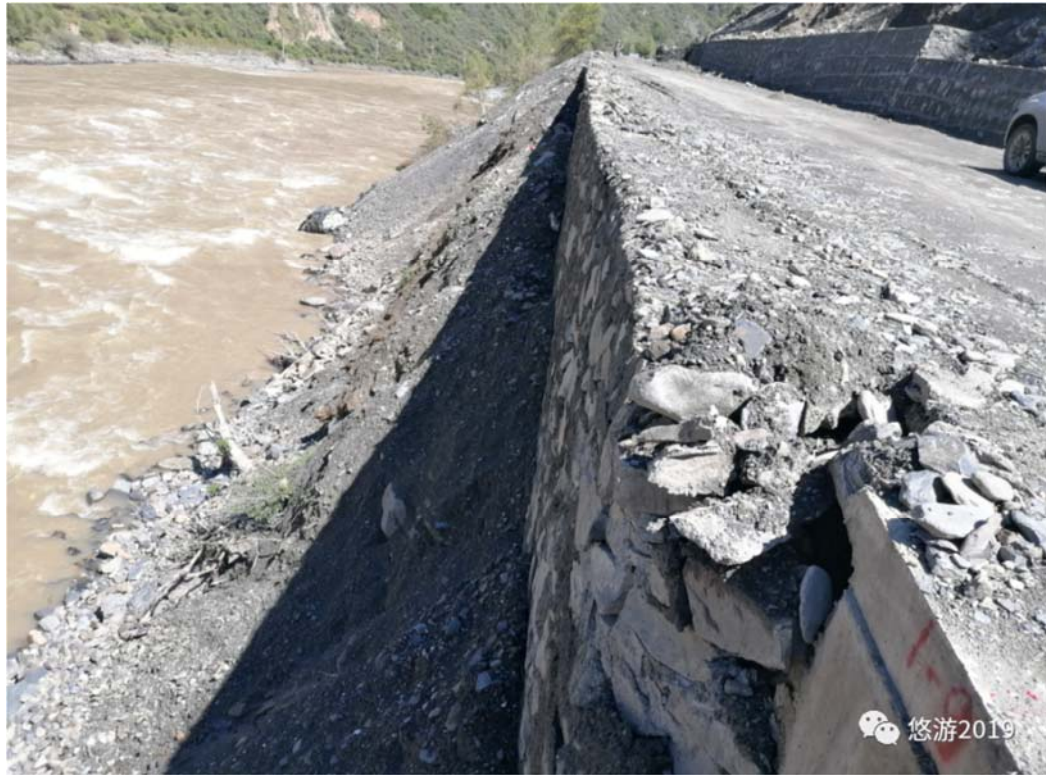
Figure 3.61 Outwards displacement of the bank slope and retaining wall.
