## Field testing of the overflow erosion of Rhone river levees

Key words: Levee, Overflow, Erosion, Field test.

To quantify the resistance of the soil to surface erosion, it is impossible to use results such as those used for surface protection systems. As is the practice in geotechnics, a test on the soil in question is necessary. Small-scale tests are excluded, as they do not provide a correct representation of the actual soil in place. For this reason, INRAE (Aix-en-Provence) developed an on-site overflow device in 2015. The procedure followed is based on ASTM-D6460 standard. Two types of tests were performed in May 2022 on a CNR 6.2 m high dike near Avignon (France).

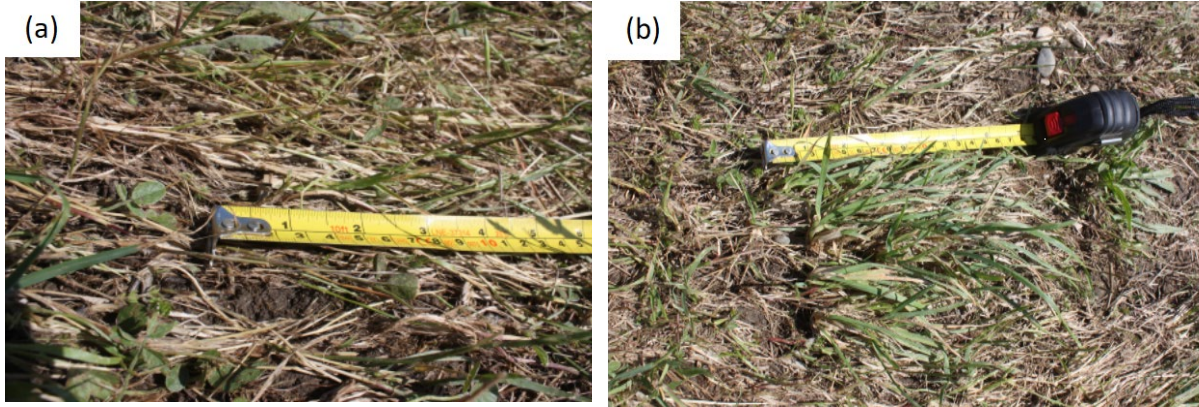
This analysis concerns channel 1. The natural grass cover was cut to a length of 3 cm two weeks before the trials. The site had a few days of rain and mainly sunshine during this period. Several plant species are present. Vegetation grew heterogeneously, depending on the species present. The cover on the high slope was overall homogeneous in density and did not have any significant uncovered soil surface. At the beginning of the trials, the length of the grass blades was variable and could reach up to 5 cm. After the 6h of flow, the grass blades remained lying in the direction of the flow (Figure 5). As for the gravel shoulder, which contains little fines, the vegetation cover is not significant. This is also true for the berm.

**Figure 5.** Natural vegetation cover after 6 hours of flow.

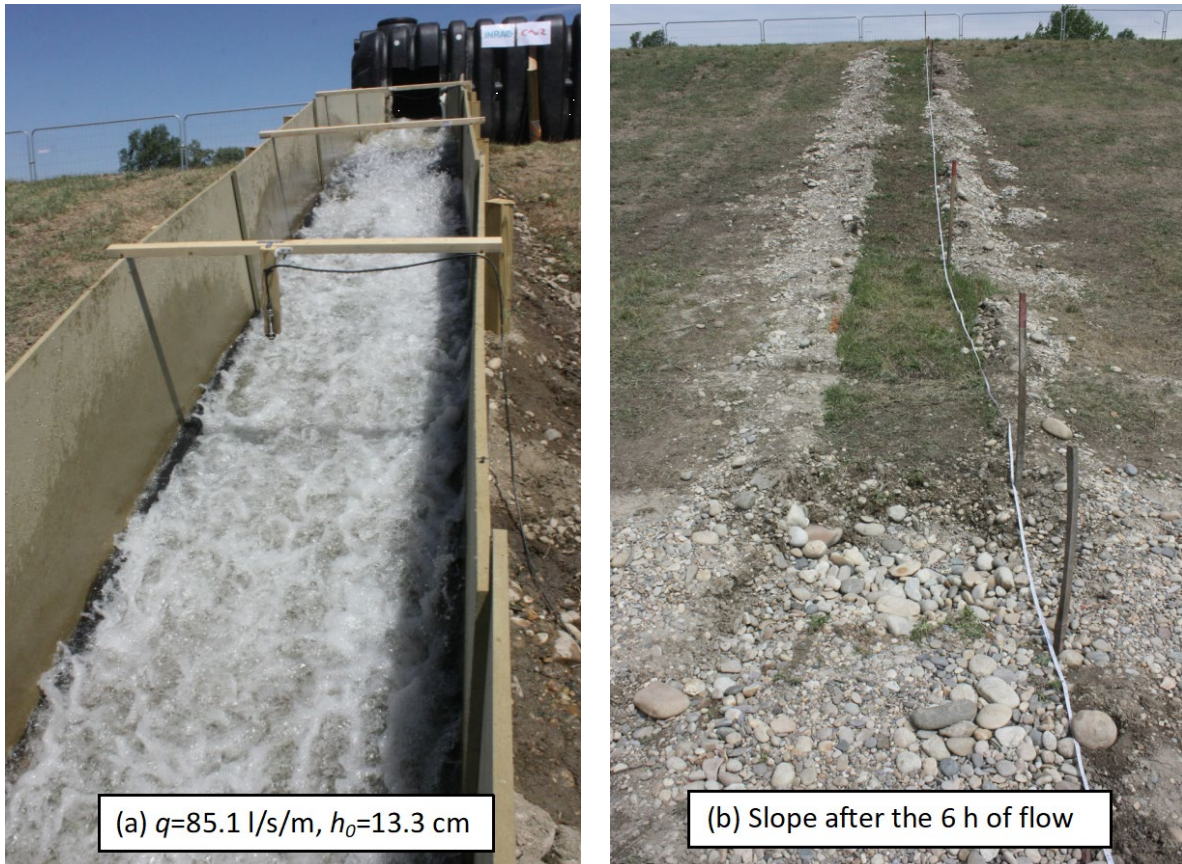
The flow rate was gradually increased from  $q=12.8$  l/s/m to  $q=128$  l/s/m. The flow corresponding to  $q=85.1$  l/s/m and  $h_0 = 13.3$  cm is shown in Figure 6a. The slope after the 6 h of flow is visible in Figure 6b. No significant erosion, in the sense of the Clopper index (ASTM, 2012), was observed.

It is remarkable that the silt deposit at the slope toe, also grassed over, was not eroded either.

It is not compacted silt, as it is constituted of deposited soil that comes from the surface erosion of the slope during rainy periods. This shows that the natural vegetation cover also protected this area. Therefore, no scouring of the slope toe was observed.

**Figure 6.** (a) Flow corresponding to  $q=85.1$  l/s/m and  $h_0 = 13.3$  cm. (b) Slope after the 6 h of flow.

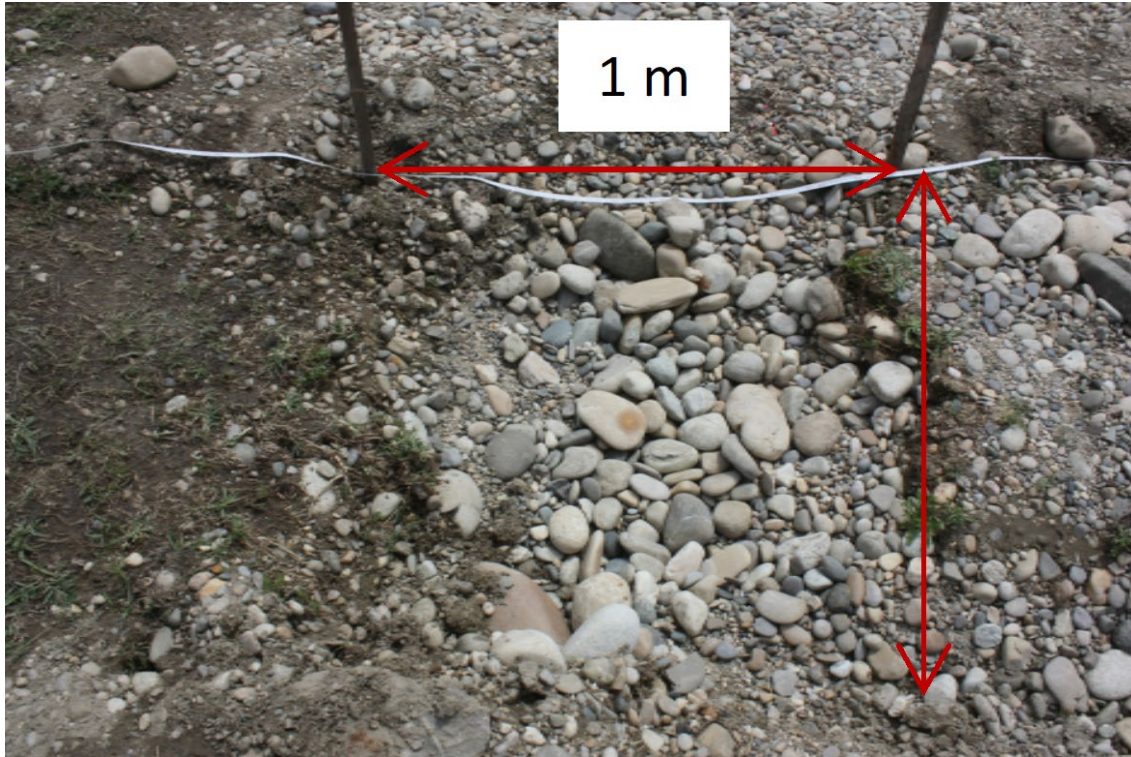
This analysis concerns channel 1. The scour on the berm is visible in Figure 5b: it is the gravel square between the two wooden posts. It is about 1 m wide, 1 m long and 20 cm deep after 6h00 of flow (Figure 6). This scour occurs about 2 m from the slope toe, just before the road, which is made of hard, compacted gravel.

**Figure 7.** Scouring at the slope toe after the 6 h of flow (channel 1), depth is 20 cm. The flow goes from the left to the right.

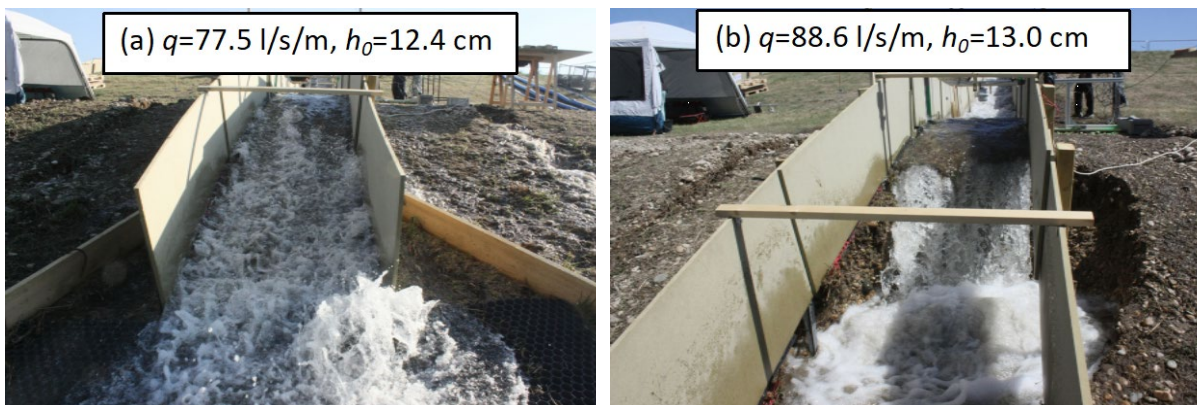
This analysis is for channel 1. The erosion of the gravel fill was initiated just below the road track, at the flow level  $q = 77.5$  l/s/m and  $h_0 = 12.4$  cm (Figure 4a). This flow is visible in Figure 8a. The situation one hour later is visible in Figure 8b for a similar flow ( $q = 88.6$  l/s/m,  $h_0 = 13.0$  cm), showing significant erosion of the gravel fill. The erosion between  $t=210$  min (initiation) and  $t=300$  min, for a little variable flow ( $q \approx 82$  l/s/m and  $h_0 \approx 13$  cm) is visible in Figure 9. After 6 hours of flow, the eroded area is 4 m long, maximum width of 2 m, maximum depth of 1.10 m, and corresponds to about 4 m<sup>3</sup> of eroded material (Figure 10).

**Figure 8.** (a) Flow corresponding to  $q=77.5$  l/s/m and  $h_0 = 12.4$  cm at the time of erosion initiation of the gravel fill. (b) Flow corresponding to  $q=88.6$  l/s/m and  $h_0 = 13.0$  cm one hour later, showing significant erosion of the gravel fill.

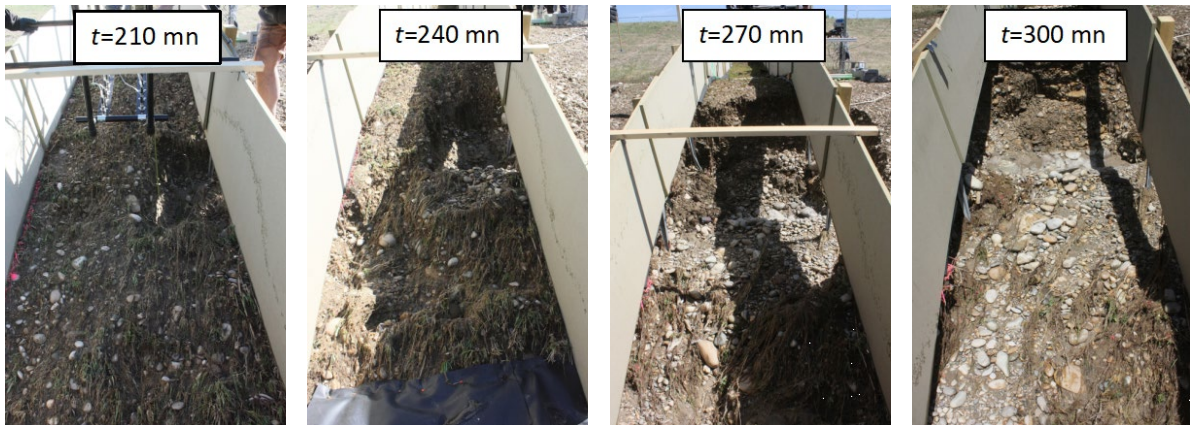
**Figure 9.** Erosion of gravel fill, between  $t = 210$  min (initiation) and  $t = 300$  min, for a little variable flow ( $q \approx 82$  l/s/m and  $h_0 \approx 13$  cm).

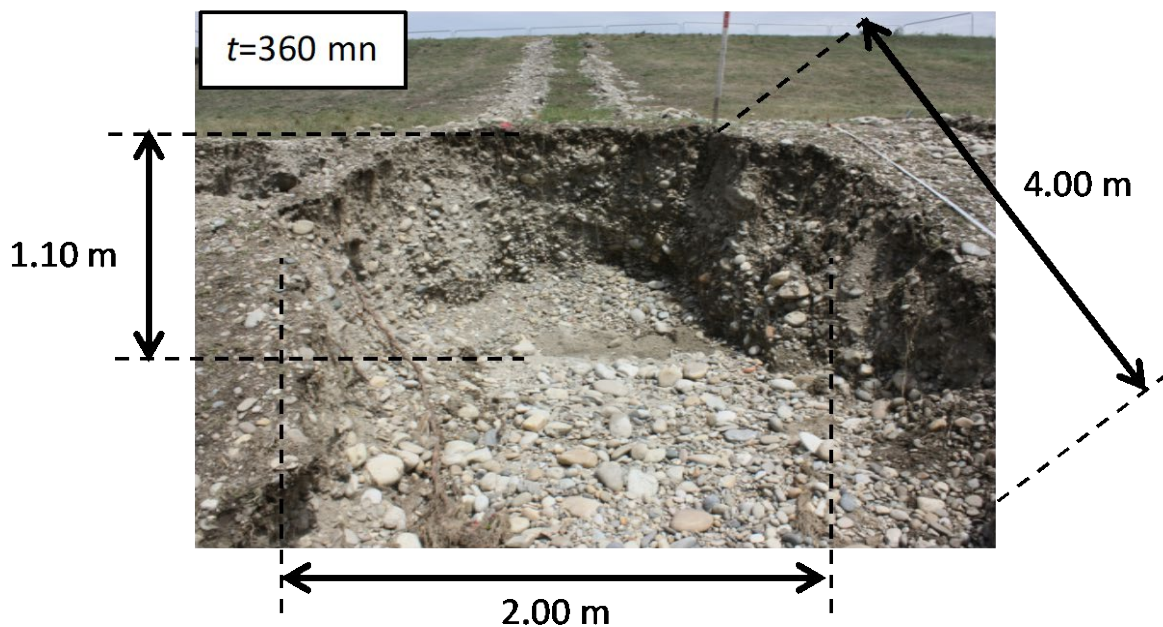
**Figure 10.** Erosion of gravel fill after 6 h of flow (channel 1).

- No erosion of the gravel fill was observed during the 60 min of flow at  $h_0 = 3.8$  cm, and the 120 min at  $h_0 = 8.3$  cm; erosion was initiated by the flow at  $h_0 = 12.9$  cm (approximately); the area eroded by 120 min of flow at  $h_0 = 12.9$  cm and 60 min at  $h_0 = 17.3$  cm is 4 m long, maximum width of 2 m, maximum depth of 1.10 m, and corresponds to about  $4 \text{ m}^3$  of eroded material;

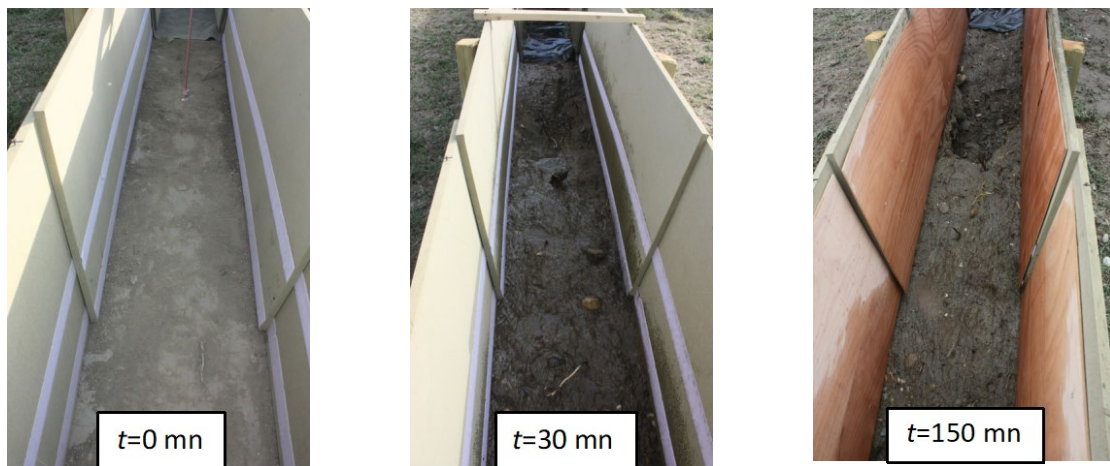
The soil before testing is visible in Figure 11. After 30 minutes of flow at  $q=24.0$  l/s/m and  $h_0 = 5.7$  cm, the visible erosion corresponds to that of the surface soil, which is not significant. The initiation of a scouring (Figure 11) is probably due to the fact that the flow has a locally high velocity at the outlet of the geomembrane. This result will allow to quantify the erosion threshold from the velocity measurements at this location. After 90 min of flow at  $q=24.0$  l/s/m and  $h_0 = 5.7$  cm, and 60 min of flow at  $q=43$  l/s/m and  $h_0 = 11.8$  cm, surface erosion is a few cm and scouring is more significant (Figure 11).

**Figure 11.** Erosion of compacted sandy silt, between  $t = 0$  and  $t = 150$  min (channel 1).

- Surface erosion of the sandy silt during the hydraulic conditions of Table 2 (channel 2) was only a few centimeters; this observation is surprising because laboratory and in situ erosion tests showed very little resistance to erosion; possible explanations include: (i) the role of the intertwined roots of the vegetation, (ii) the importance of the presence of the coarse fraction (gravel) in the silt, removed for the erosion tests; (iii) the importance of the intactness of the soil, compared to a laboratory specimen;

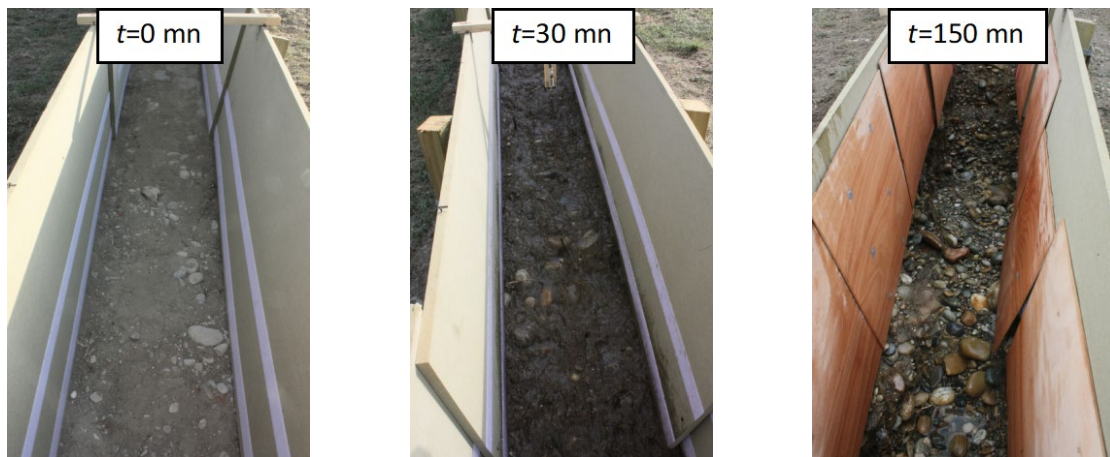
This analysis concerns channel 2. The soil before testing is visible in Figure 12. Significant surface erosion was observed from the first flow stage, corresponding to  $q=24.0$  l/s/m, and  $h_0 = 5.7$  cm (Figure 12). After 90 min of flow at  $q=24.0$  l/s/m and  $h_0 = 5.7$  cm, and 60 min of flow at  $q=43$  l/s/m and  $h_0 = 11.8$  cm, surface erosion reaches 20 to 30 cm (Figure 12). The visible soil corresponds to the coarse fraction, the fines having been washed away.

**Figure 12.** Erosion sandy gravel, between  $t = 0$  and  $t = 150$  min (channel 1).

Erosion of the sandy gravel formed a step with the sandy silt, located 8.70 m from the crest at  $t=30$  min. This step then regressed to 3.20 m from the crest. This evolution is probably more responsible for the departure of the sandy silt (by mechanical instability), than the surface erosion of the silt itself.

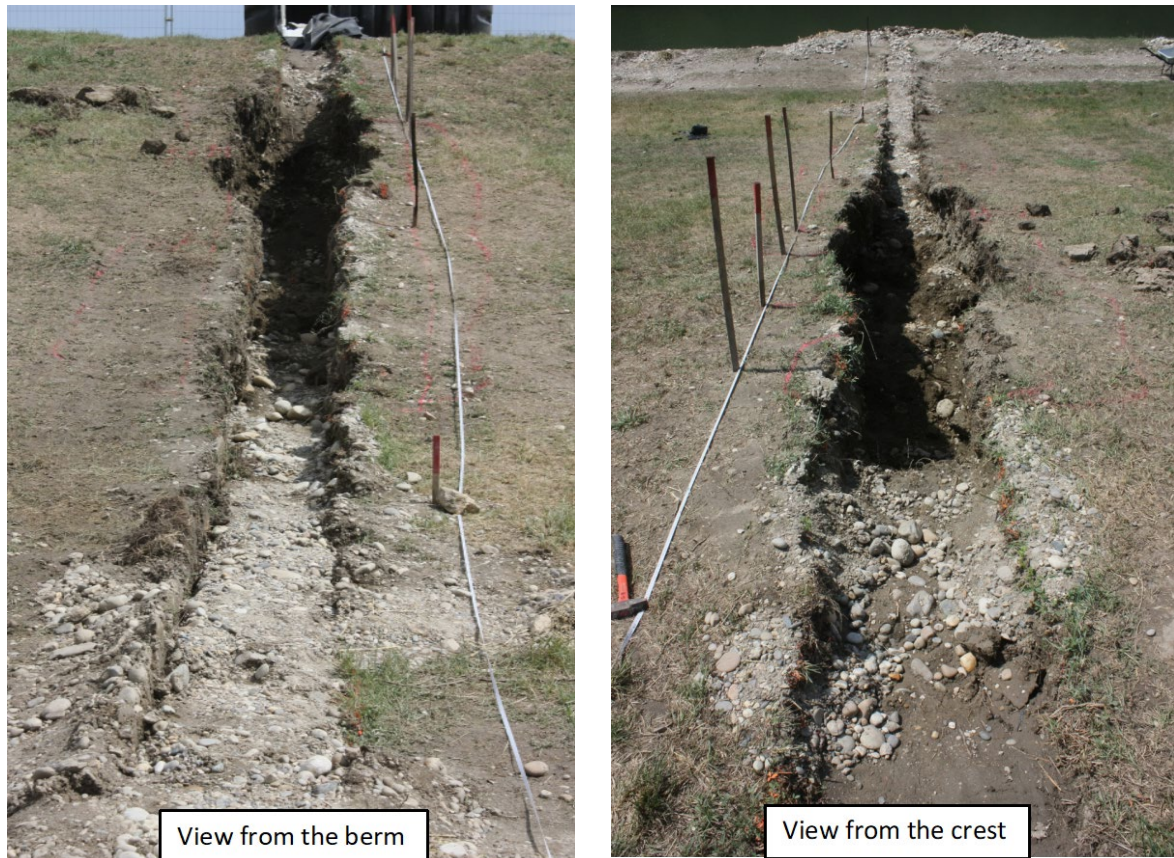
After 4h30 hours of flow, the eroded area is 10 m long, maximum width of 1.80 m, maximum depth of 1.50 m, and corresponds to about 9 m<sup>3</sup> of eroded material (Figure 13).

Part of the coarse fraction of the eroded soils was deposited in the downstream part of the eroded areas, especially on the berm. This probably explains why the silt deposited at the foot of the slope, covered by these gravels, was not eroded. These deposits are visible in Figure 13.

**Figure 13.** Erosion of compacted sandy silt and sandy gravel after 4h30 of flow (channel 2).

- Erosion of the sandy gravel began at the first flow corresponding to  $h_0 = 5.7$  cm; the area eroded by 90 min of flow at  $h_0 = 5.7$  cm, and 90 min at  $h_0 = 11.8$  cm and 90 min at  $h_0 = 18.5$  cm is 10 m long, maximum width of 1.8 m, maximum depth of 1.5 m,

and corresponds to about 9 m<sup>3</sup> of eroded material;

- The removal of the compacted sandy silt is mainly due to the erosion of the sandy gravel layer; this erosion formed a step whose height increased as it regressed towards the crest; it resulted in mechanical instabilities which caused the removal of the silt by clods;
- No scouring of the slope toe was observed on channel 2; this is probably due to the deposit of the coarse fraction of the eroded soils that protected the soil.

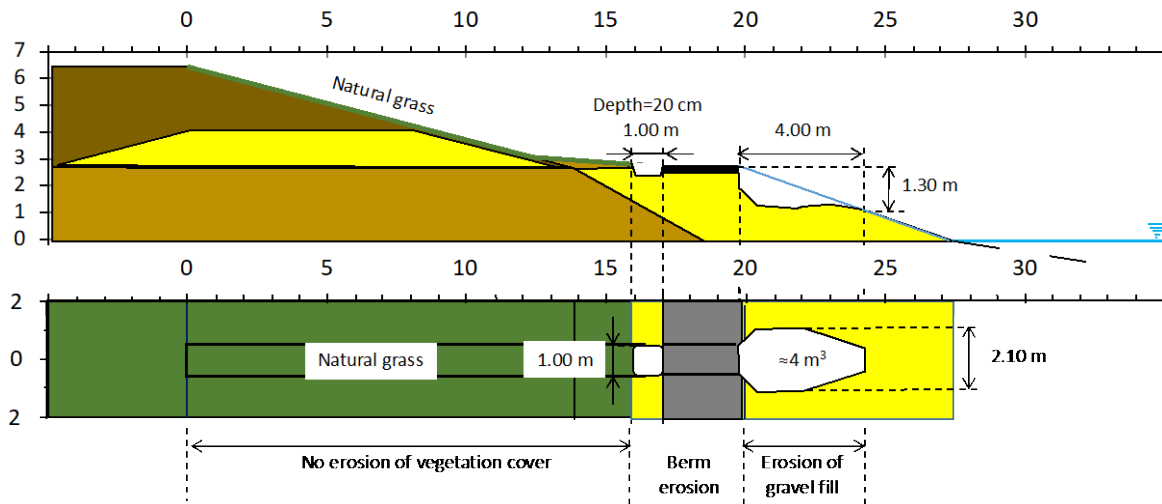
- No significant erosion of the natural vegetation cover, in the sense of the Clopper index (ASTM, 2012), was observed; this vegetation appears to be resistant to a flow of the type described in Table 2 (channel 1), i.e. 6 h in duration, with a water depth at the crest that starts at  $h_0 = 3.8$  cm and increases in stages to  $h_0 = 17.3$  cm; it constituted a protection for all types of soils concerned: compacted sandy silt, sandy gravel, and deposited sandy silt;
- No scouring of the slope toe was observed on channel 1; this is probably due to the protection by the vegetation cover;
- A small erosion scour formed on the berm, of 1m x 1m and 20 cm deep; it was located between the slope toe and the road track, where vegetation cover is not significant;

**Figure 14.** Summary of erosion observations on channel 1 after 6 h of flow.

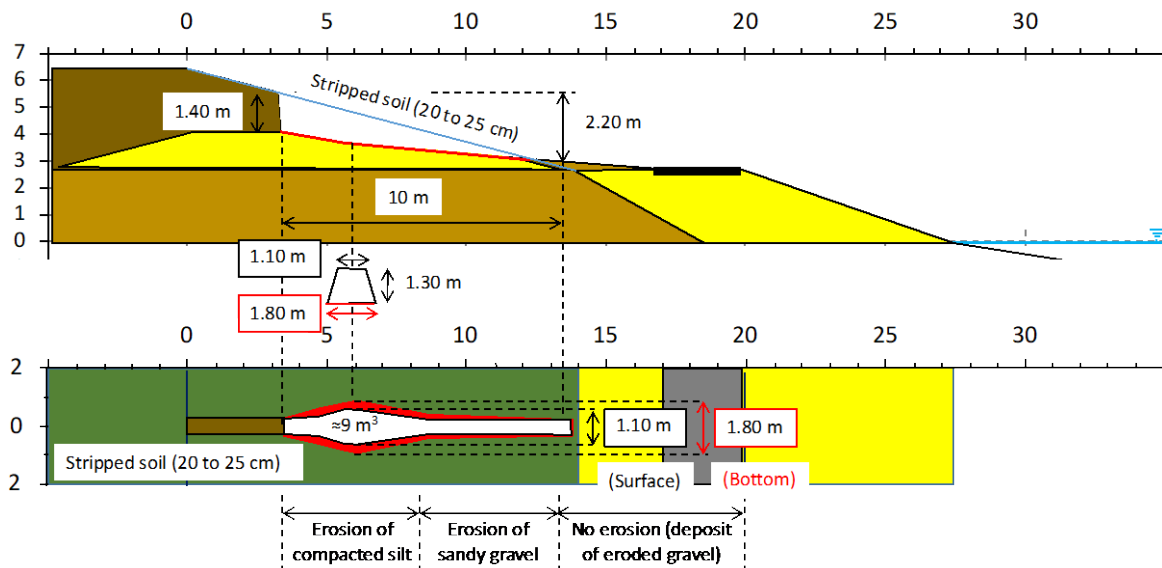
**Figure 15.** Summary of erosion observations on channel 2 after 4h30 of flow.
