FIELD TESTING OF THE OVERFLOW EROSION OF RHONE RIVER LEVEES

Key words: Levee, Overflow, Erosion, Field test.

To quantify the resistance of the soil to surface erosion, it is impossible to use results such as those used for surface protection systems. As is the practice in geotechnics, a test on the soil in question is necessary. Small-scale tests are excluded, as they do not provide a correct representation of the actual soil in place. For this reason, INRAE (Aix-en-Provence) developed an on-site overflow device in 2015. The procedure followed is based on ASTM-D6460 standard. Two types of tests were performed in May 2022 on a CNR 6.2 m high dike near Avignon (France).

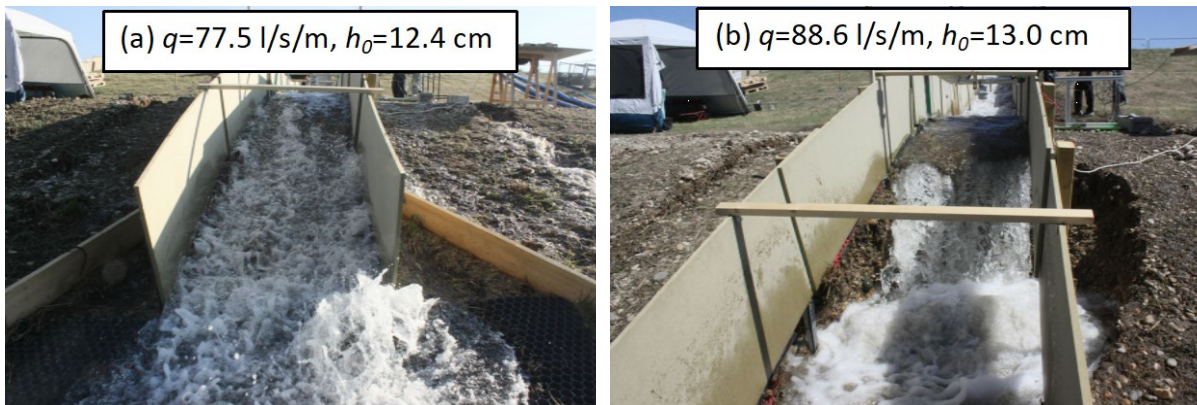
This analysis is for channel 1. The erosion of the gravel fill was initiated just below the road track, at the flow level $q = 77.5$ l/s/m and $h_0 = 12.4$ cm (Figure 4a). This flow is visible in Figure 8a. The situation one hour later is visible in Figure 8b for a similar flow ($q = 88.6$ l/s/m, $h_0 = 13.0$ cm), showing significant erosion of the gravel fill. The erosion between $t=210$ min (initiation) and $t=300$ min, for a little variable flow ($q \approx 82$ l/s/m and $h_0 \approx 13$ cm) is visible in Figure 9. After 6 hours of flow, the eroded area is 4 m long, maximum width of 2 m, maximum depth of 1.10 m, and corresponds to about 4 m³ of eroded material (Figure 10).

Figure 8. (a) Flow corresponding to $q=77.5$ l/s/m and $h_0 = 12.4$ cm at the time of erosion initiation of the gravel fill. (b) Flow corresponding to $q=88.6$ l/s/m and $h_0 = 13.0$ cm one hour later, showing significant erosion of the gravel fill.

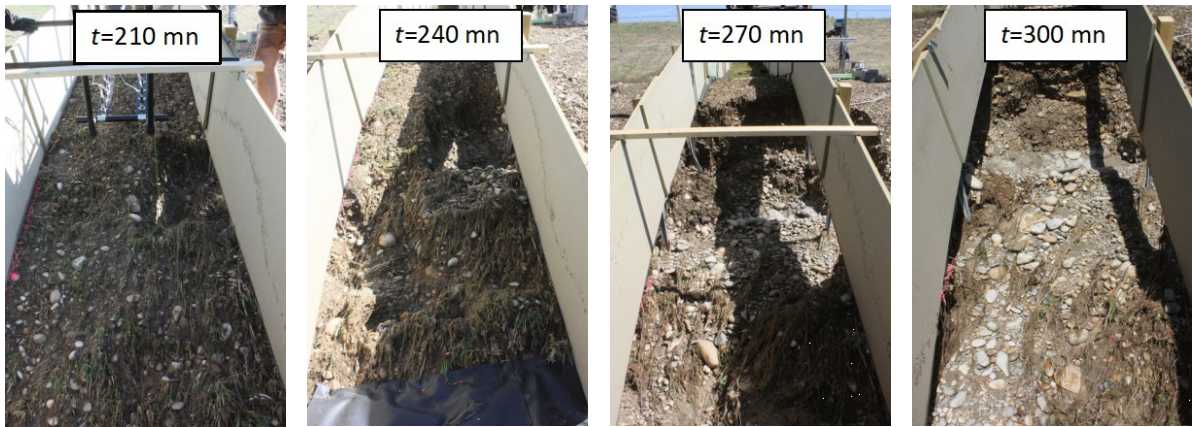
Figure 9. Erosion of gravel fill, between $t = 210$ min (initiation) and $t = 300$ min, for a little variable flow ($q \approx 82$ l/s/m and $h_0 \approx 13$ cm).

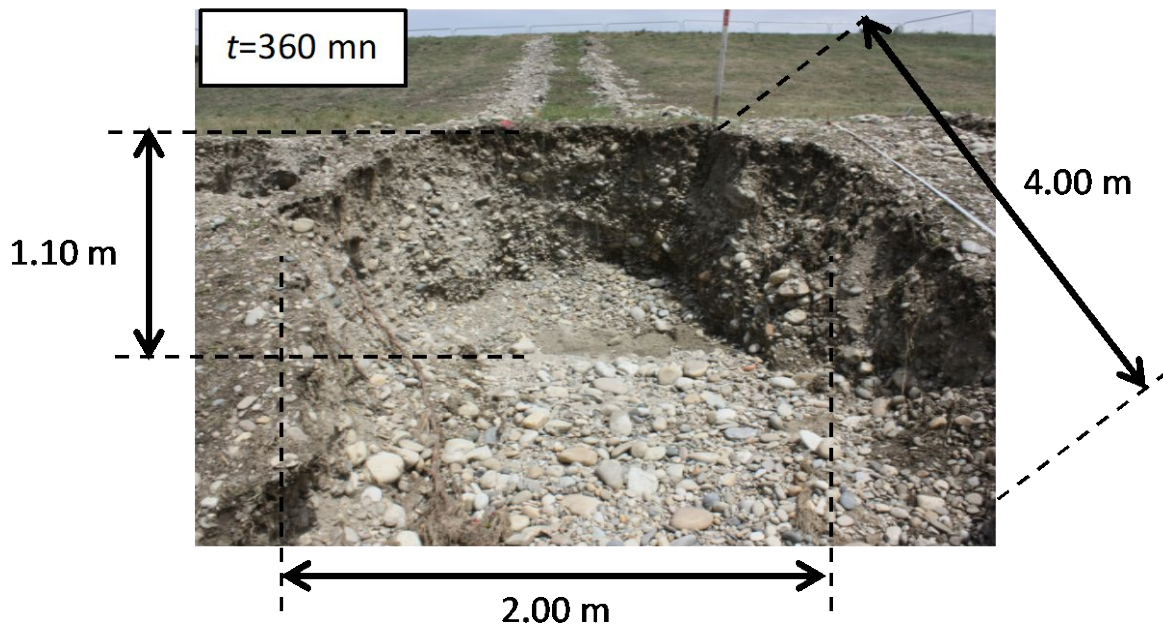
Figure 10. Erosion of gravel fill after 6 h of flow (channel 1).

- No erosion of the gravel fill was observed during the 60 min of flow at $h_0 = 3.8$ cm, and the 120 min at $h_0 = 8.3$ cm; erosion was initiated by the flow at $h_0 = 12.9$ cm (approximately); the area eroded by 120 min of flow at $h_0 = 12.9$ cm and 60 min at $h_0 = 17.3$ cm is 4 m long, maximum width of 2 m, maximum depth of 1.10 m, and corresponds to about 4 m^3 of eroded material;
