FloodProBE Project WP 3: Reliability of Urban Flood Defences. Guidebook for Using Helicopter-Borne Lidar to Contribute to Levee Assessment – Experiment on “Val d’Orléans” Pilot Site

Date: October 2012

Report Number: WP03-01-12-03

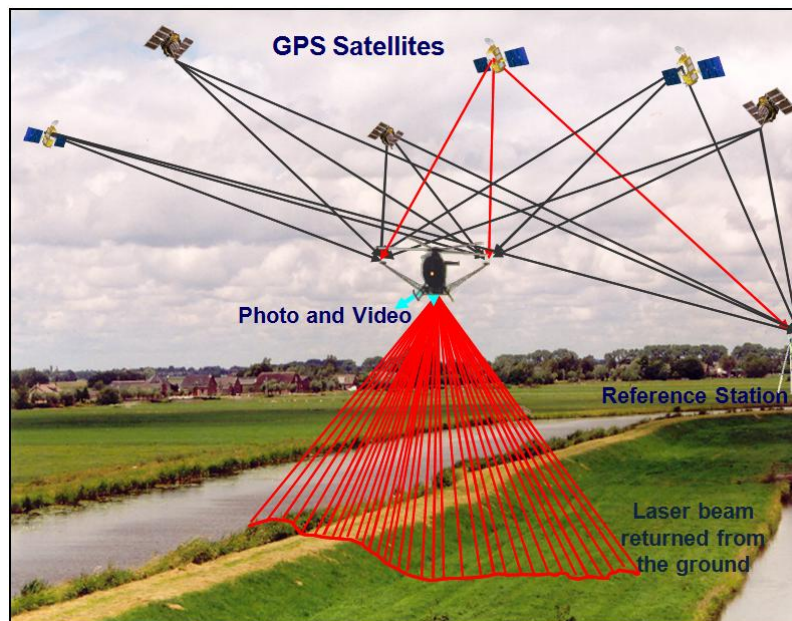
Figure 1: Helicopter-Borne LiDAR Acquisition Principle [source: Fugro-Geoid©]

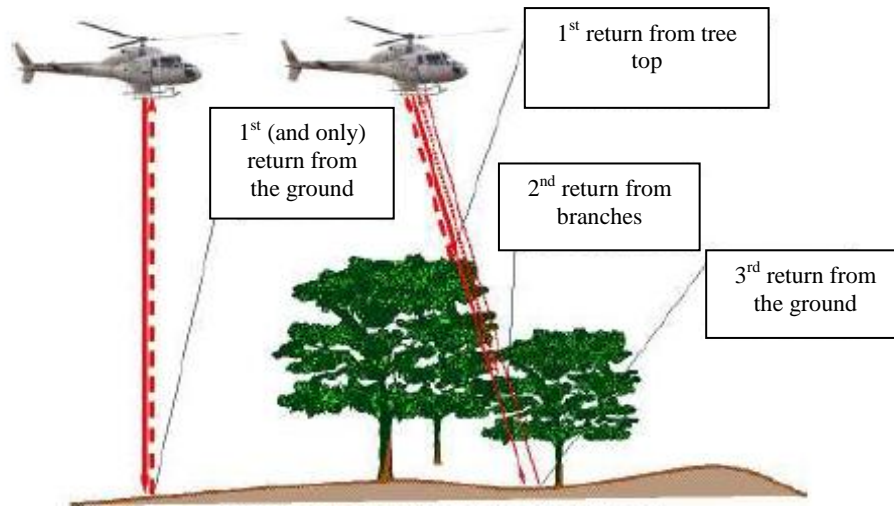
Figure 2: Laser Multiple Return Principle [source: Fugro-Geoid©]

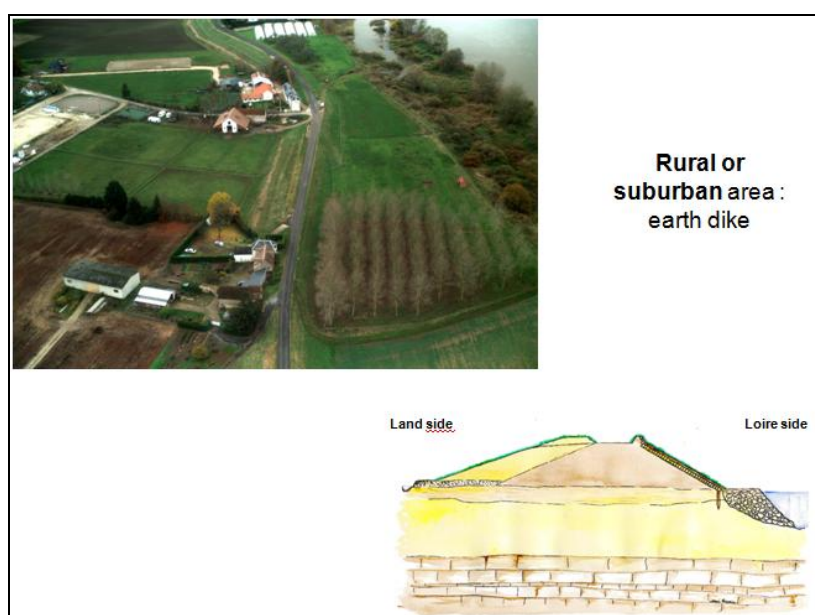
- ◆ Levees or embankment dikes, in rural and suburban areas (50 km), either touching the low-water bed (10 km), or more or less distant from the said low water-bed (40 km) with a "franc-bord" (*freeboard*) covering the area between the low-water bed and the levee. Compared to traditional dikes, Loire river levees typically feature a "banquette" (earth ridge or parapet) on top, either on the river side or on the land side (and sometimes on both sides) and a drainage blanket on the land side of the levee

Figure 3: Example of Rural or Suburban Area Levee. Constructions Embedded in the Landside Slope

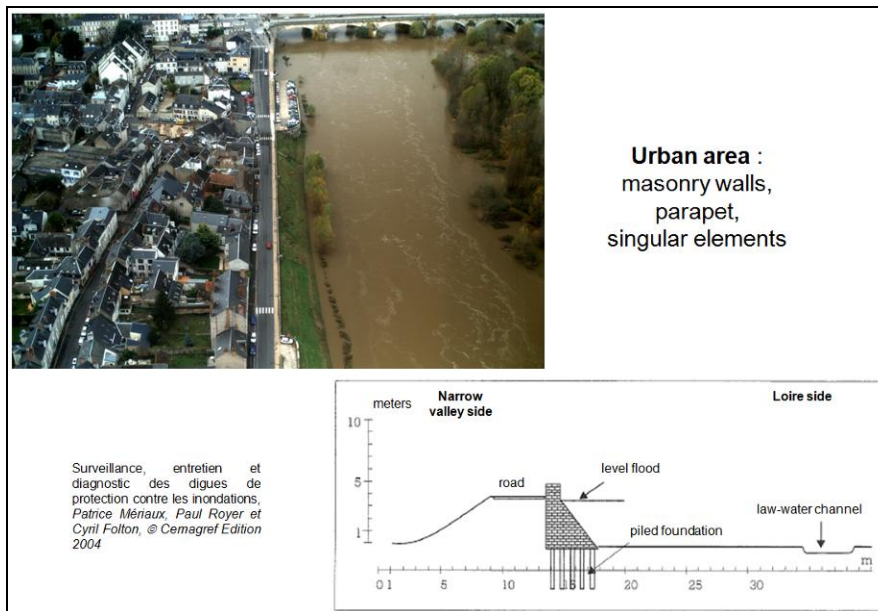
- ◆ Embedded stone or embankment-masonry composite dikes or docks in urban areas (4 km), either topped or not with parapets or curbs and including or not many singular works (flashboards, wedges, pipes or sluices)

Figure 4: Example of Urban Area Levee. Wall and Irregular Works in the Loire River Side Slope

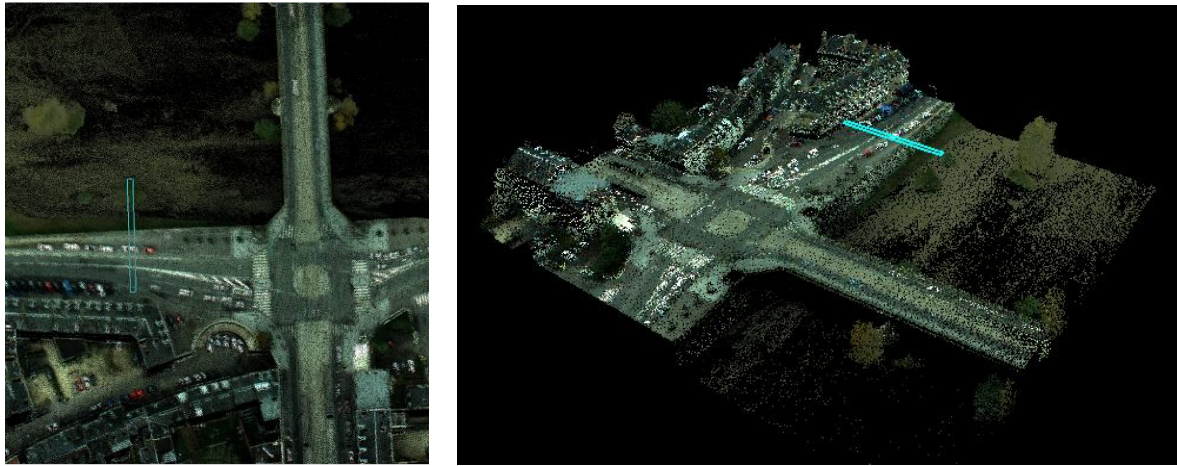
The raw laser point density higher than 80 points per square meter helps display all visible and identifiable topographical items with an image size that is more than 1 mm on a scale of 1:500. The FliMap system features a camera built in the laser for real-time coloring of all measured laser points. Laser point color is the natural color of the object obstructing the first laser return path. There is no need to wait for ortho-photographs to read into the laser points.

Figure 5: Plan and 3D Views of Natural Colored Raw Points of Left Bank Abutment Area

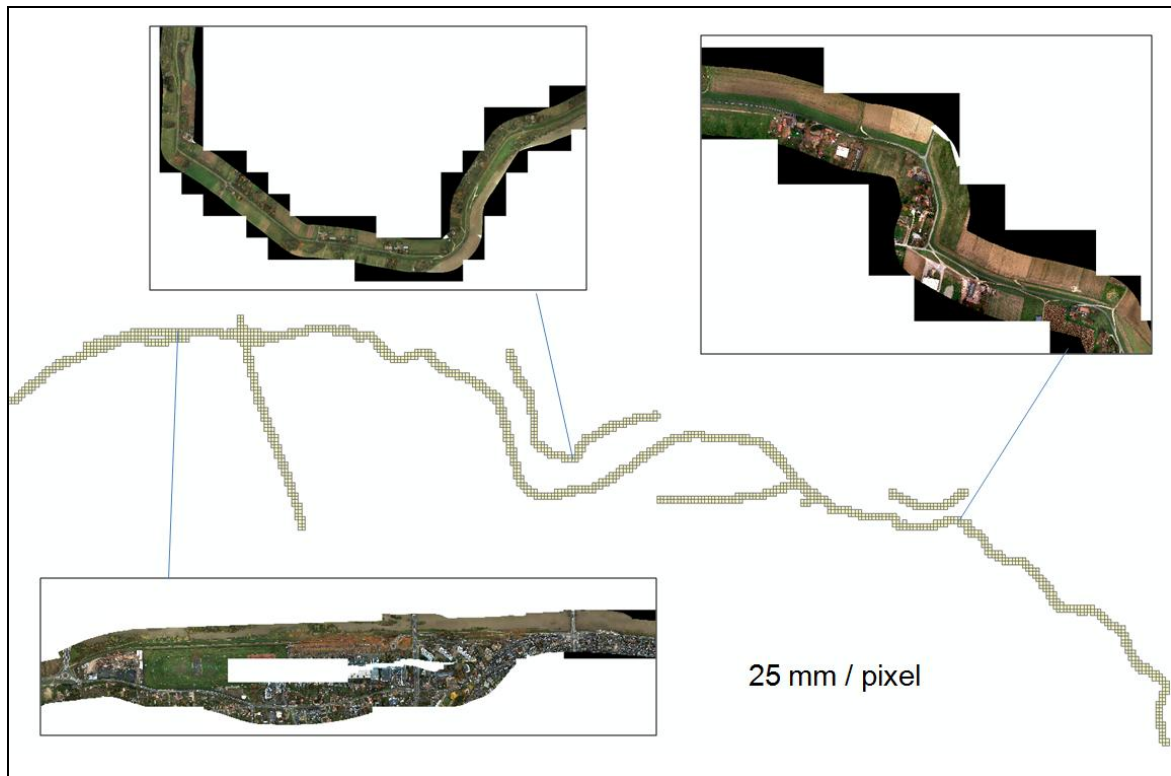
Figure 8: Ortho-Mosaic Index Charts

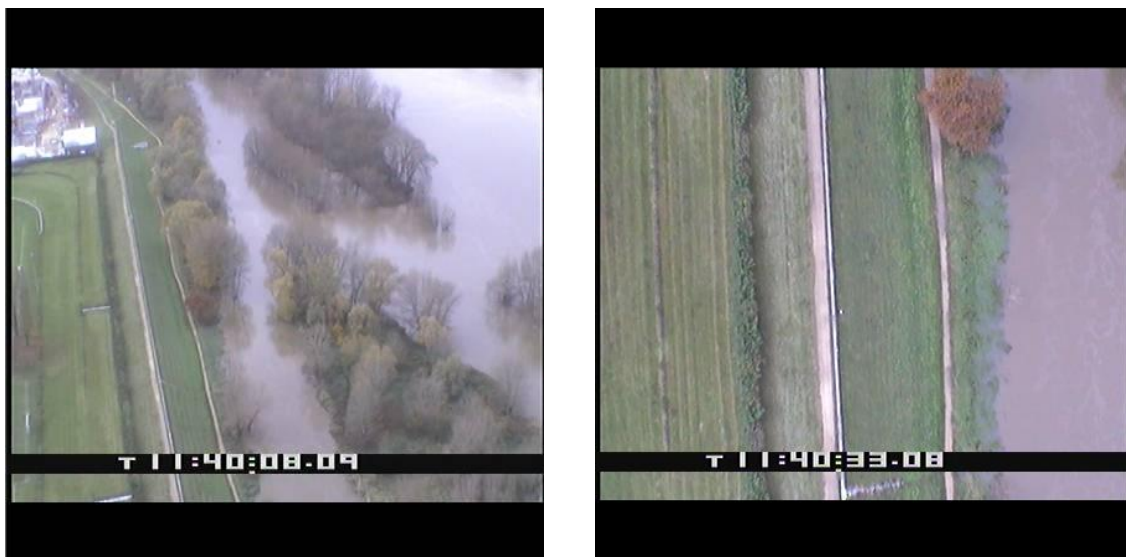
In raw version, these videos are geo-referenced from the recording hours and may be viewed on Windows Media Player and on ArcGis through FliMap Analyst plug-in.

Figure 9: Examples of High Resolution Videos Taken During Flight: Oblique and Nadir Views

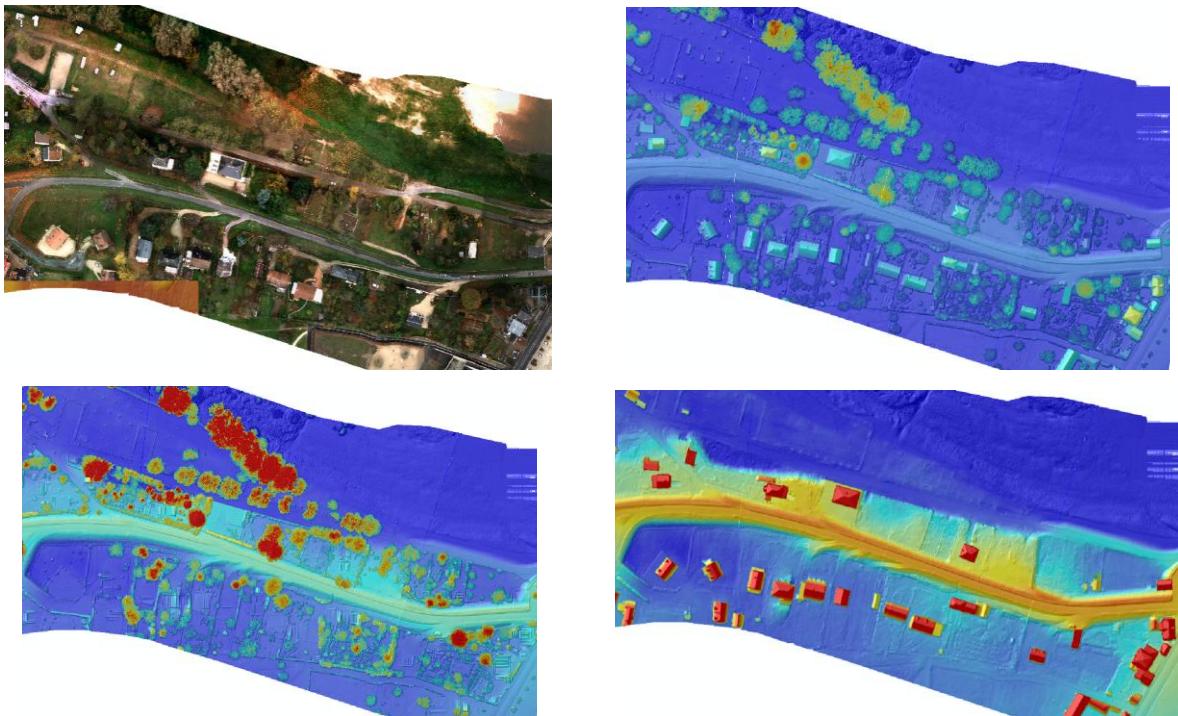
Following tests performed on three types of grids (0.5 m, 0.2 m and 0.1 m screen densities) to measure information display time on a GIS, a grid scale of 0.10 meter screen density was finally maintained for all three DSM products.

Figure 10: Left to Right, Bottom to Top: Ortho-Mosaic, DSM, No-Construction DSM, No-Vegetation DSM from the Same Area

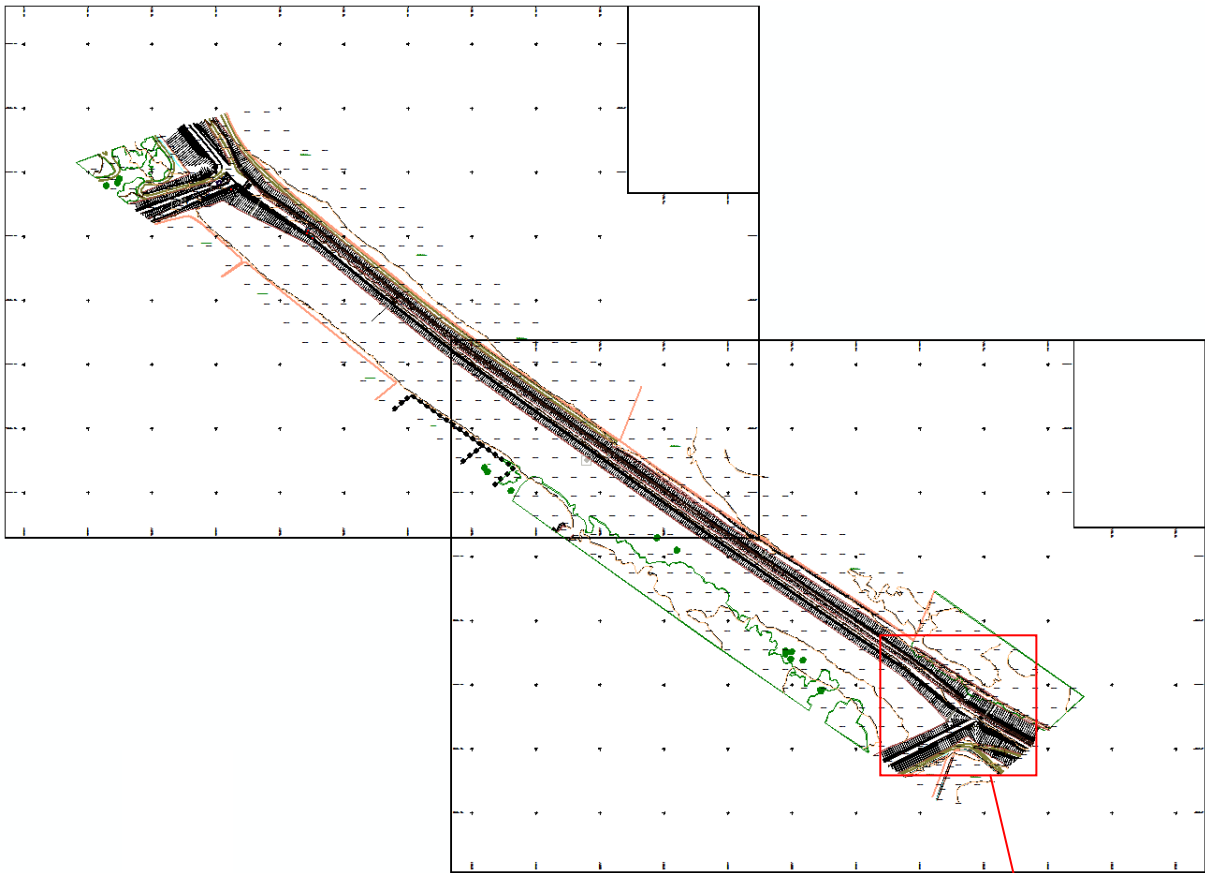
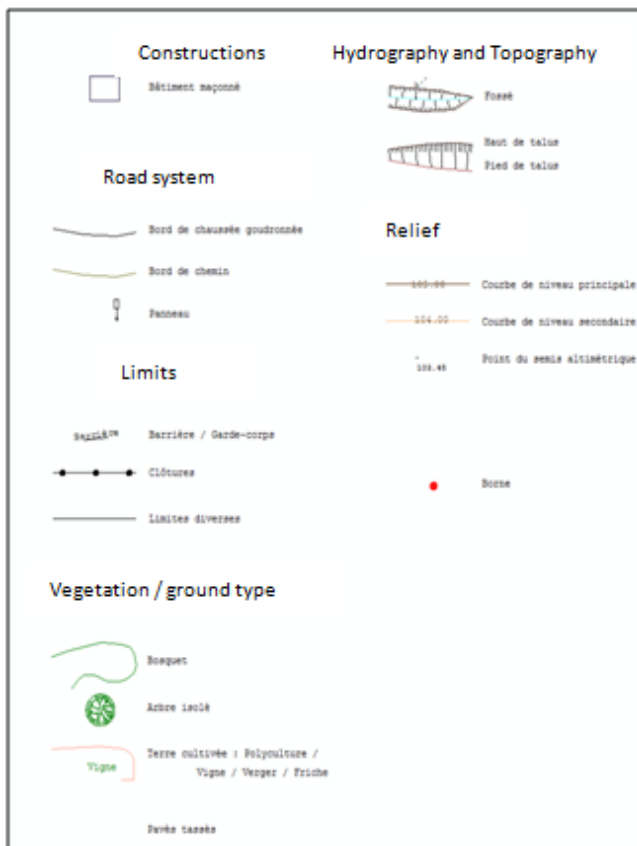
Top and toe longitudinal profiles up and down the embankment, cross-sections and topographic plans were drawn up on a number of selected specific levee sections along the overflown alignment. Below is an example (Figure 12) with Jargeau spillway topographic plan.

Figure 12: Abstract from Jargeau Spillway Topographic Plan

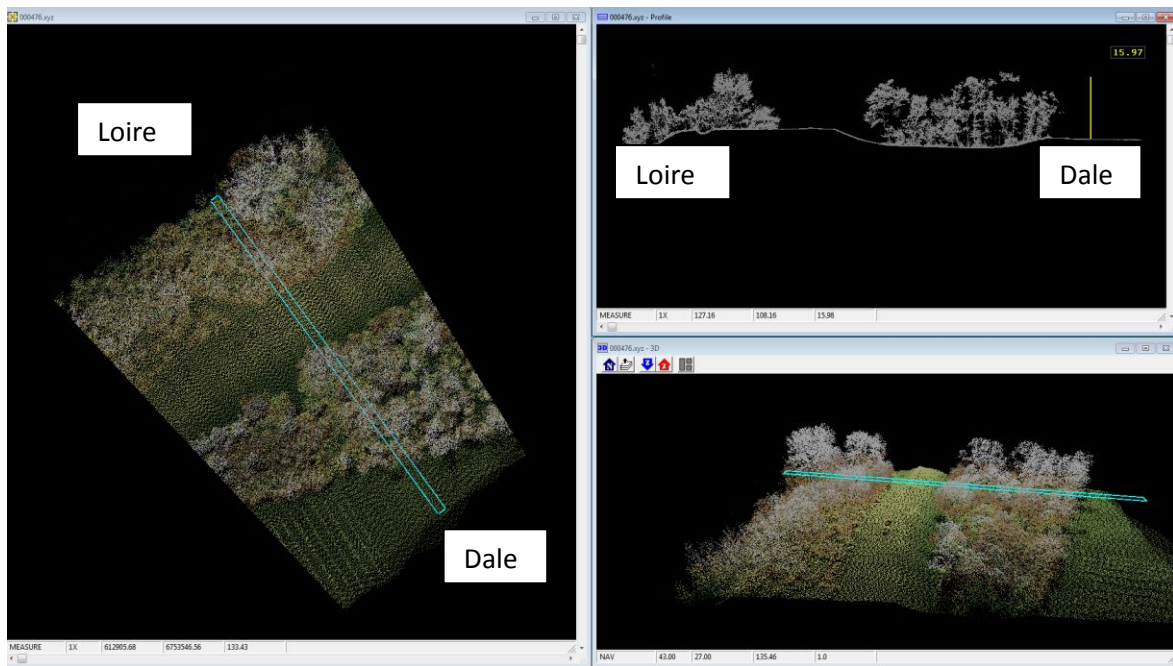
- On the levee slope, on the Loire river side and down the slope on the land side:

Figure 16: Example of Vegetation on Levee Slope, on Loire River Side and Down the Slope on the Land Side

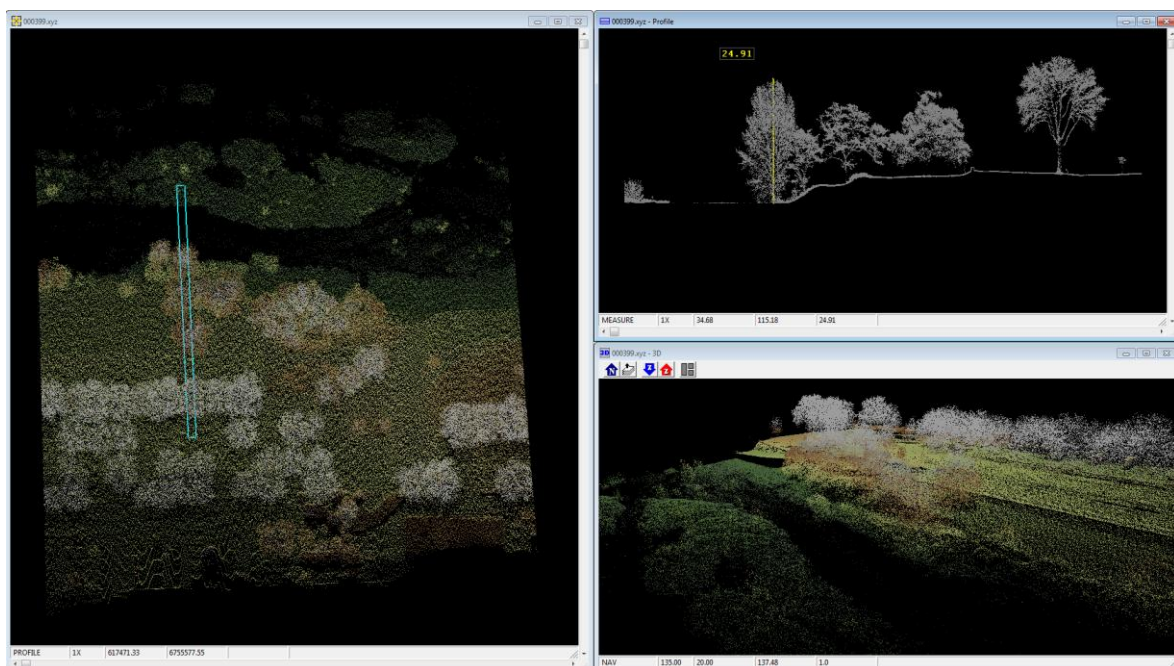
- Down the levee toe, on the Loire river side, with a stone curb:

Figure 17: Example of Vegetation down the Levee Toe, With a Curb

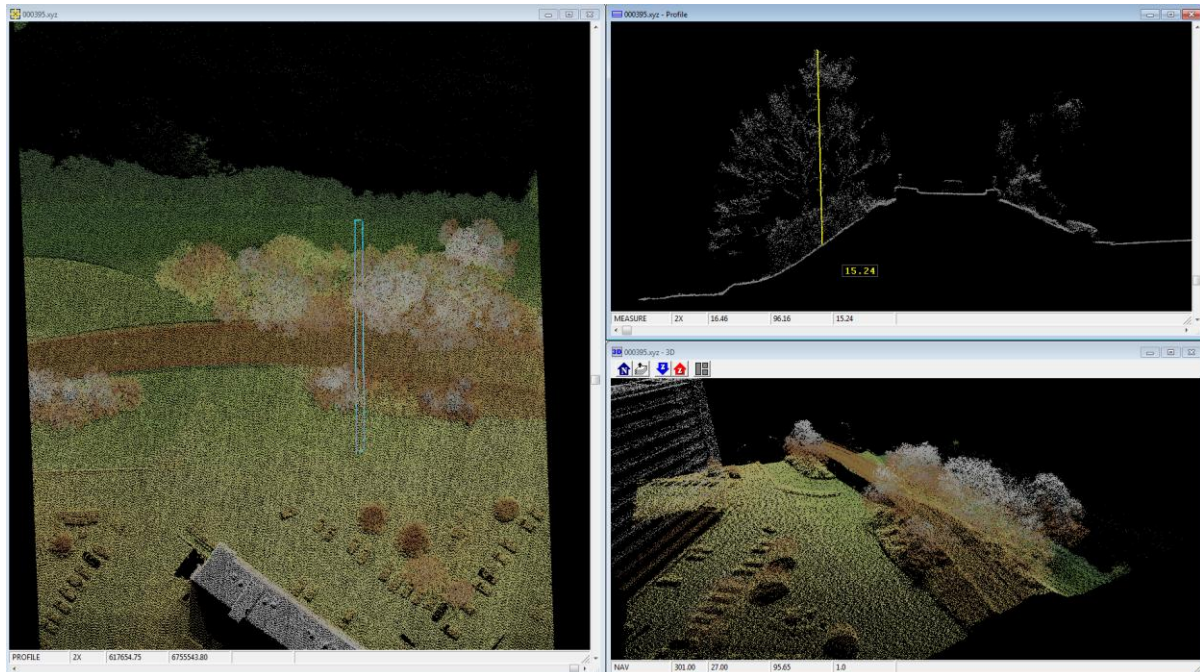
Figure 18: Example of Vegetation on the Levee River Side Slope, Close to Low-Water Bed

A group of trees has grown on that face. One of the trees identified in this group is rather massive (15 m high): its root system is most likely extensive and presumably enters deep in the levee body, which is challenging to the work manager. Moreover, the crown shows a significant wind resistance which may lead to the tree being pulled out in the event of a storm, inducing potential damage to the face and masonry works.

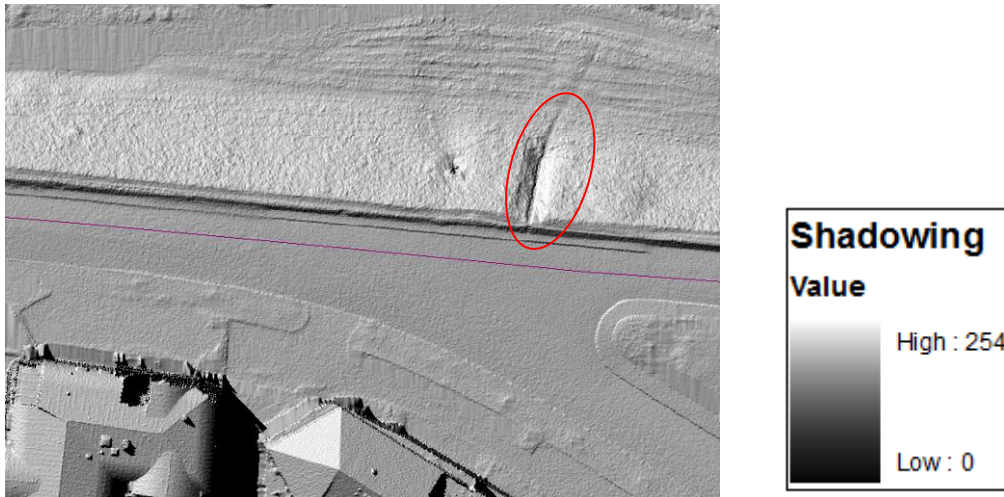
Figure 19: Shadowing Treatment on DSM

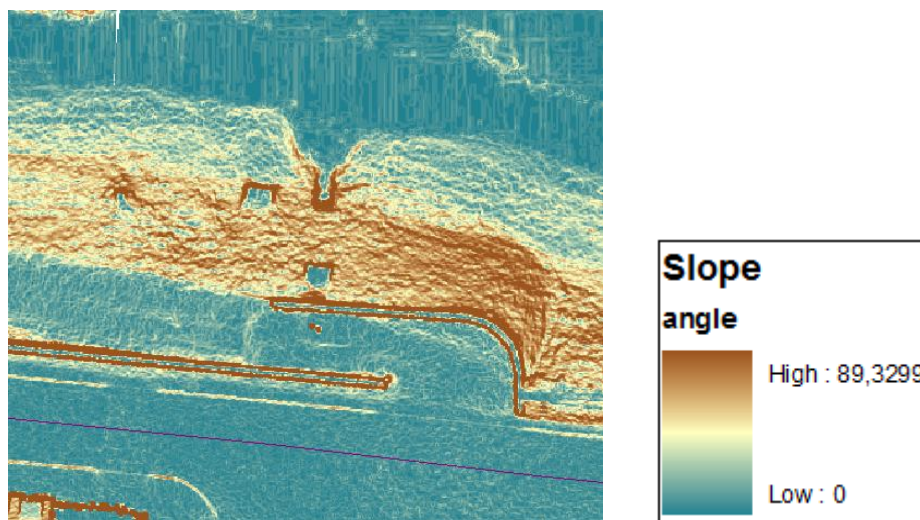
Figure 20: Slope Treatment on DSM

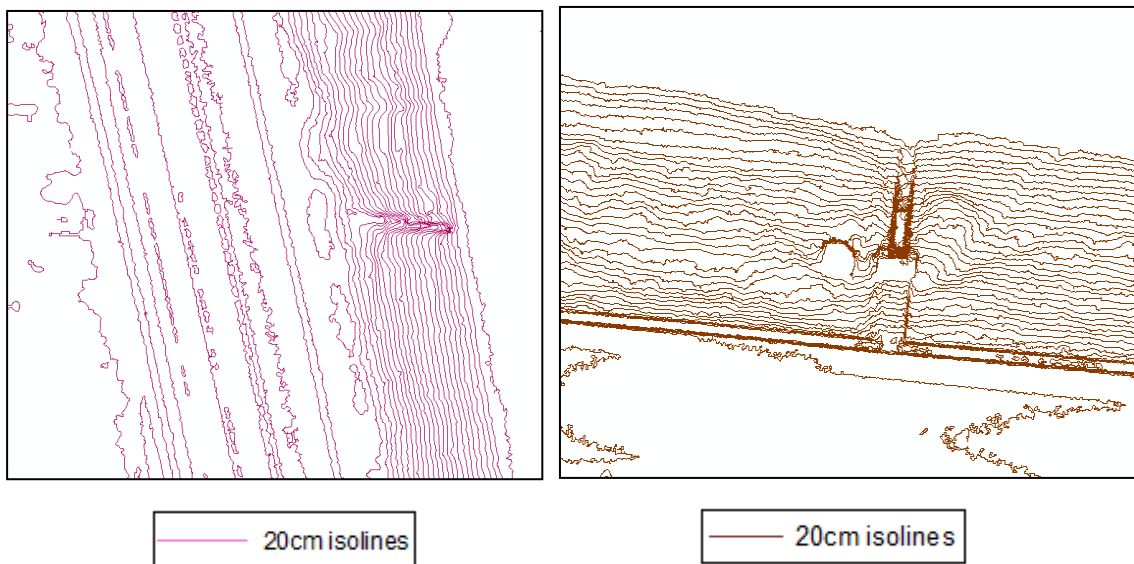
Figure 22: Isogram Treatment on DSM

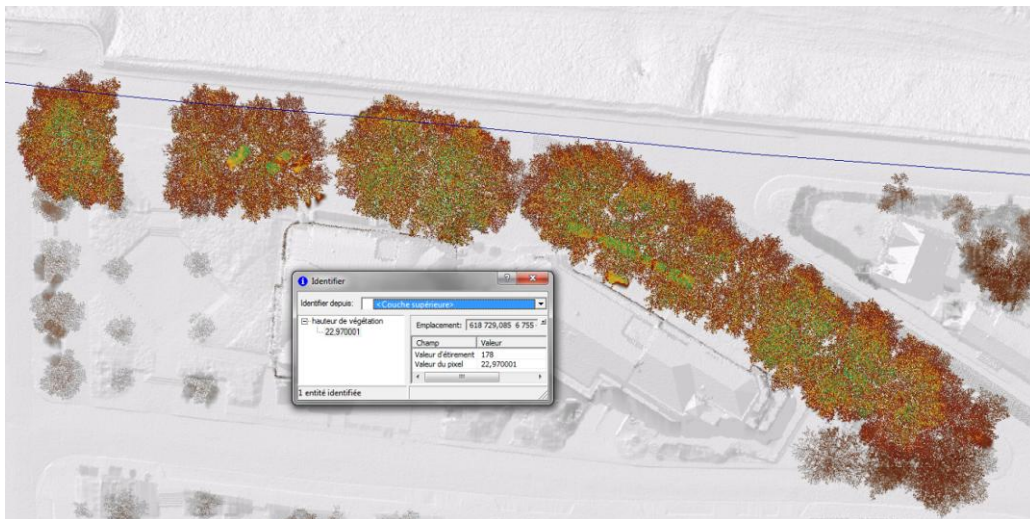
- To create a “vegetation only” layer: the only thing to do is subtract "no-vegetation DSM" from "vegetation + construction" DSM

Figure 23: Example of Vegetation Layer

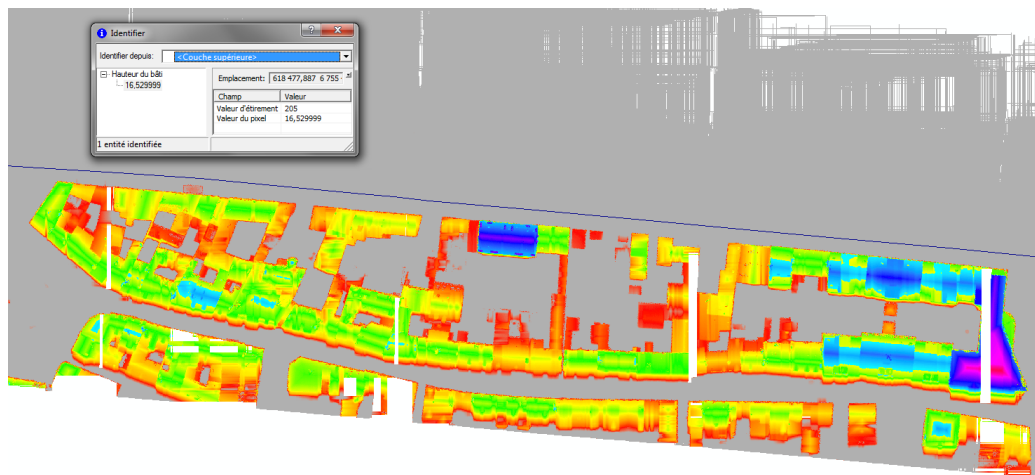
- To create a “construction only” layer: the only thing to do is subtract "no-construction DSM" from "vegetation + construction" DSM

Figure 24: Example of Construction Layer

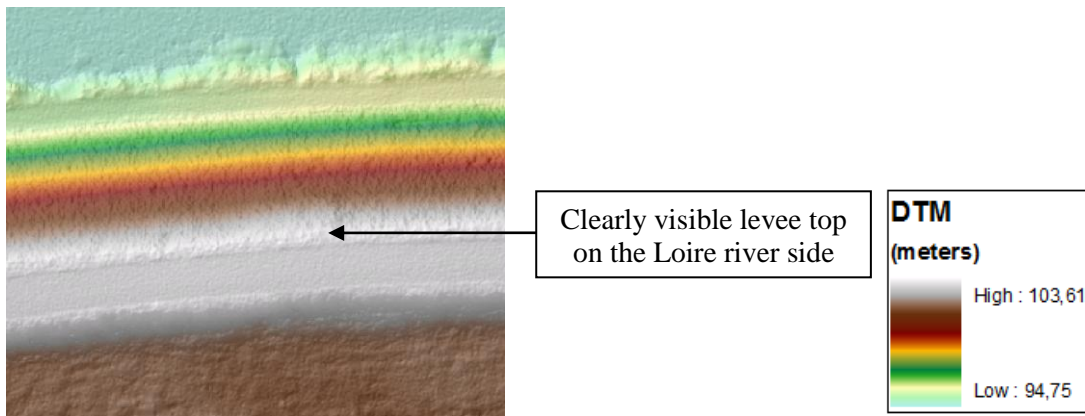
Figure 25: Superimposed DTM and Shadowing

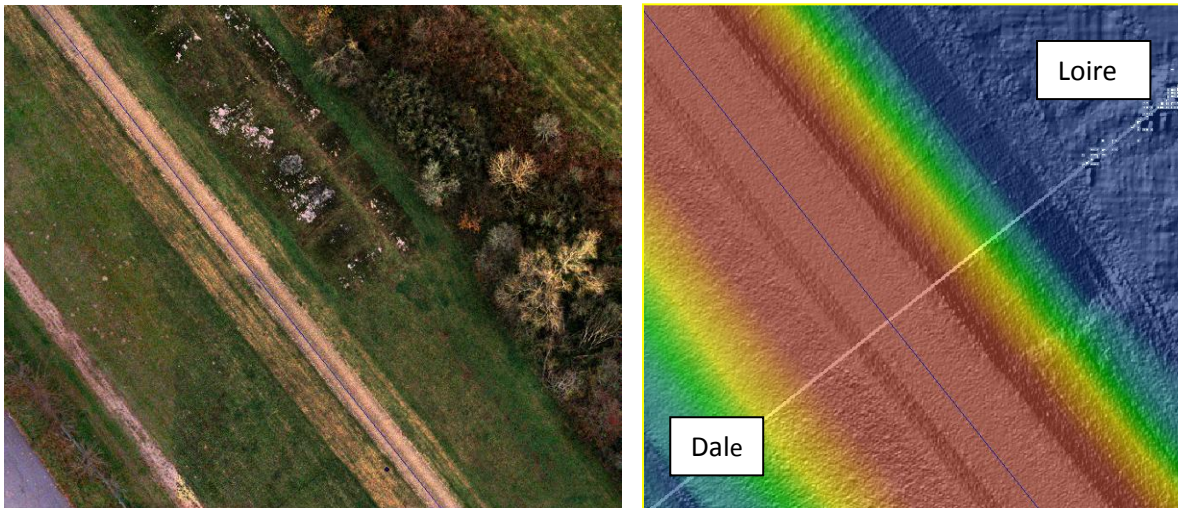
- **Area 1**

Figure 28: Example of a Transition between an Embankment and Riprap Blocks

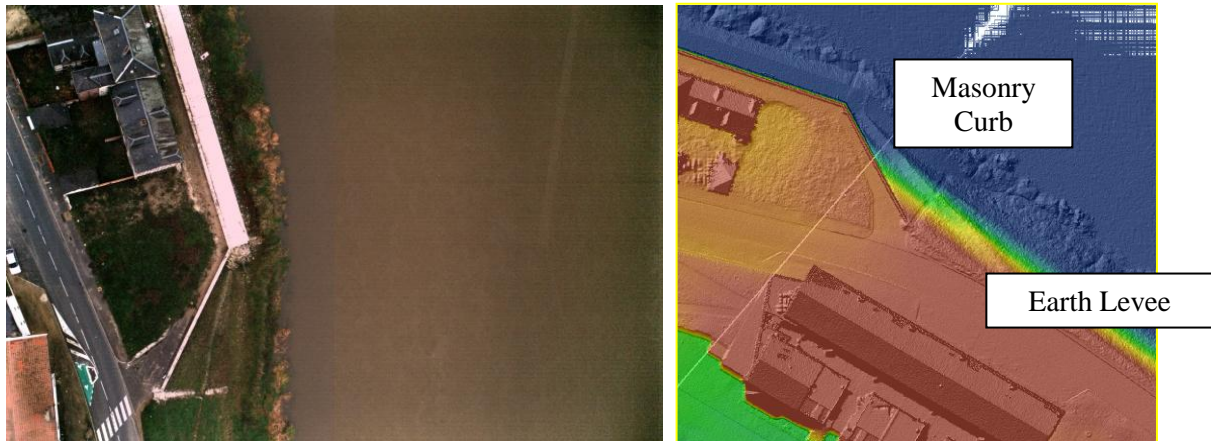
- Area 2

Figure 29: Example of a Transition between an Embankment and an Embedded Stone Wall

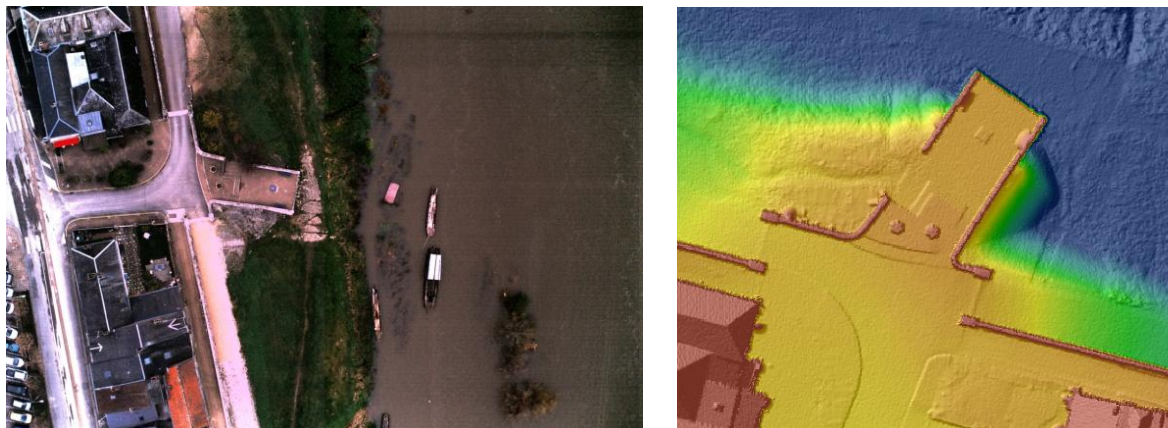
- Area 3

Figure 30: Example of a Transition between an Embankment and a Crossing Work

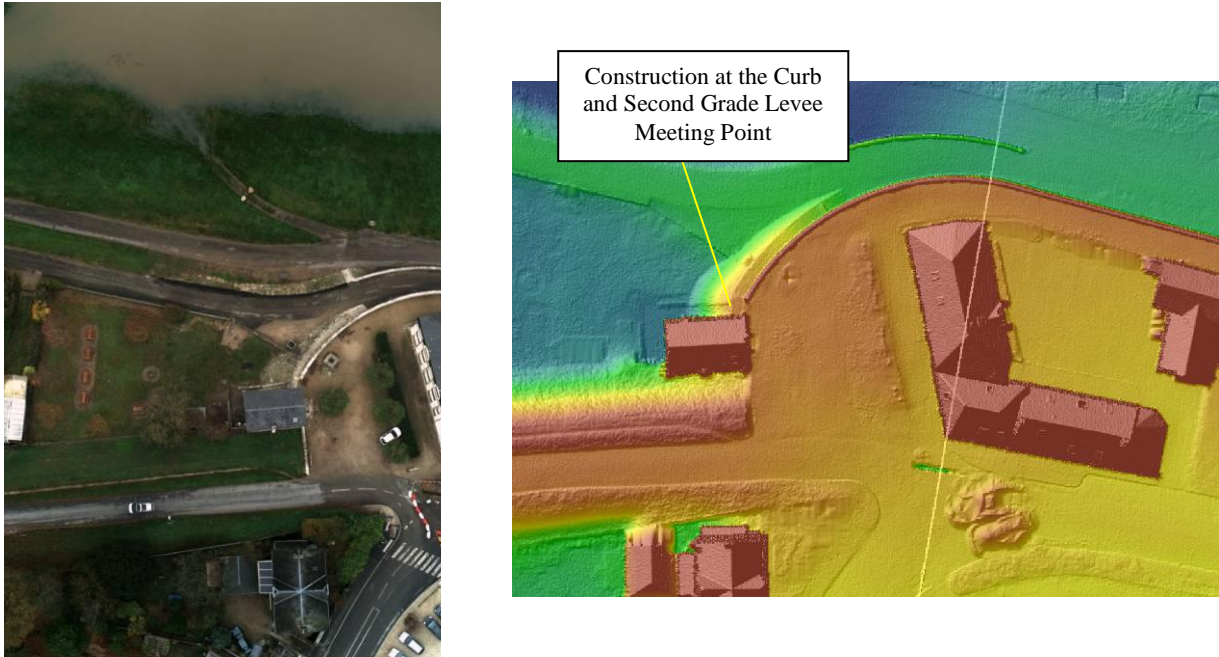
- Area 4

Figure 31: Example of a Transition between a Quay Wall, a House and an Earth Levee

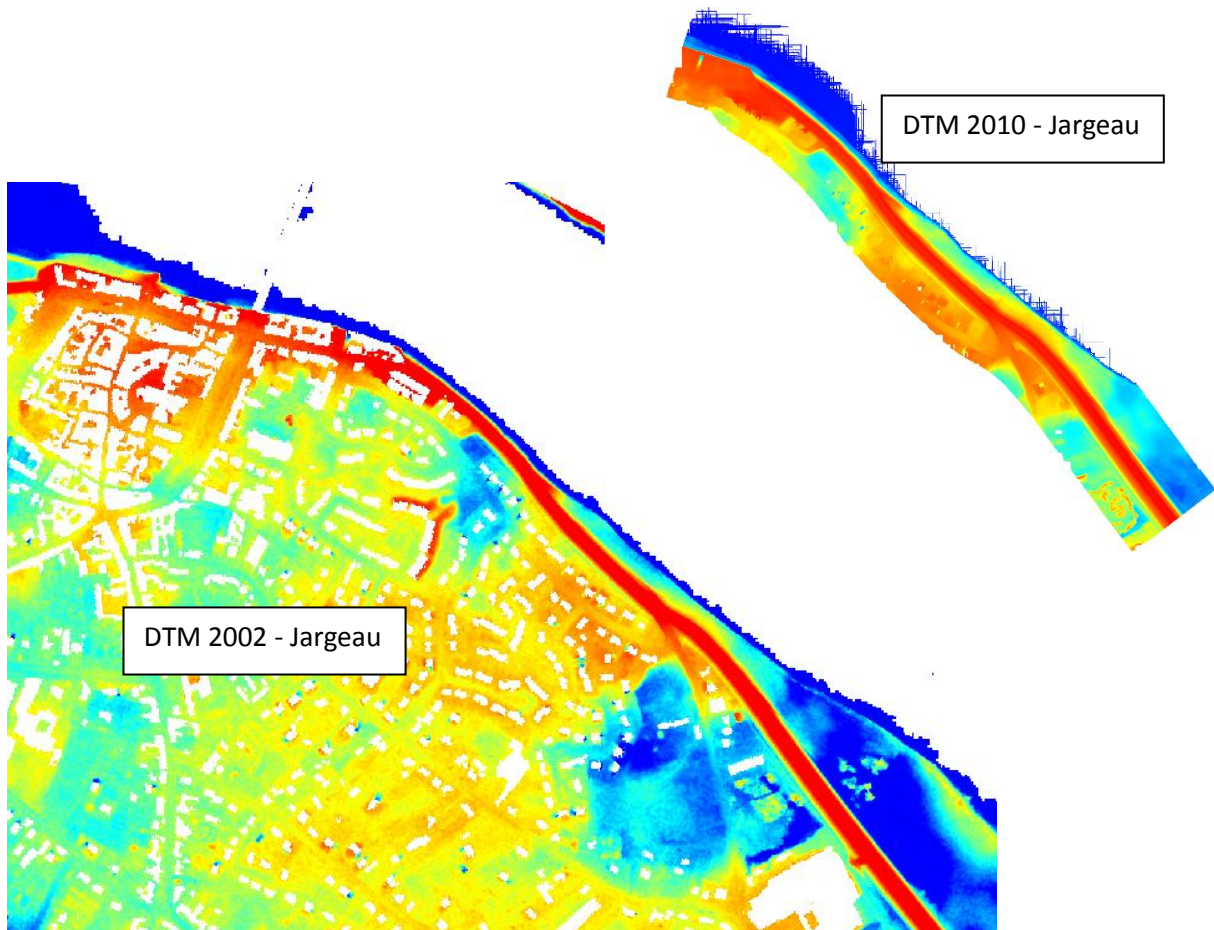
DTM 2002, that includes flood plains, should be used for a better identification of the areas where the levee connects with a "mound" (topographically high area). Although this DTM resolution is lower than DTM 2010, it provides topographical information on the entire dale (see both DTM compared in Figure 32). Therefore, both DTMs have been superimposed with MapInfo (Figure 33). The first figure clearly shows a difference in resolution between the high resolution levee section and the dale DTM. Probable mound areas are indicated by purple-colored circles on the map (Figure 33). Each of them includes, upstream and downstream respectively, a transition area between a composite (embankment + wall) levee or dyke and its connection with the mound.

Figure 32: DTMs 2002 and 2010 Compared on Jargeau Area

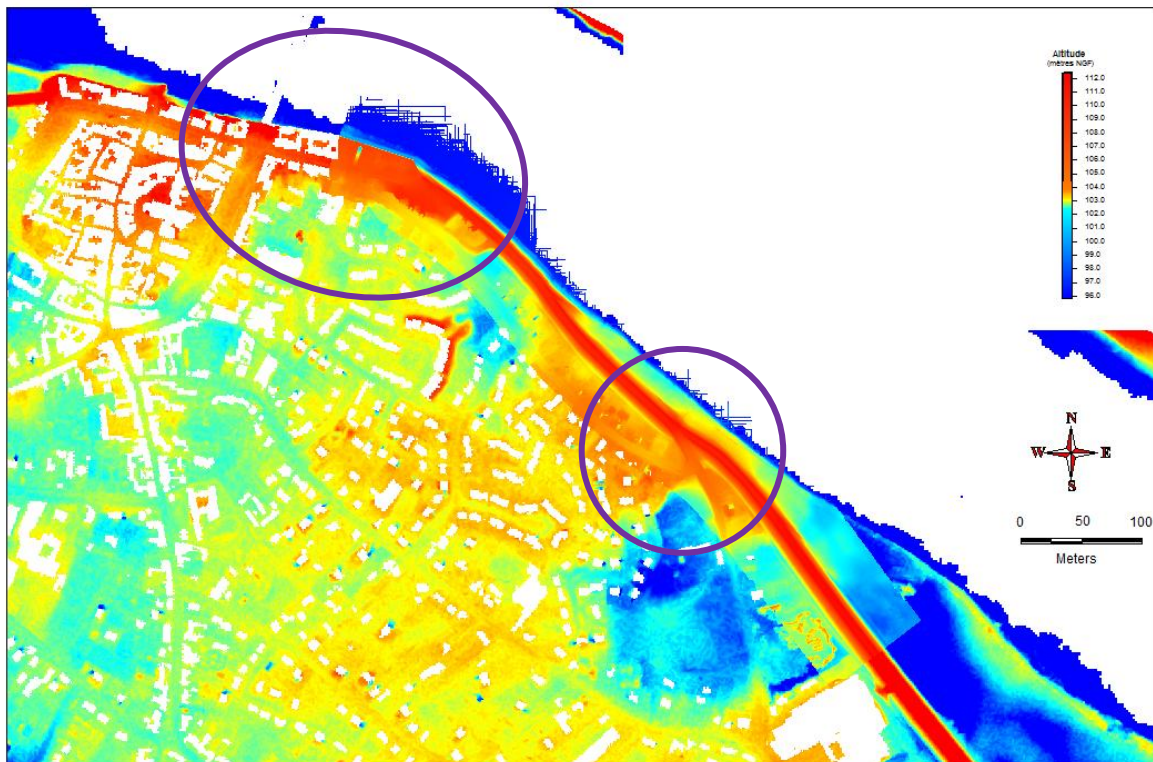
Figure 33: Superimposition of DTM 2002 and 2010

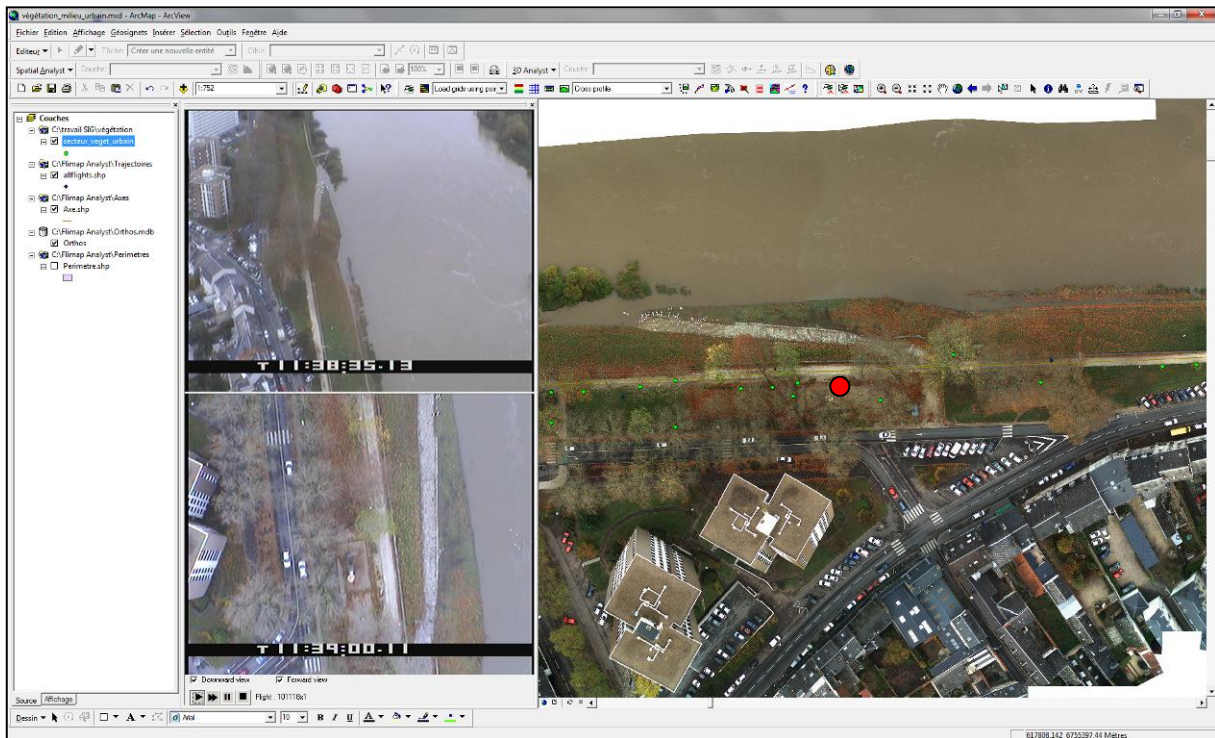
To do so, no geo-referenced raw videos may first be viewed (first delivered videos). However, identification will then prove difficult unless the levee alignment is split into sections matching the video files. Thereafter, the simplest way is to use FliMap Analyst¹⁷ plug-in with ArcGis (Figure 34) to play and run geo-referenced videos.

Figure 34: Playing Geo-Referenced Videos with FliMap Analyst Plug-In

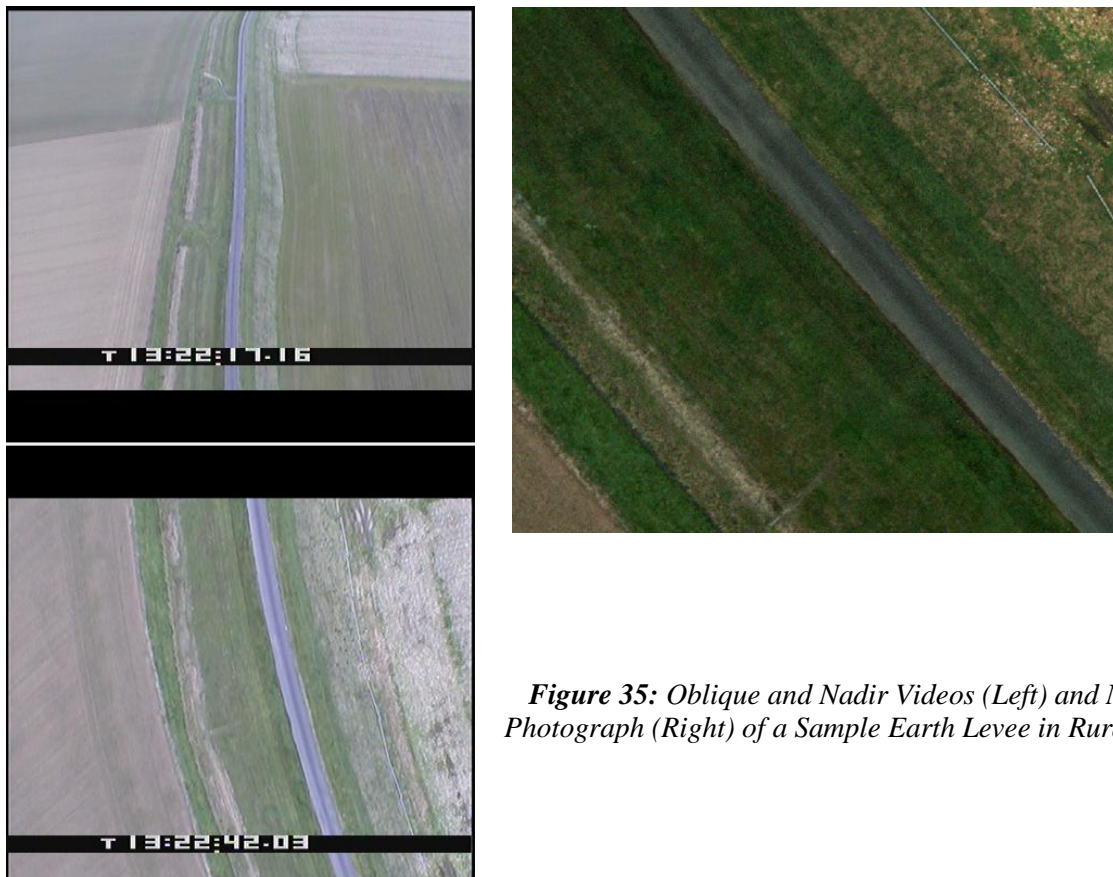
Figure 35: Oblique and Nadir Videos (Left) and Nadir Photograph (Right) of a Sample Earth Levee in Rural Area

This is a typical example of embankment dyke, or (earth) levee. The area is located between Guilly and Bouteille, up the Val d'Orléans, on the Loire river left bank. In this rural area, the impoundment system is based on an extensive embankment. Most levee set-ups in the Val de Loire area include a road running along the levee top (easy access for maintenance and in the event of a flood, provided the road traffic may be controlled). Down the slope on the land side, a light-colored stripe can be seen, indicating the draining material on the drainage blanket outlet of shell reinforcements built in the 1970's.

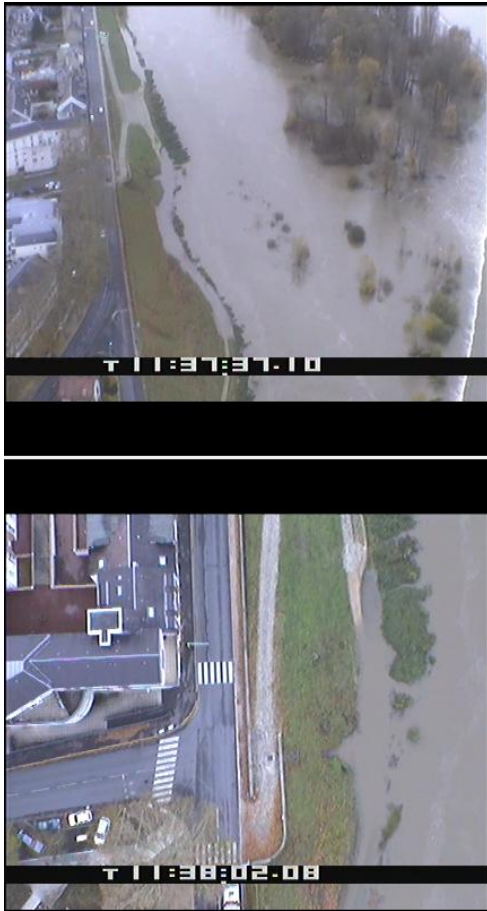
Figure 36: Oblique and Nadir Videos (Left) and Nadir Photograph (Right) of a Sample Levee with a Curb in Urban Area

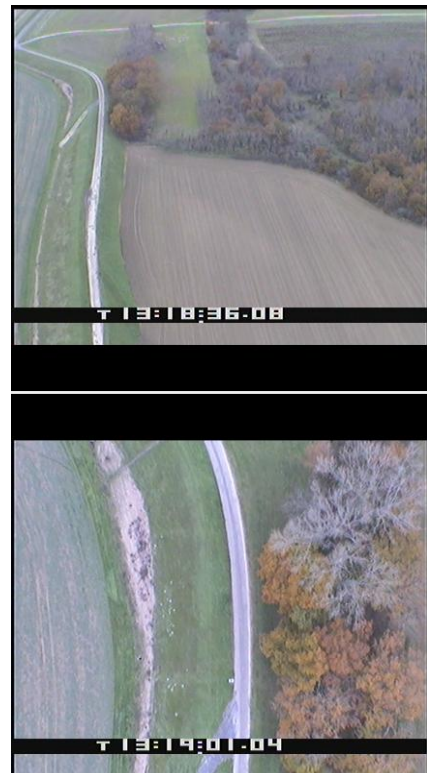
Figure 37: Oblique and Nadir Videos (Left) and Nadir Photograph (Right) of a Sample Vegetation Block on the Levee

The area is located in Guilly, on the Loire river left bank. In oblique view, a woodland block is quickly observed near the levee slope on the river side. Due to trees extensive crown growth, it is not possible to see if some of the stumps are growing down the slope, strictly speaking. Zooming in on the photograph in the upper right corner will help identify the type of trees.

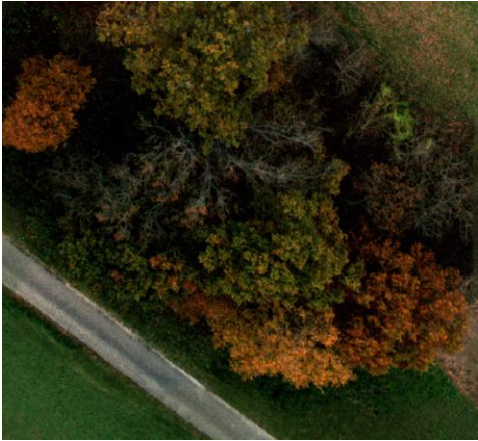
Zoom in on vegetation: to determine vegetation type (hardwood, most likely oak trees).

Figure 38: Zoom in on Vegetation Block on Figure 37 Photograph

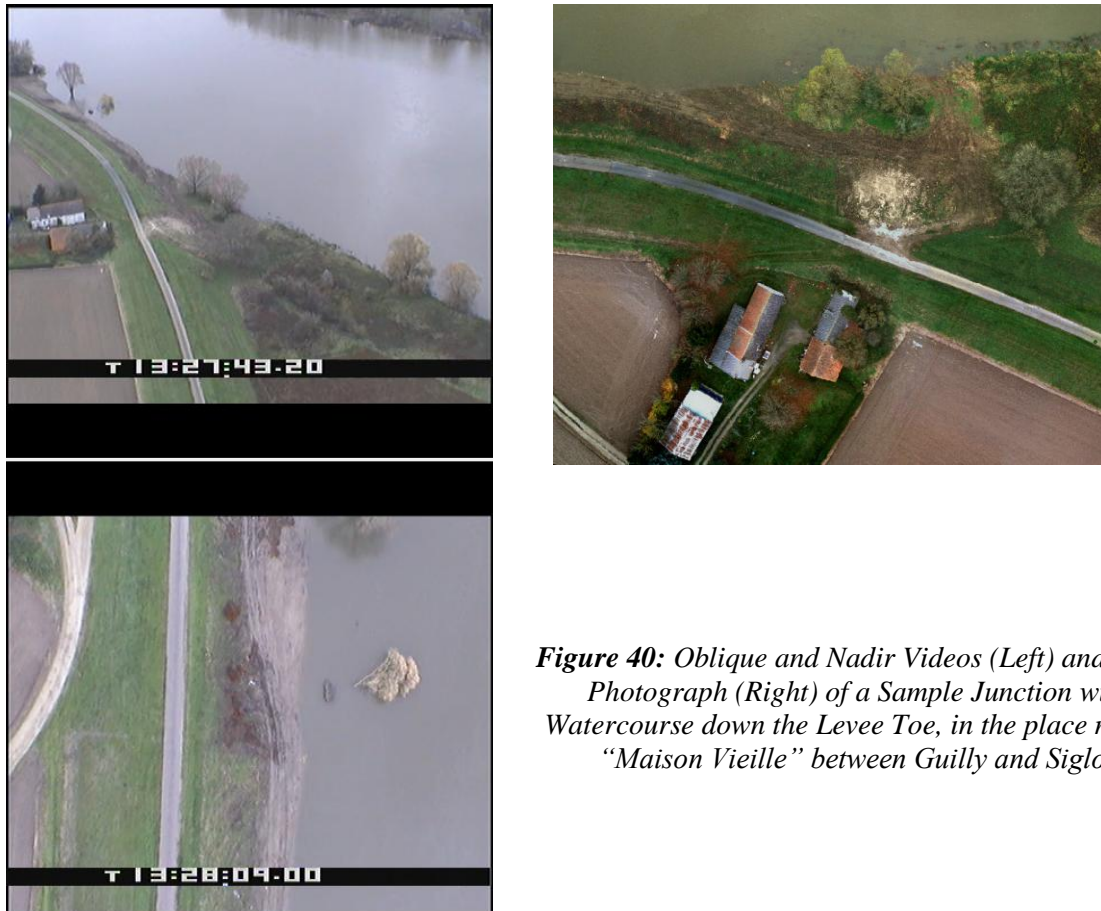
Figure 40: Oblique and Nadir Videos (Left) and Nadir Photograph (Right) of a Sample Junction with Watercourse down the Levee Toe, in the place named “Maison Vieille” between Guilly and Sigloy

Between Guilly and Sigloy on the left bank, in the place named “Maison Vieille”, the watercourse gets gradually closer to the levee toe, in downstream direction. Special attention must be paid to this river/levee “connecting” section due to external erosion or scouring hazard.

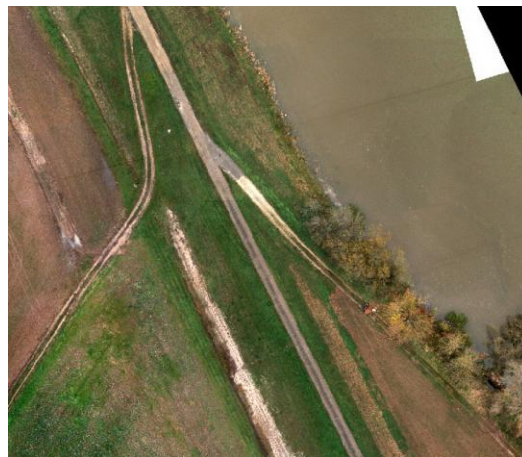
Here is another example of watercourse and levee toe getting close, a little higher upstream the river from the previous junction.

Figure 41: Other Example of Watercourse/Levee Toe Junction in the Place Named “le Vassy” in Sigloy

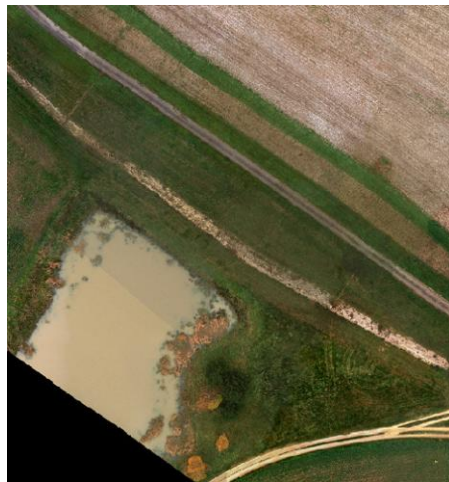
The breach shown on the opposite picture is located in the well-named "la Brèche" locality. The former hole created by the breach was filled up with water.

Figure 42: Example of a Breach in the place named "la Brèche", upstream Sigloy Village
