FloodProBE Project WP 3: Reliability of Urban Flood Defences. Guidebook for Using Helicopter-Borne Lidar to Contribute to Levee Assessment – Experiment on “Val d’Orléans” Pilot Site

Date: October 2012

Report Number: WP03-01-12-03

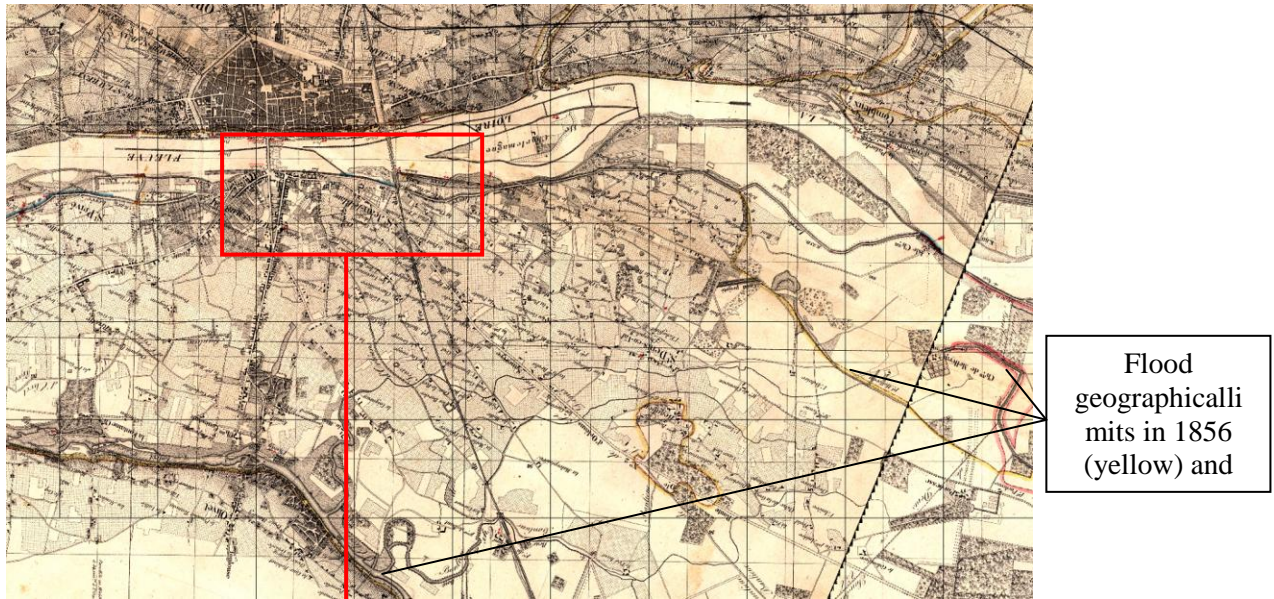
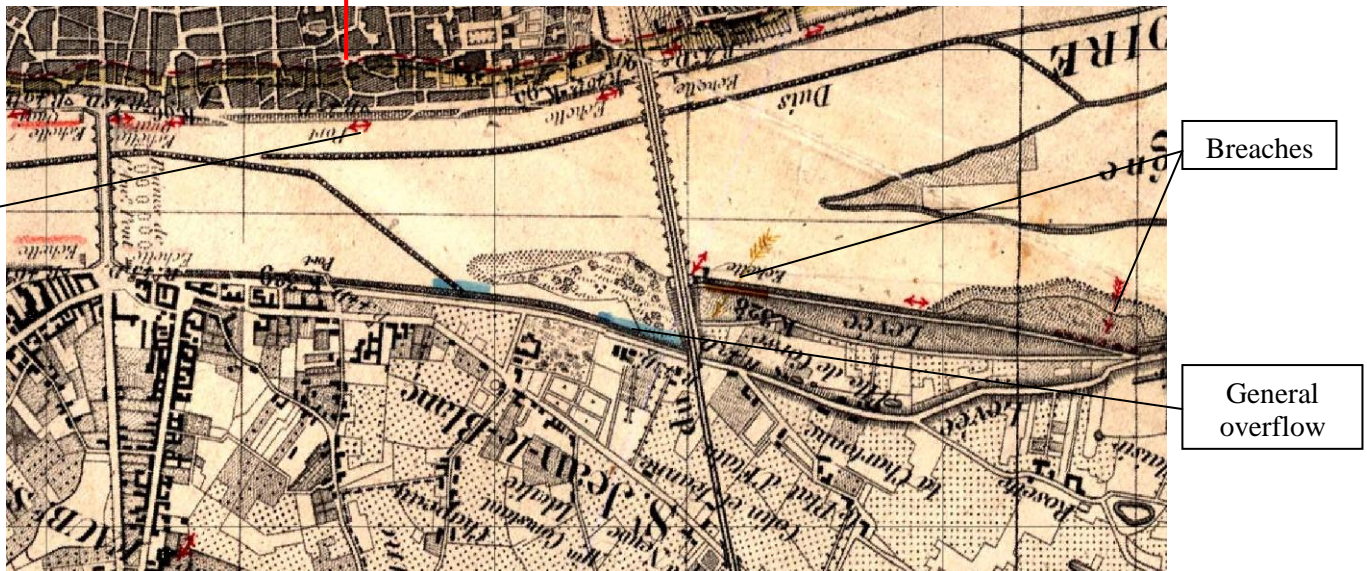
Figure 43 below shows an old map of the Val d'Orléans left bank levee and, on the second map further down below, zooms in on the area between the railway embankment (already existing back in 1856) and Georges V bridge, in Orléans urban district.

Figure 43: Old 1850 Map Showing Information on High Floods

From this map, one can see that all former breach areas have been repaired.

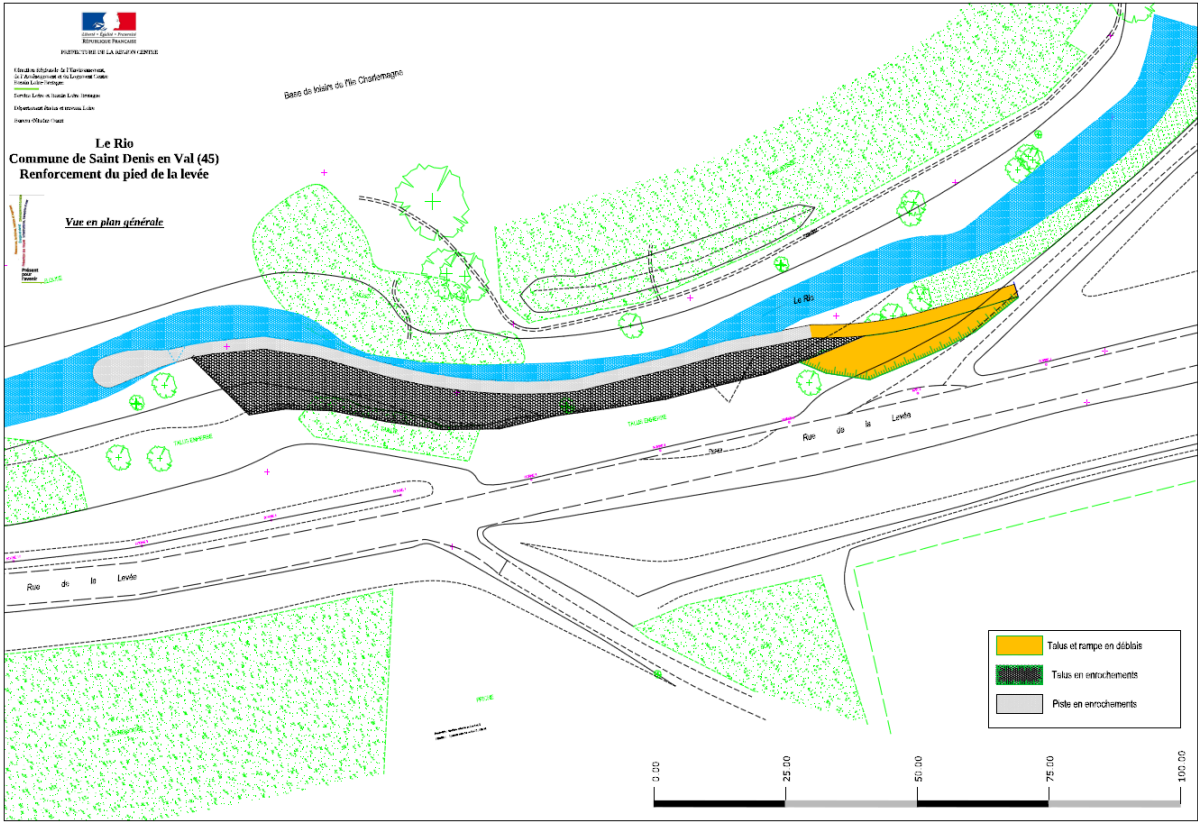
Below is an example of a reinforcement area topographic plan. The area is located over the “Rio de l’Ile Charlemagne” on the Loire river left bank, in Saint Denis en Val (upstream Orléans). This is a riprap reinforced levee toe, on the Loire river side.

Figure 44: Rio Topographic Plan Including Levee Toe Reinforcement Area

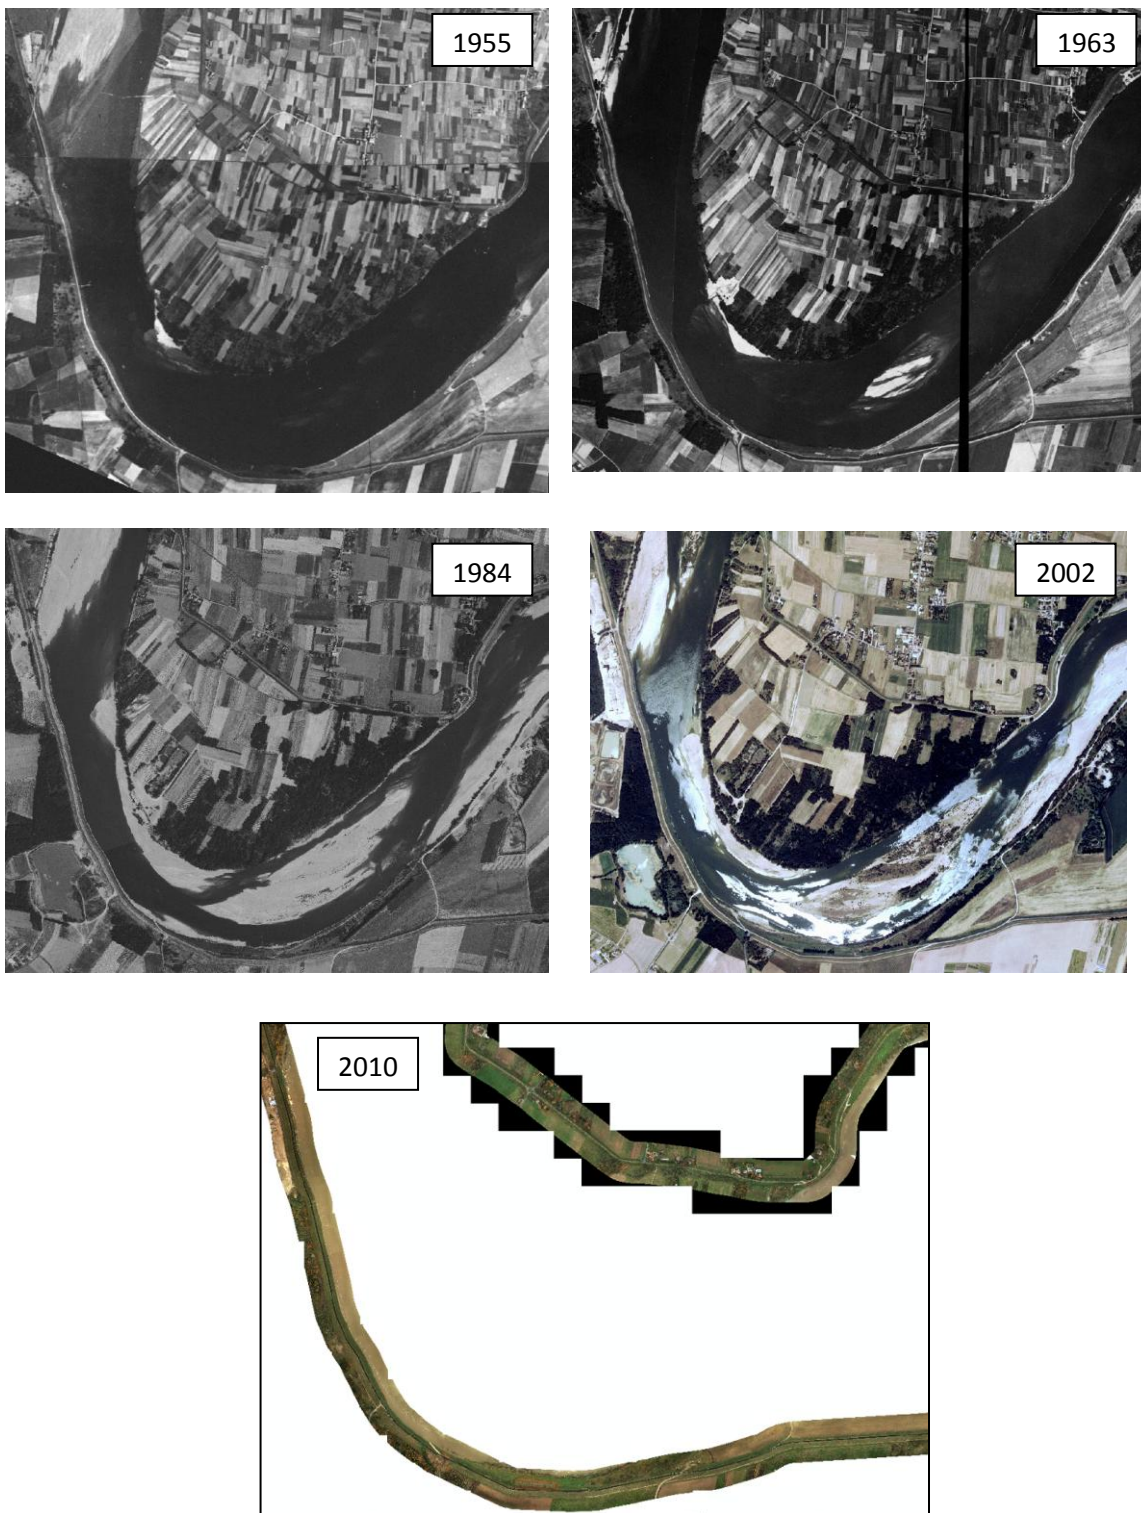
A great number of aerial photograph acquisition campaigns were carried out over the Val d'Orléans area. Below are compared photographs taken over the same area near Sandillon:

Figure 45: Aerial Photographs Taken during Various Acquisition Campaigns (1955, 1963, 1984, 2002, 2010) over Sandillon Area

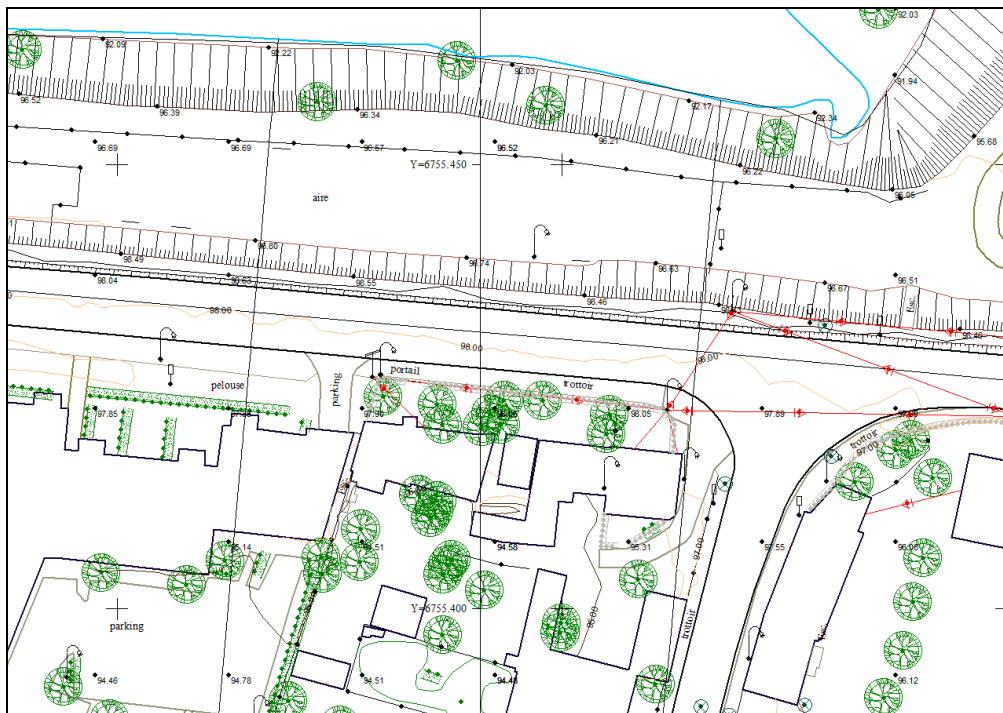
Figure 46: Example of 1/500 Topographic Plan on Capucins Levee

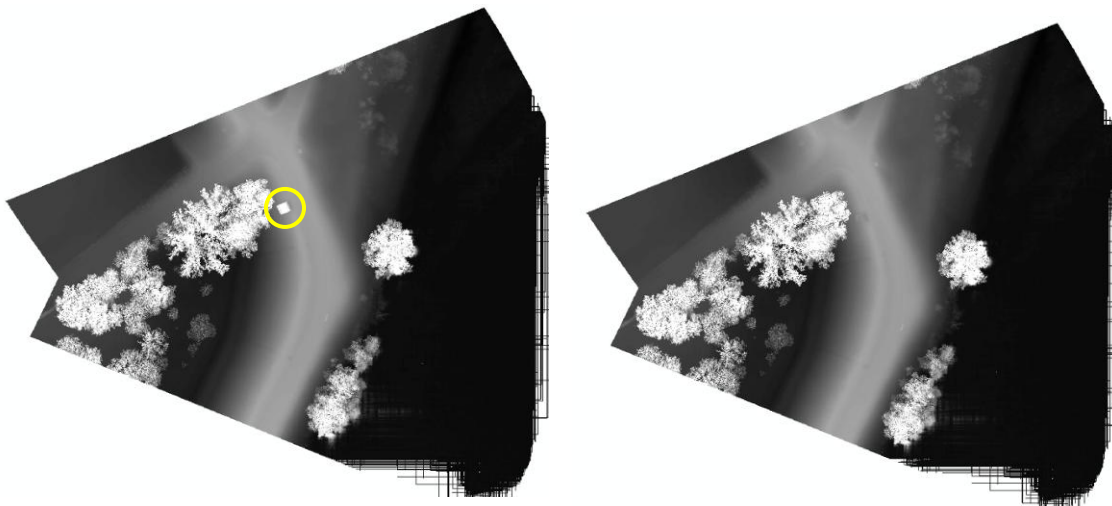
Figure 47: DSM (Left) and No-Construction DSM (Right)

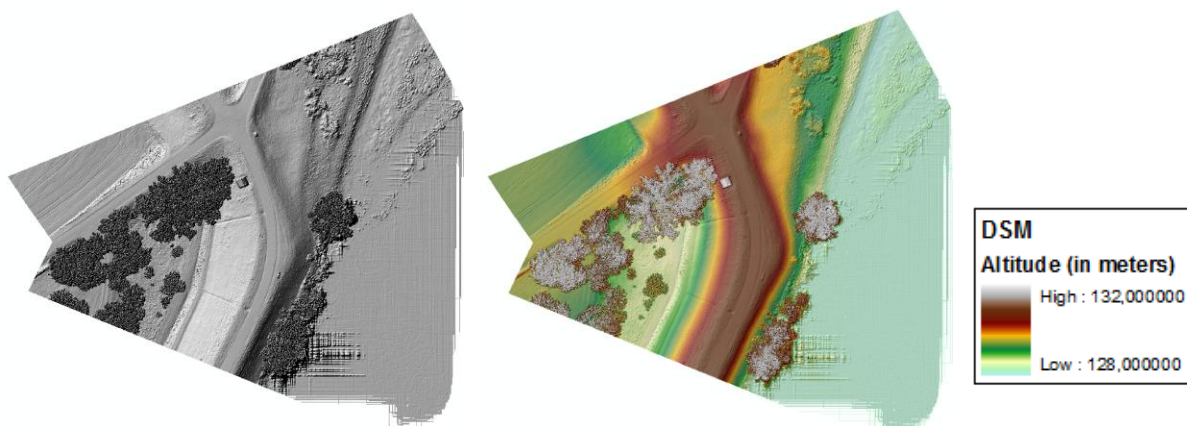
Figure 50: DSM with Black-and-White (Left) and Color (Right) Shadowing

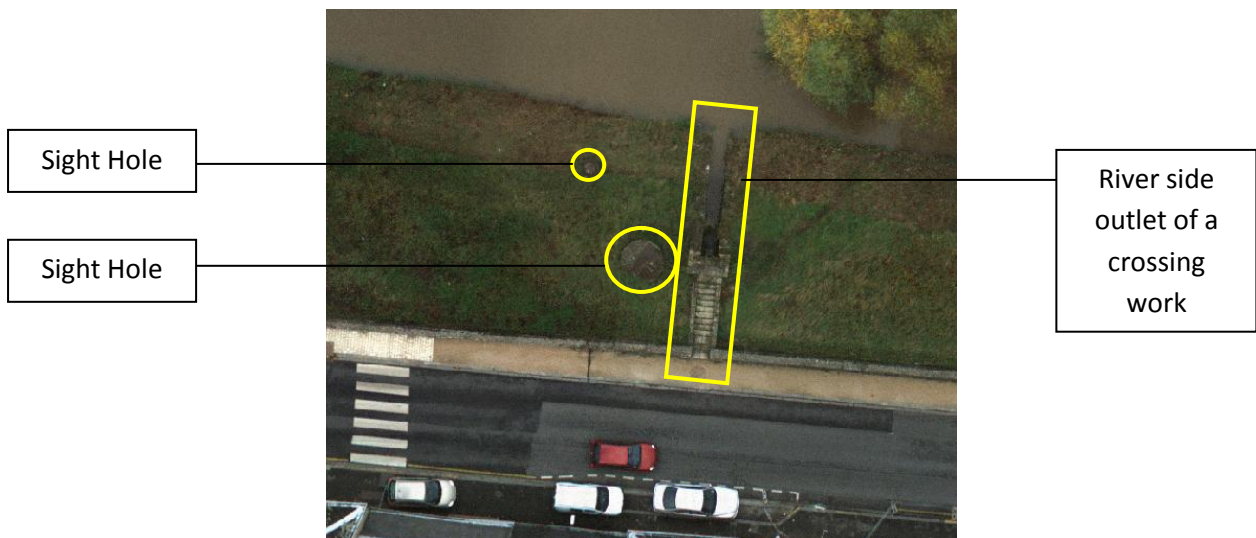
Let us see for example a crossing work on Capucins levee. Two sight holes appear on the left side of this work.

Figure 52: Photograph of Sight Holes and Outlet on Capucins Levee Crossing Work.

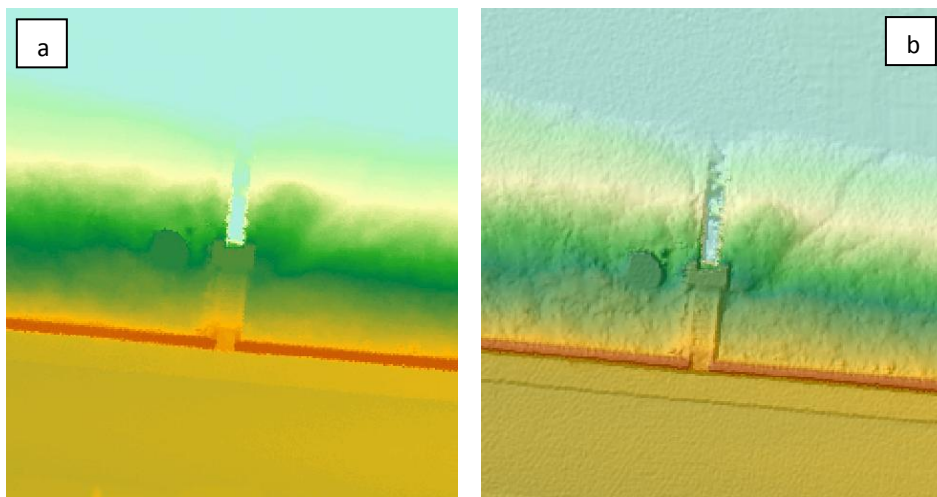
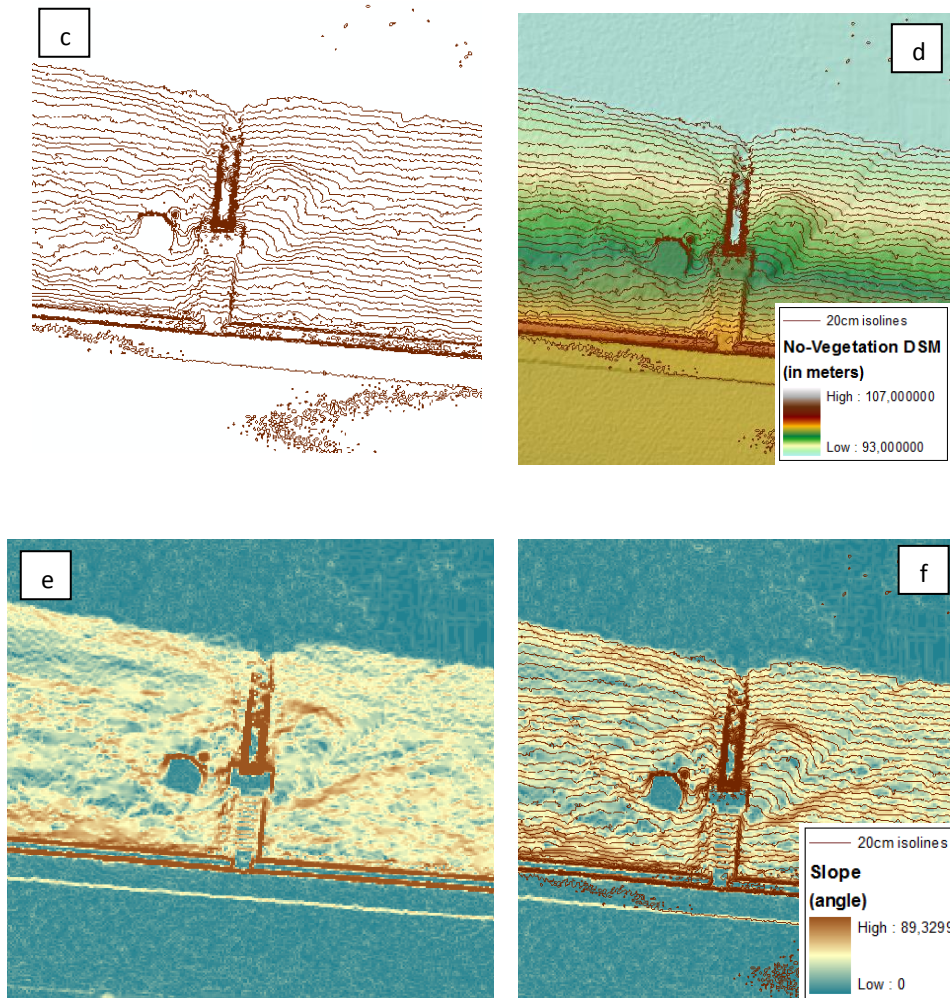
Figure 53: *Treatments Performed with ArcGis on Figure 52 Area.*

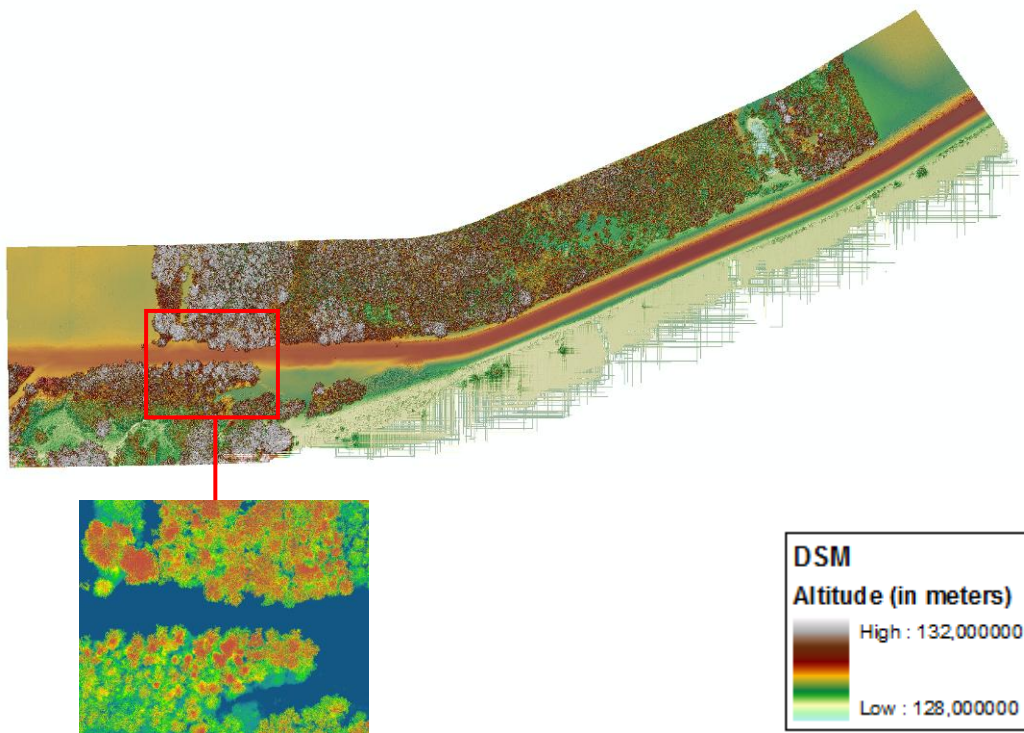
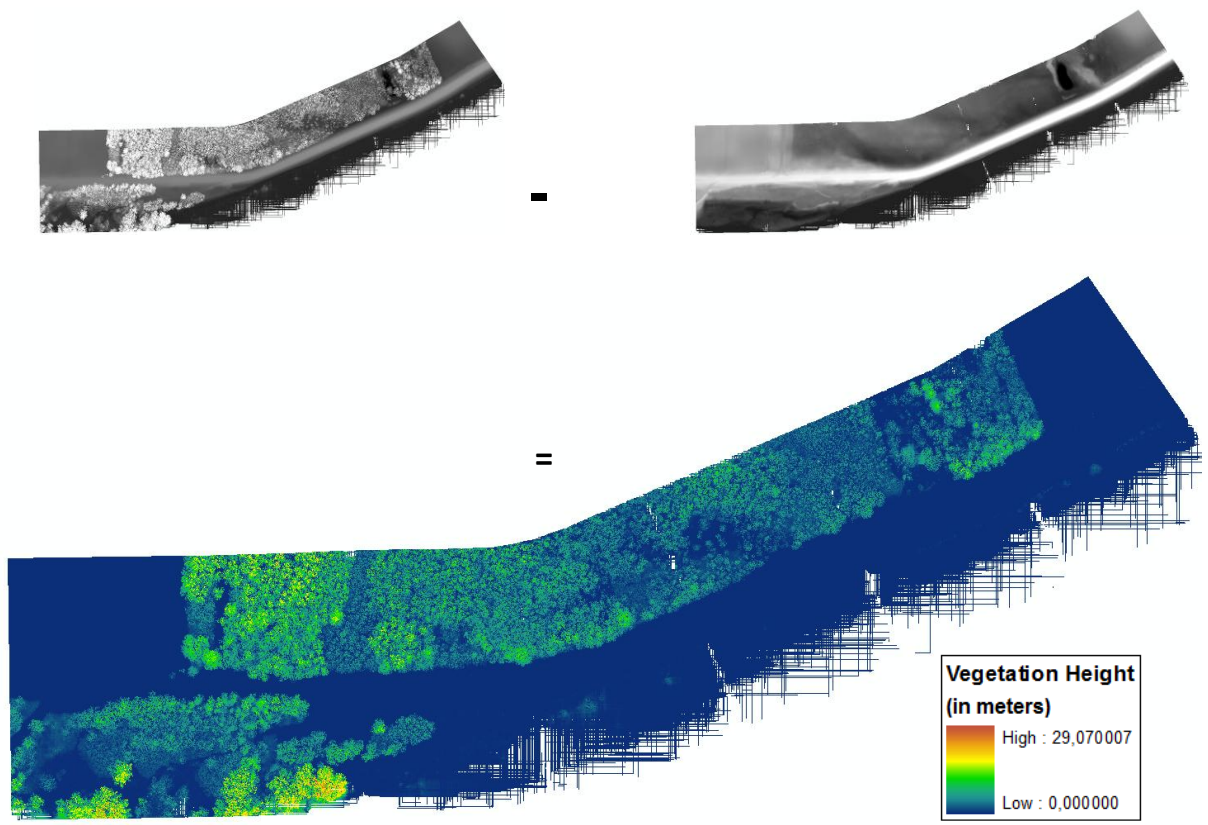
Figure 55: Example of DSM/No-Vegetation DSM Subtraction to Display Vegetation

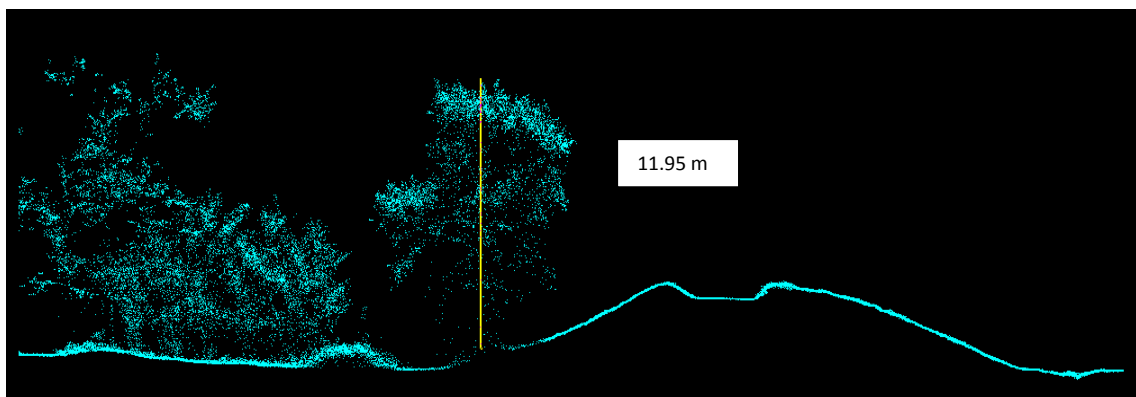
Figure 56: Cross-section on raw laser points

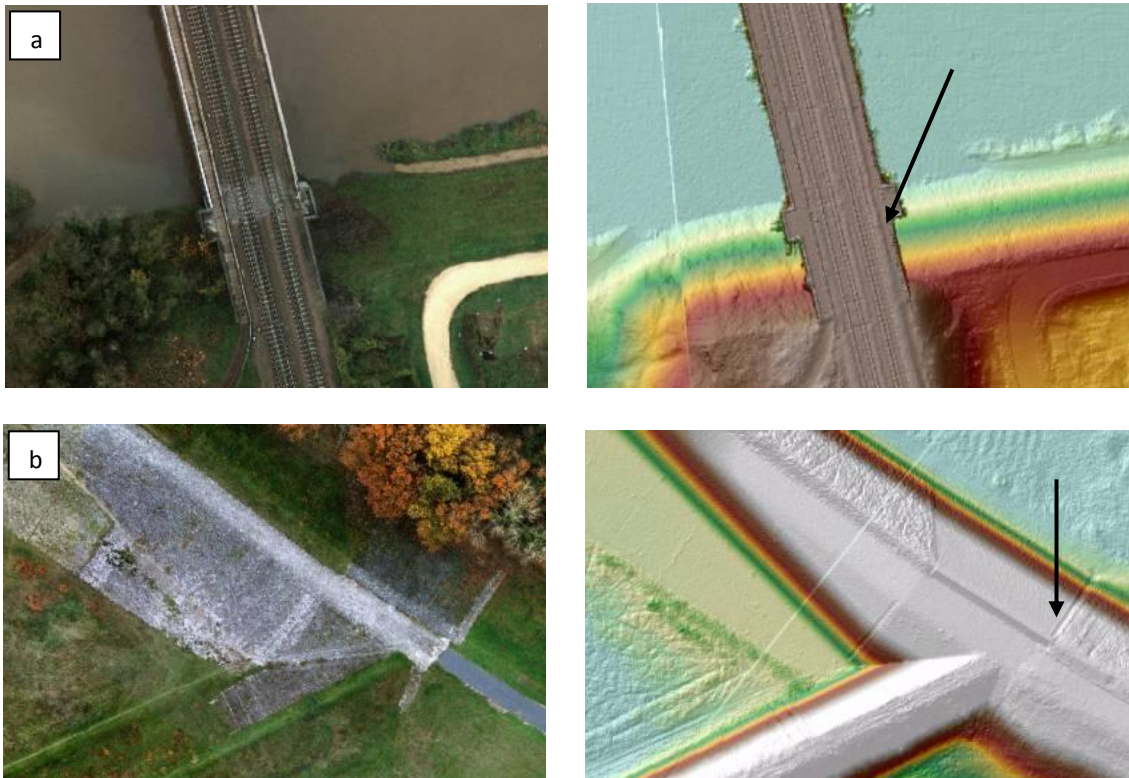
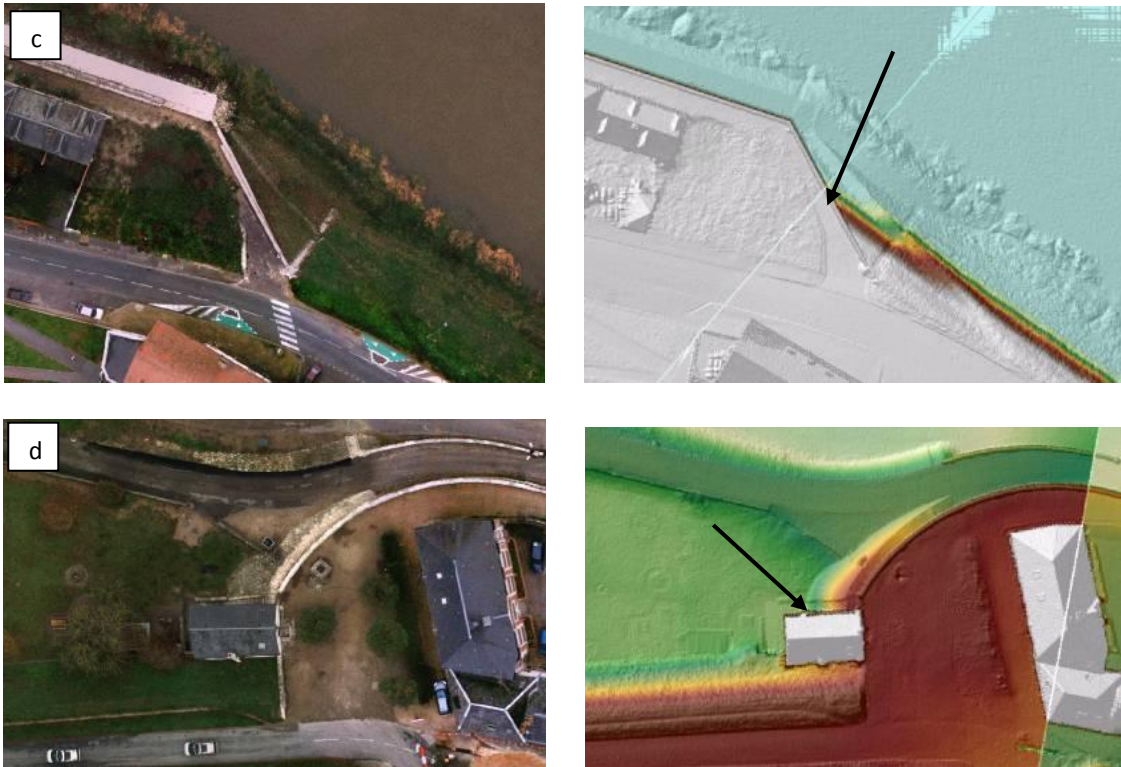
Figure 57: Photographs and DSMs of Sample Transition Structures

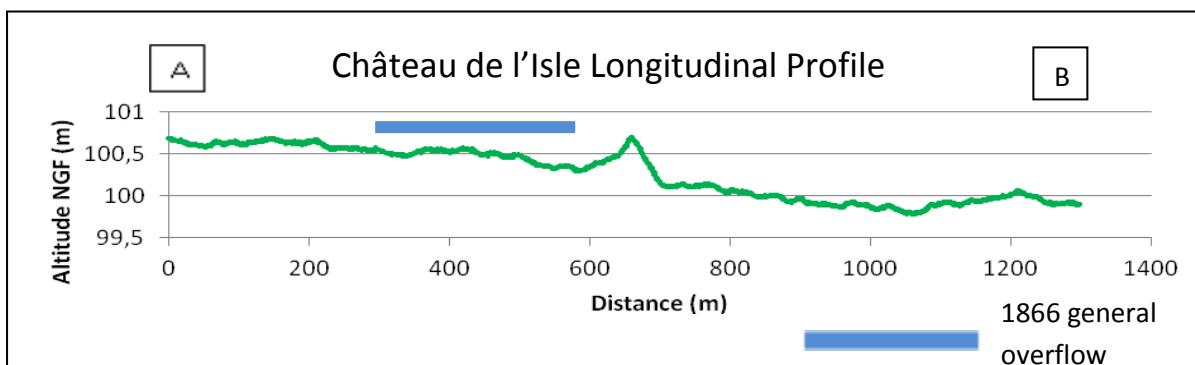
Figure 59: Levee Longitudinal Profile from Point A to Point B in Figure 57

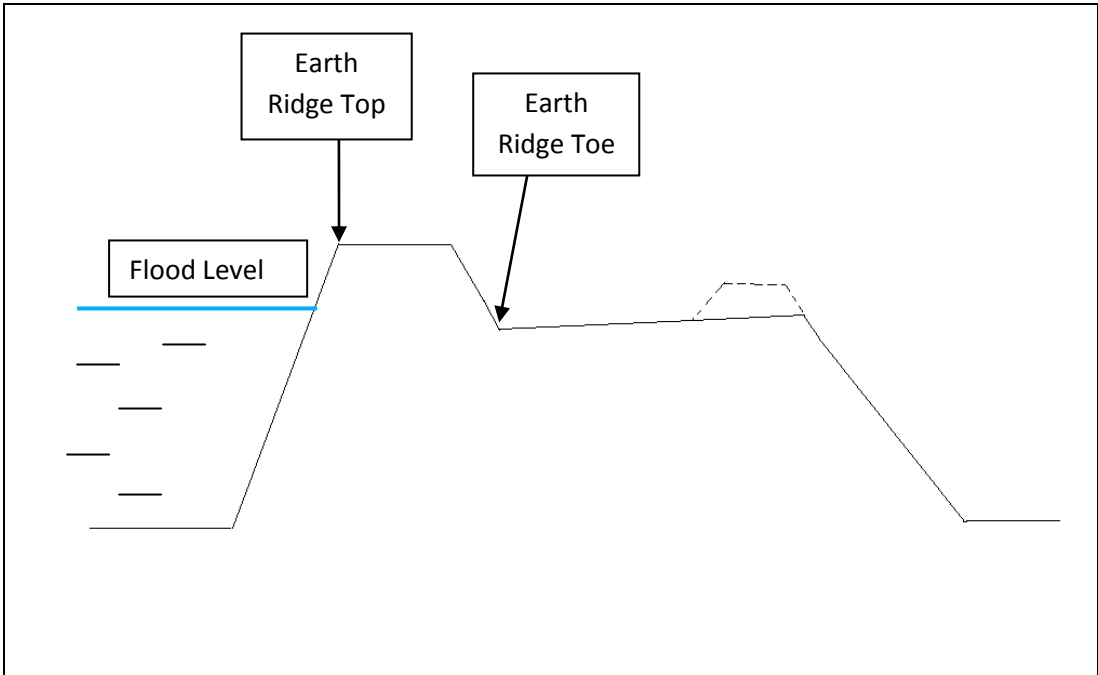
Figure 60: Loire River Levee Typical Profile

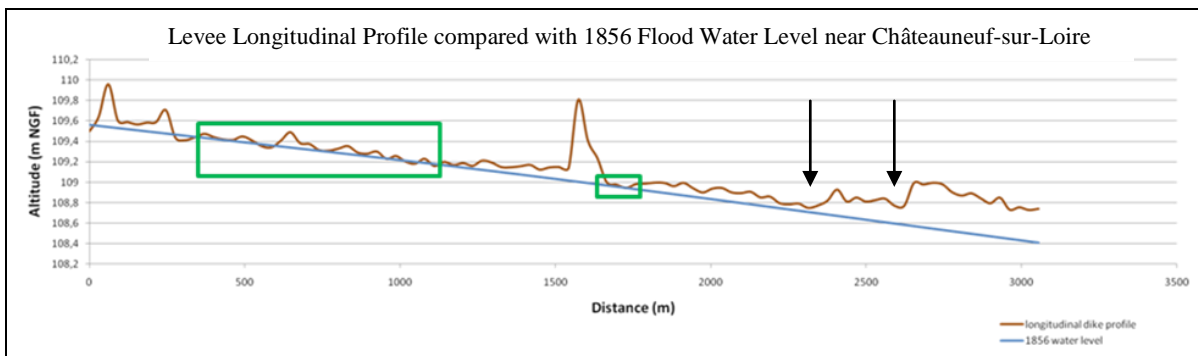
Figure 62: Diagram Showing 1856 Flood Water Level and Levee Profile from Point A to Point B on Loire River Left Bank

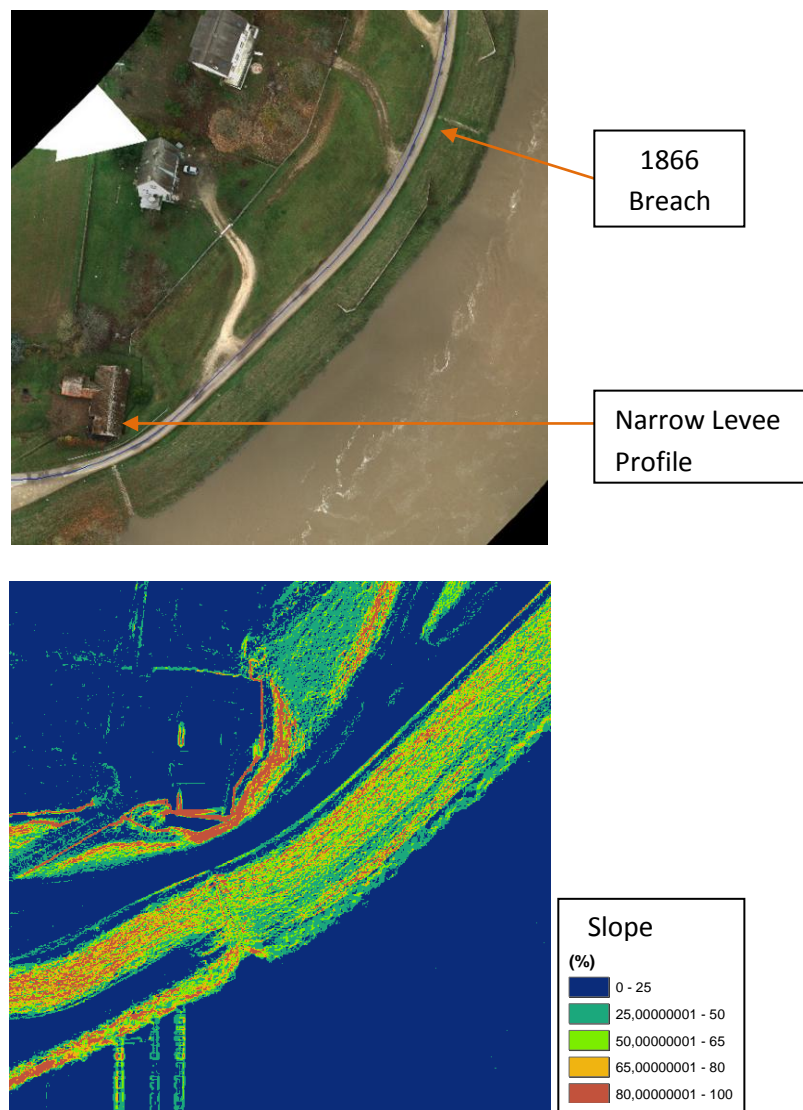
Figure 65: Example of a Narrow Levee Profile on the Loire River Right Bank, in Val de Bou

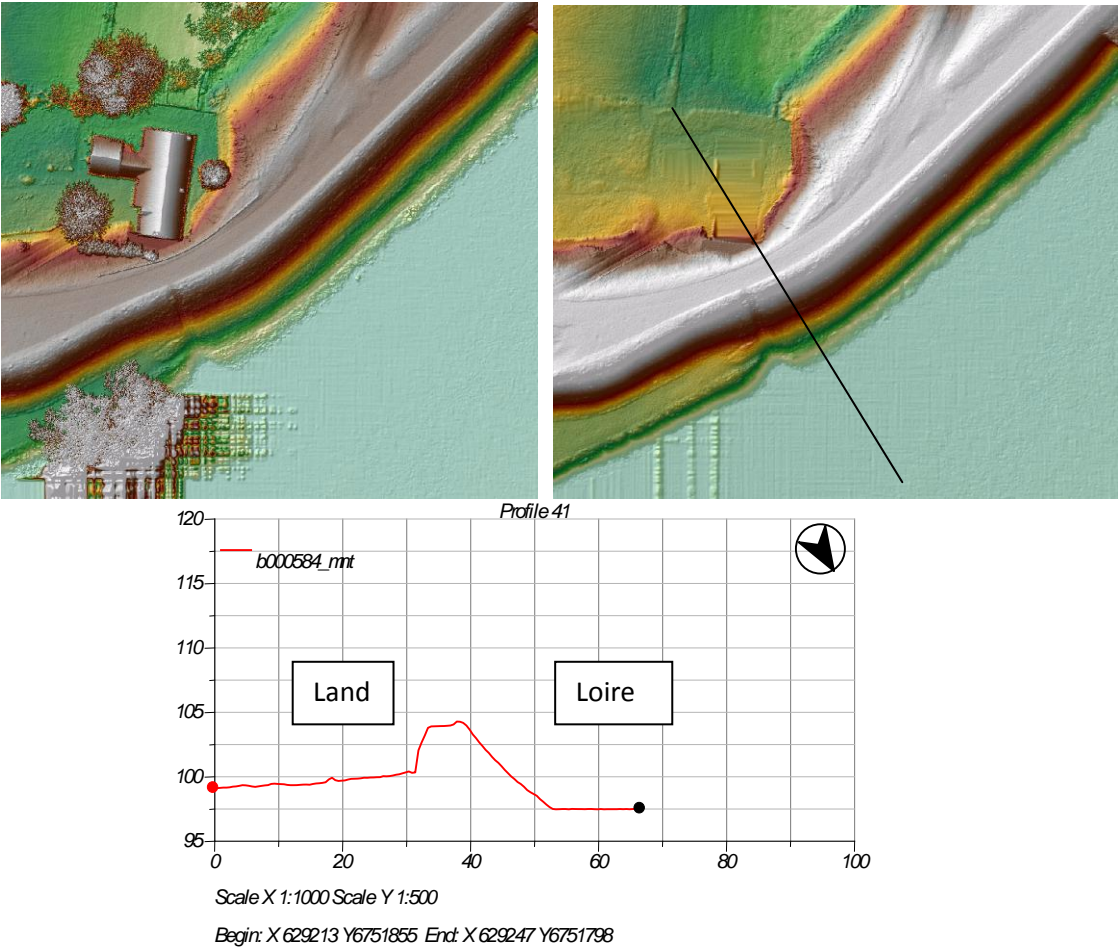
Figure 66: DSM Image of the Area on Figure 64 (Left), DTM (Right) and Cross-Section along Black Line (Bottom)

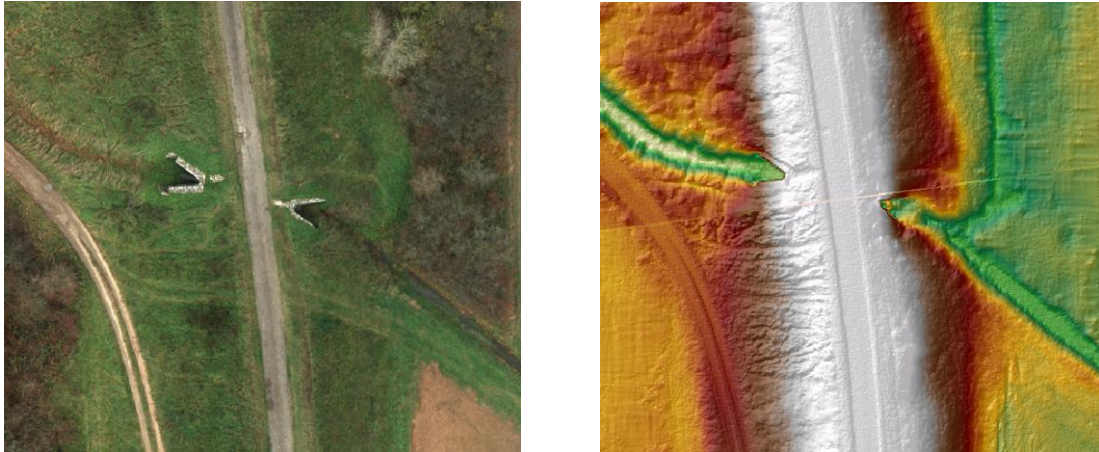
Figure 67: Flashboard Gallery on Val de Bou

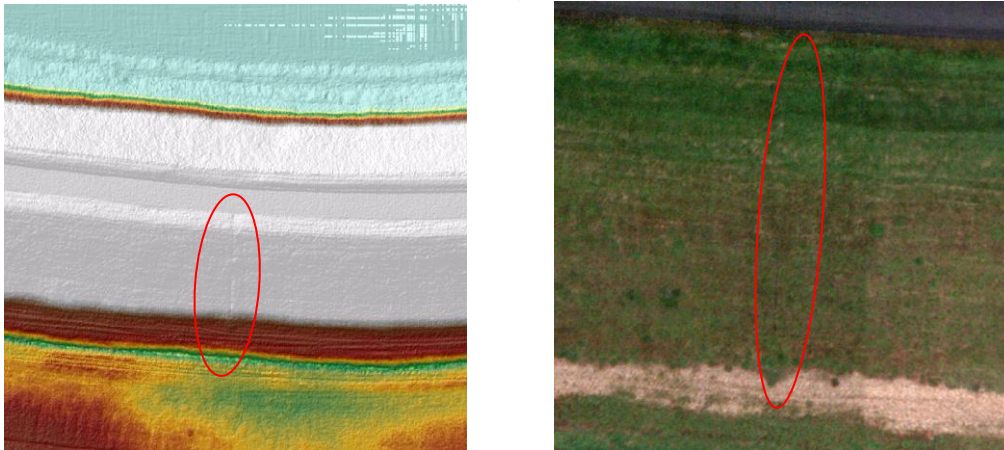
Figure 70: Storm Drainage Pipe on Loire Land Side

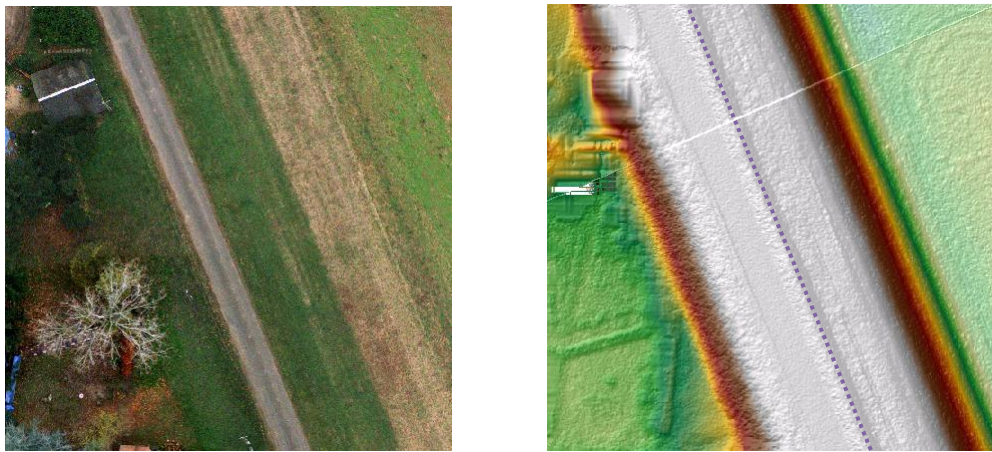
Figure 71: Levee with Earth Ridge, on Loire River Side

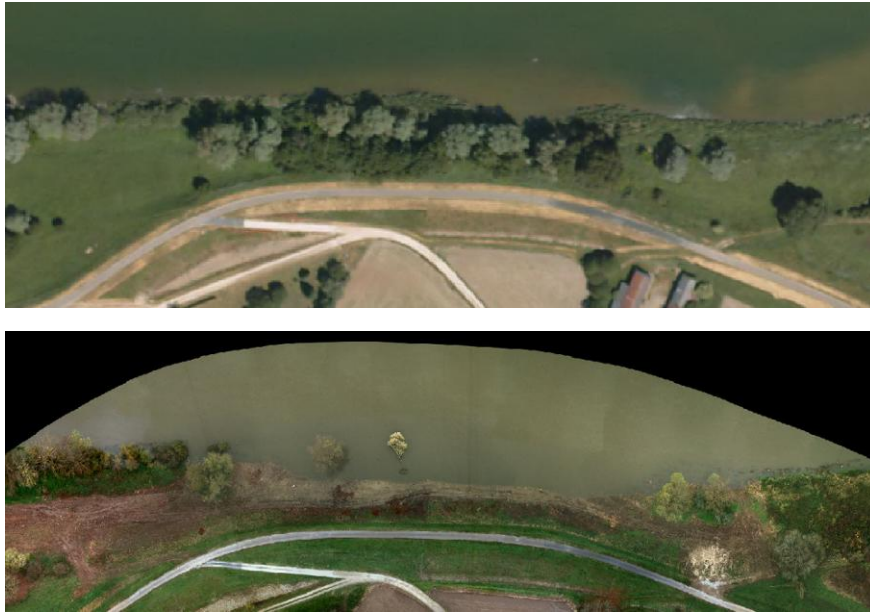
Figure 73: 2006 (Top) and 2010 (Bottom) Aerial Photographs in Location “Maison Vieille”

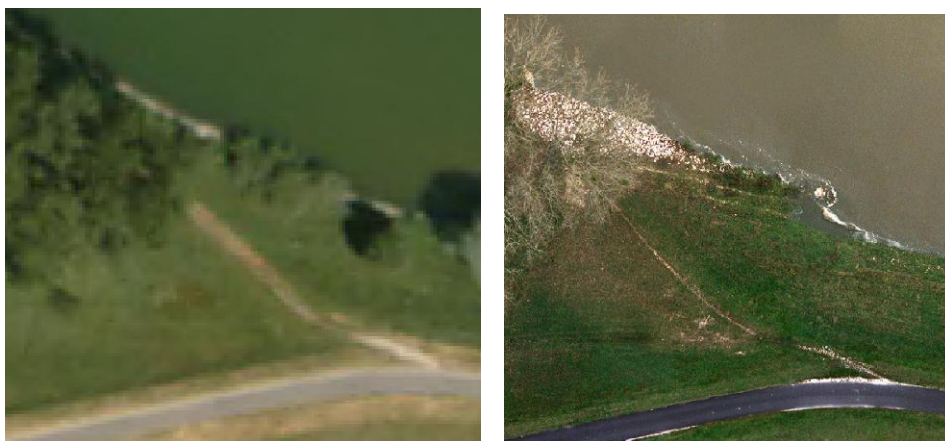
Figure 74: 2006 (Left) and 2010 (Right) Aerial Photographs in Ouvrouer-les-Champs

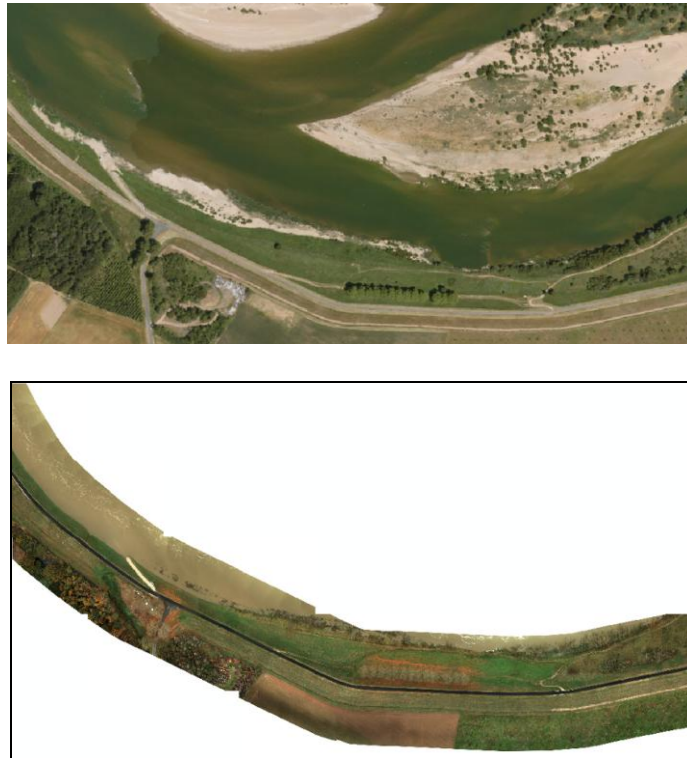
Figure 75: 2006 (Top) and 2010 (Bottom) Aerial Photographs in Sandillon
