Quantifying the erosion resistance of dikes with the overflowing simulator

S. Bonelli, S. Nicaise, G. Charrier, N. Chaouch, F. Byron and Y. Grémeaux

Irstea, Aix-en-Provence, France

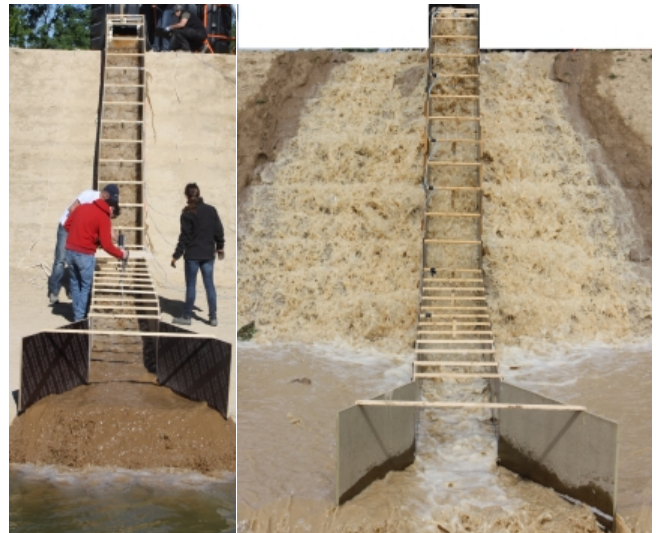
Figure 4. View during test for a flow rate of 95 l/s/mL (minimum flow rate, test No. 1) (left) and a flow rate of 570 l/s/mL (maximum flow rate) (right).

The free-surface flow on this slope (angle of 33 °) is super-critical, with a Froude number of about 4 to 5. It is an aerated flow over stepped slope, as shown in Figure 4. The entrance flow rate is measured with a Doppler flowmeter. The velocity of the flow is measured with an electromagnetic current meter and with a radar. The water level and the soil position are

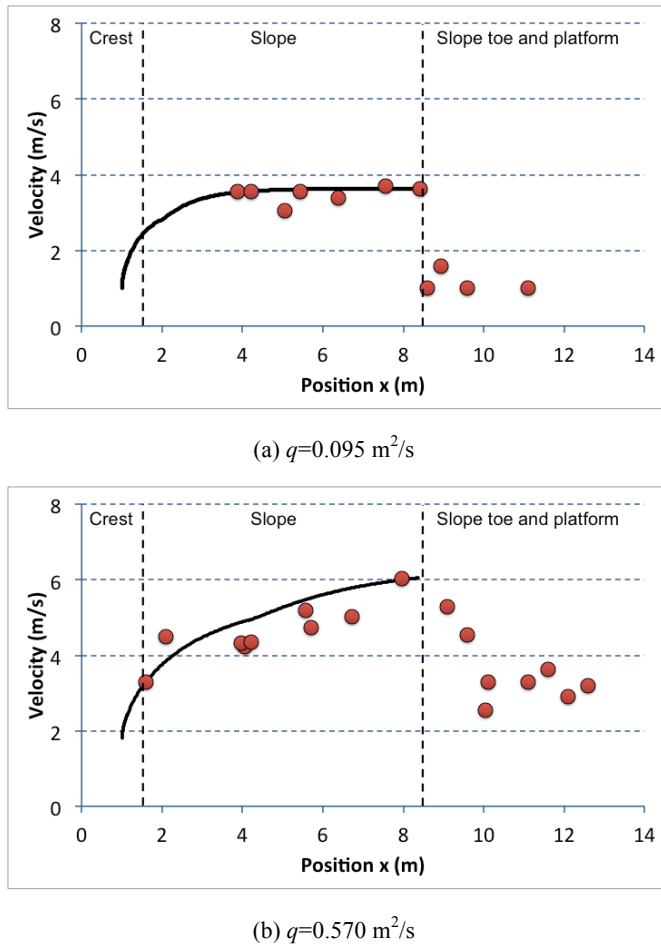
Figure 5. Flow velocity for a flow rate of 0.095 m²/s (minimum flow rate, test No. 1) (a) and a flow rate of 0.570 m²/s (maximum flow rate) (b). Symbols represent the measurements. Solid lines represent the Chanson model.

The flow accelerates along the slope to reach its maximum velocity at the toe of the slope, between 3.5 and 6 m/s. The flow is established for a flow rate of 0.095 m²/s but not established for 0.570 m²/s because the slope is too short (Figure 5). The flow conditions in stepped slopes have been classified into nappe flows, transition flows, and skimming flows: the Chanson model is therefore used for measurement analysis (Chanson, 2001).

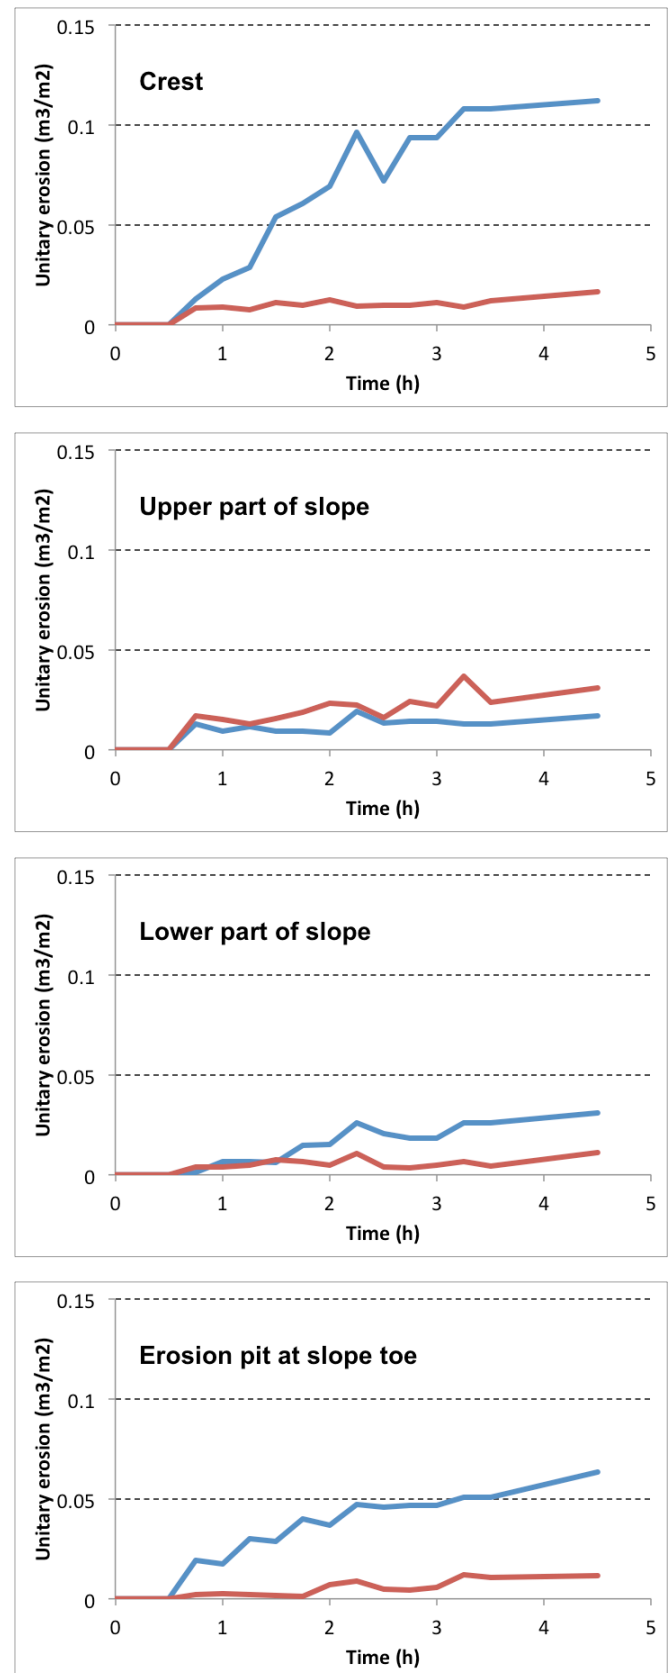
Figure 8. Unitary erosion (eroded volumes per square meter) as a function of time from the end of test No. 1, after the surface layer erosion. Erosion of untreated soil (blue) and lime-soil (red) for each zone.

The first test at $0.095 \text{ m}^2/\text{s}$ caused significant erosion of both soils. It is representative of the surface layer, altered by thermal, water and chemical exchanges with the external environment for 10 months, since the construction. In order to better highlight the resistance of the embankment soil itself, which appears to be superior to that of the surface layer, the evolutions over time of the unitary erosion are plotted from the end of the test No. 1, Figure 8.

The data in Figure 8 are used to evaluate the average ratios of eroded unit volume, and average ratios of erosion kinetics. These two ratios are of the same order of magnitude:

- on the crest, the erosion of untreated soil is 6 to 7 times greater than that of soil-lime;
- on the slope toe, where the erosion pit is developing, the erosion of untreated soil is 5 to 10 times greater than that of soil-lime;
- in the lower part of the slope, the erosion of untreated soil is 3 times greater than that of soil-lime;
- in the upper part of the slope, the erosion of untreated soil is of the same order of magnitude as that of soil-lime.

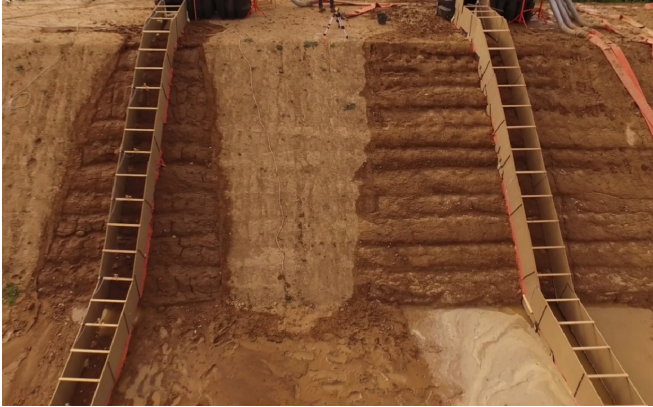
Figure 9. View after the tests campaign. Leaks caused soil erosion on both sides of the canals. Untreated soil being more erodible, erosion on both sides of the canal is more localized and deeper (left). On the contrary, the lime-soil is less erodible, and the leakage flows spread more widely on both sides of the channel (right). On both soils, the erosion of the surface layer highlights the layers of compaction.

Leaks under the sidewalls caused soil erosion on both sides of the canals. This is seen in Figure 9. Untreated soil being more erodible, erosion on both sides of the channel is more localized and deeper (left channel in Figure 9). On the contrary, the lime-soil is less erodible, and the leakage flows spread more widely on both sides of the channel (right channel in Figure 9). On both soils, the erosion of the surface layer highlights the layers of compaction.
