# Quantifying the erosion resistance of dikes with the overflowing simulator

S. Bonelli, S. Nicaise, G. Charrier, N. Chaouch, F. Byron and Y. Grémeaux

*Irstea, Aix-en-Provence, France*

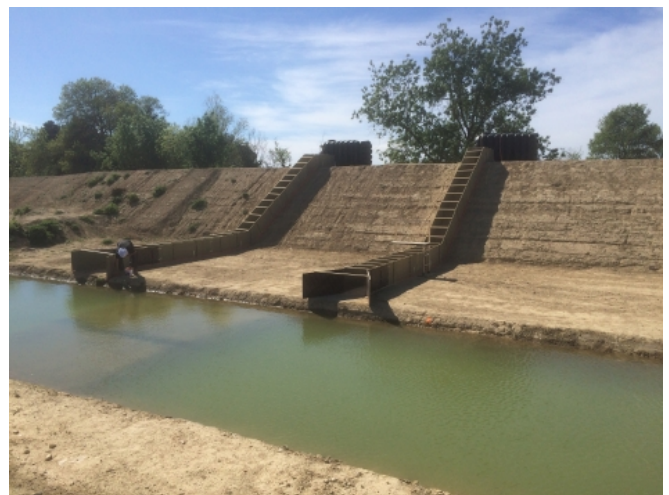
Figure 1. The DigueElite demonstrator, with the two channels before tests, untreated soil on the left, soil-lime on the right.

A dike dedicated to the French DigueELITE research program ([www.digueelite.fr](http://www.digueelite.fr)) was built near Montpellier (France) on the banks of the Vidourle River. It has a height of 3.5 m and a slope of 3H / 2V. The structure consists of a 30 m section treated with lime and a 10 m section of untreated soil (natural soil). The slopes are non-vegetated (Figure 1). The

The experimental set-up consists of two 15 m long and 61 cm wide channels located on the downstream slope of the dike, one in the lime treated zone, the other on the untreated soil, for the purpose to test the erosion resistance at the crest, on the downstream slope and at the foot of the slope (Figure 1). A buffer tank is located on the crest between the arrival of the pumping system and the inlet of the channel. The test channel leads to a bassin that houses the pumps, which makes it possible to operate in a closed circuit (Figure 2).

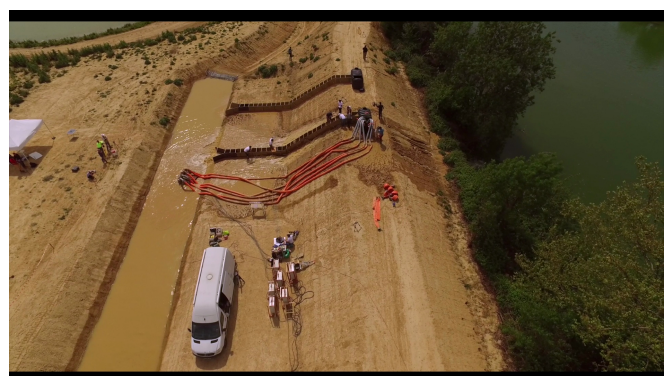
Figure 2. Overview of the site and overflow simulator. The Vidourle River is on the right.

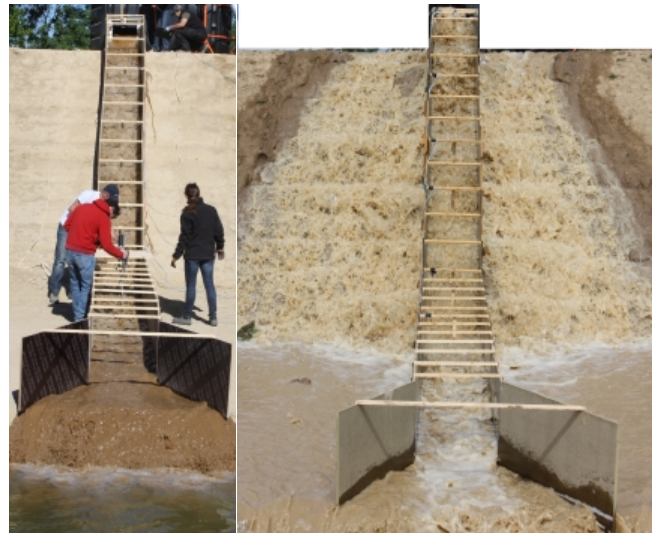
Figure 4. View during test for a flow rate of 95 l/s/mL (minimum flow rate, test No. 1) (left) and a flow rate of 570 l/s/mL (maximum flow rate) (right).

The free-surface flow on this slope (angle of 33 °) is super-critical, with a Froude number of about 4 to 5. It is an aerated flow over stepped slope, as shown in Figure 4. The entrance flow rate is measured with a Doppler flowmeter. The velocity of the flow is measured with an electromagnetic current meter and with a radar. The water level and the soil position are

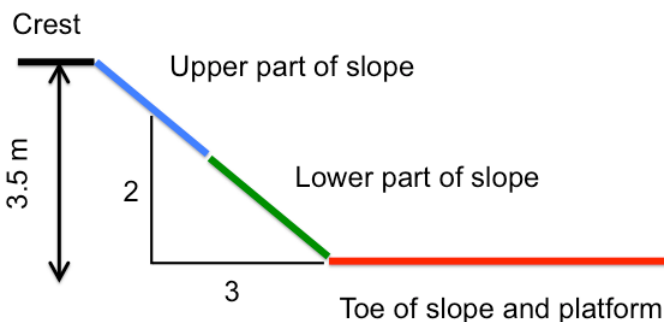
Figure 6. The four zones of erosion analysis.

Erosion is not uniform, and the spatial distribution is different for the two soils tested. To better analyze this, the analysis is done in four areas: the crest, the upper part of the slope, the lower part of the slope and the slope toe (Figure 6). The time evolution of the unitary erosion for these 4 zones is given in Figure 7.

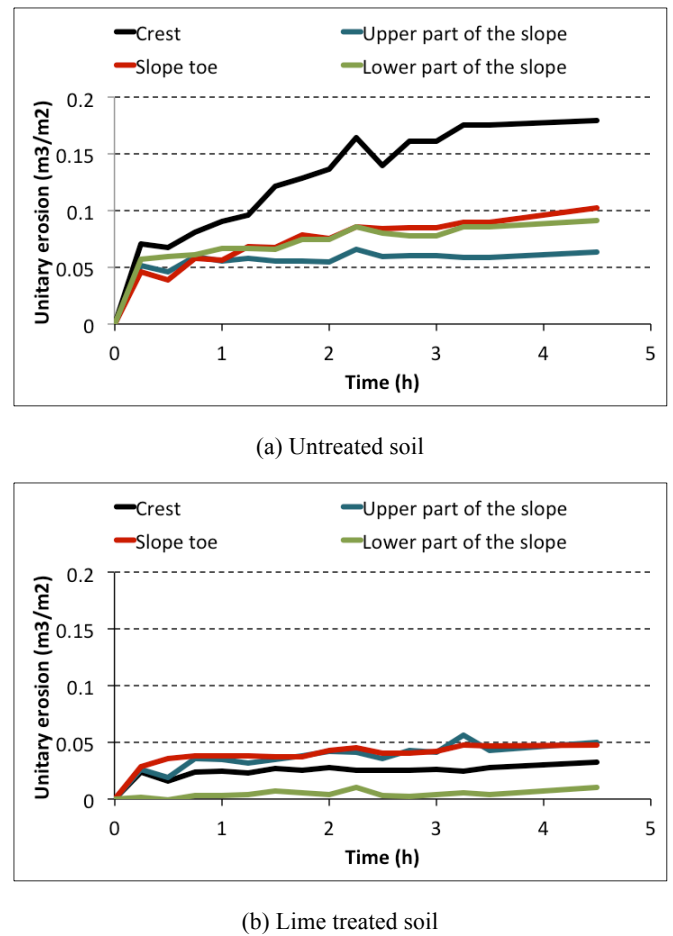
Figure 7. Unitary erosion (eroded volumes per square meter) as a function of time. Comparison of erosion of untreated soil and lime-soil for each zone.

More precisely, the observations made in Figure 7 are as follows:

- Untreated soil
  - the first test caused relatively uniform initial erosion in the 4 zones of the order of  $0.05 \text{ m}^3/\text{m}^2$ , ie an average of 5 cm;
  - the erosion was the largest at crest, reaching  $0.17 \text{ m}^3/\text{m}^2$ , with an average kinetics of 3 cm/h after test No. 1;
  - along the slope, erosion kinetics averaged 0.4 cm/h in the upper part and 0.8 cm/h in the lower part after the first initial test;
  - the erosion of the slope toe is of the same order of magnitude as in the lower part of the slope, but it is more localized and deeper.
- Lime-soil
  - the first test causes an initial erosion of the order of  $0.02$  to  $0.04 \text{ m}^3/\text{m}^2$ , except on the lower part of the slope, where this initial erosion is negligible;
  - the area with the lowest erosion is the lower part of the slope;

- along the slope, erosion kinetics averaged 0.8 cm/h in the upper part and 0.3 cm/h in the lower part after the first test;
  - erosion at crest and erosion at the upper part of the slope are of the same order of magnitude (0.8 cm/h);
  - after test No. 1, the erosion kinetics of the slope toe and the lower part of the slope are of same order of magnitude (0.3 cm/h).

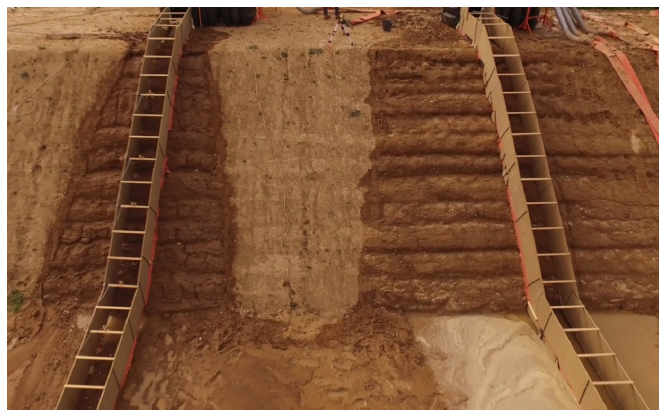
Figure 9. View after the tests campaign. Leaks caused soil erosion on both sides of the canals. Untreated soil being more erodible, erosion on both sides of the canal is more localized and deeper (left). On the contrary, the lime-soil is less erodible, and the leakage flows spread more widely on both sides of the channel (right). On both soils, the erosion of the surface layer highlights the layers of compaction.

Leaks under the sidewalls caused soil erosion on both sides of the canals. This is seen in Figure 9. Untreated soil being more erodible, erosion on both sides of the channel is more localized and deeper (left channel in Figure 9). On the contrary, the lime-soil is less erodible, and the leakage flows spread more widely on both sides of the channel (right channel in Figure 9). On both soils, the erosion of the surface layer highlights the layers of compaction.
