An experimental investigation of the response of slender protective structures to rockfall impacts

Stéphane Lambert, Frank Bourrier, Philippe Gotteland, and François Nicot

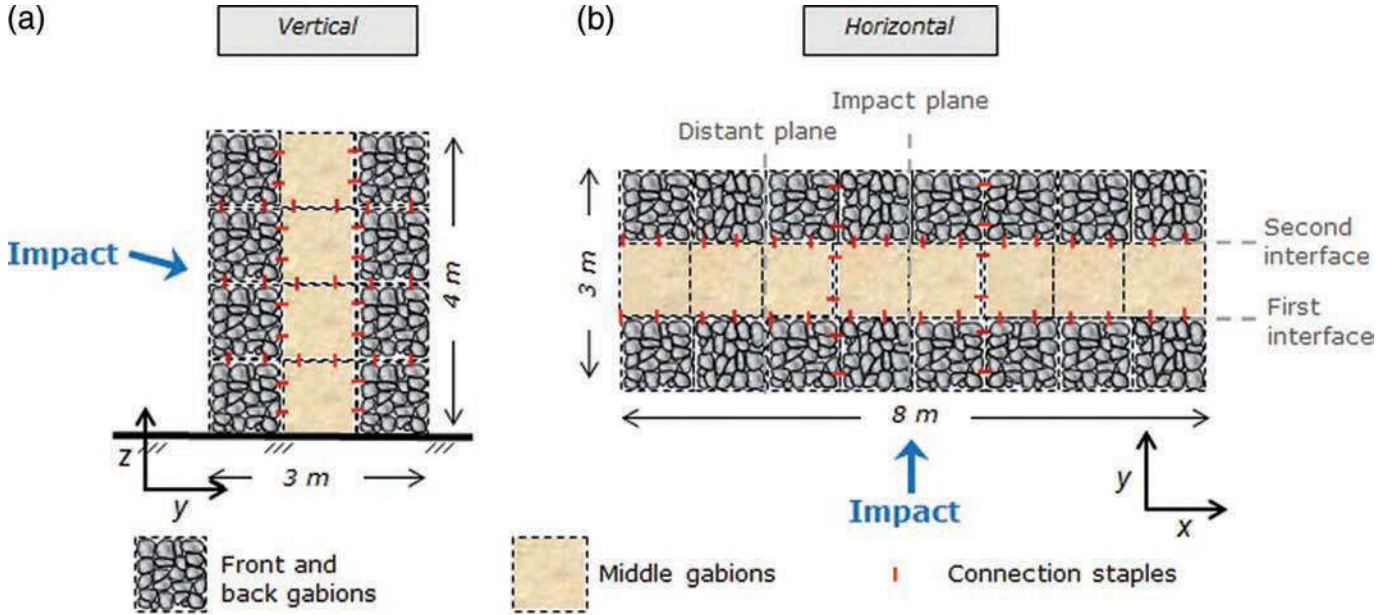
Fig. 2. (a) Vertical and (b) horizontal structure cross-sections. [Colour online.]

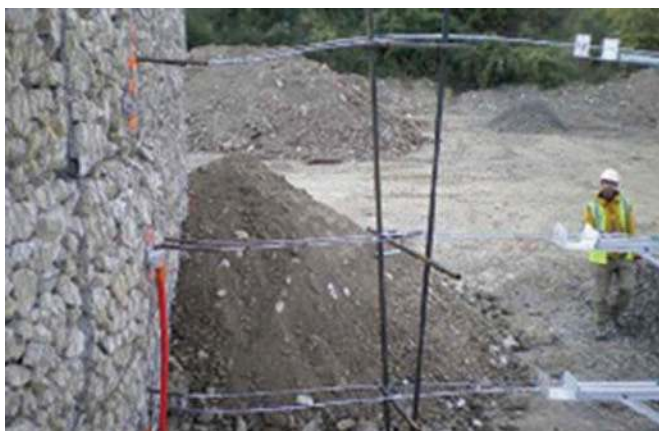
Fig. 4. Deformation of displacement sensor extension rods after the third impact on structure BA (i.e., ballast). [Colour online.]

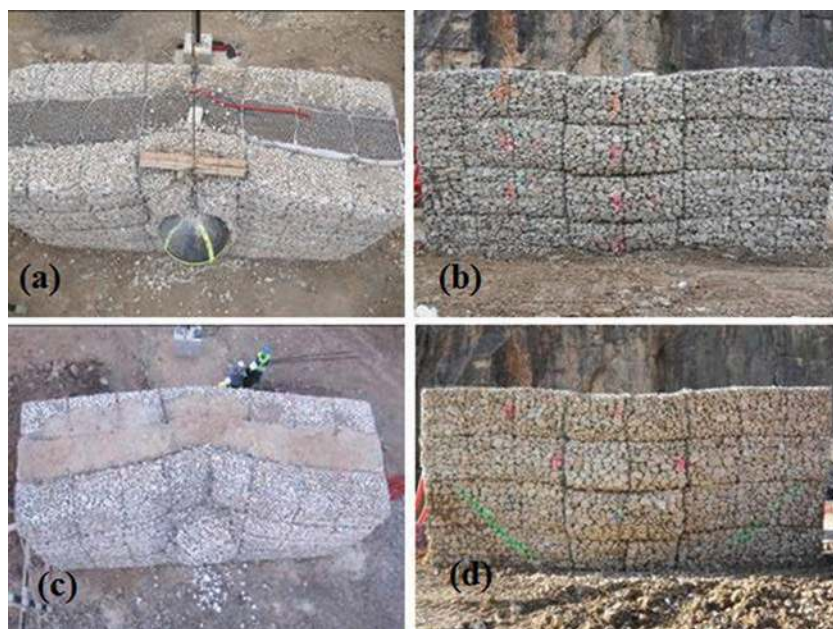
Fig. 6. Views of (a, c) the uphill face and crest and (d, b) the downhill face of structures (a, b) BA and (c, d) STM after the 2000 kJ kinetic energy impact test. [Colour online.]

The 2000 kJ impacts led to much more deformation and damage to the structures. In the impacted area, stone crushing was generalized and gabion cages were torn open, resulting in gravity-driven dump of the fill material after projectile removal (Fig. 6c). The back face post-impact displacement was substantial, combining outward translation and settlement of the gabion cages in the middle section (Figs. 6b and 6d). During the impact tests, an uplift of the crest above the impacted area was clearly observed.

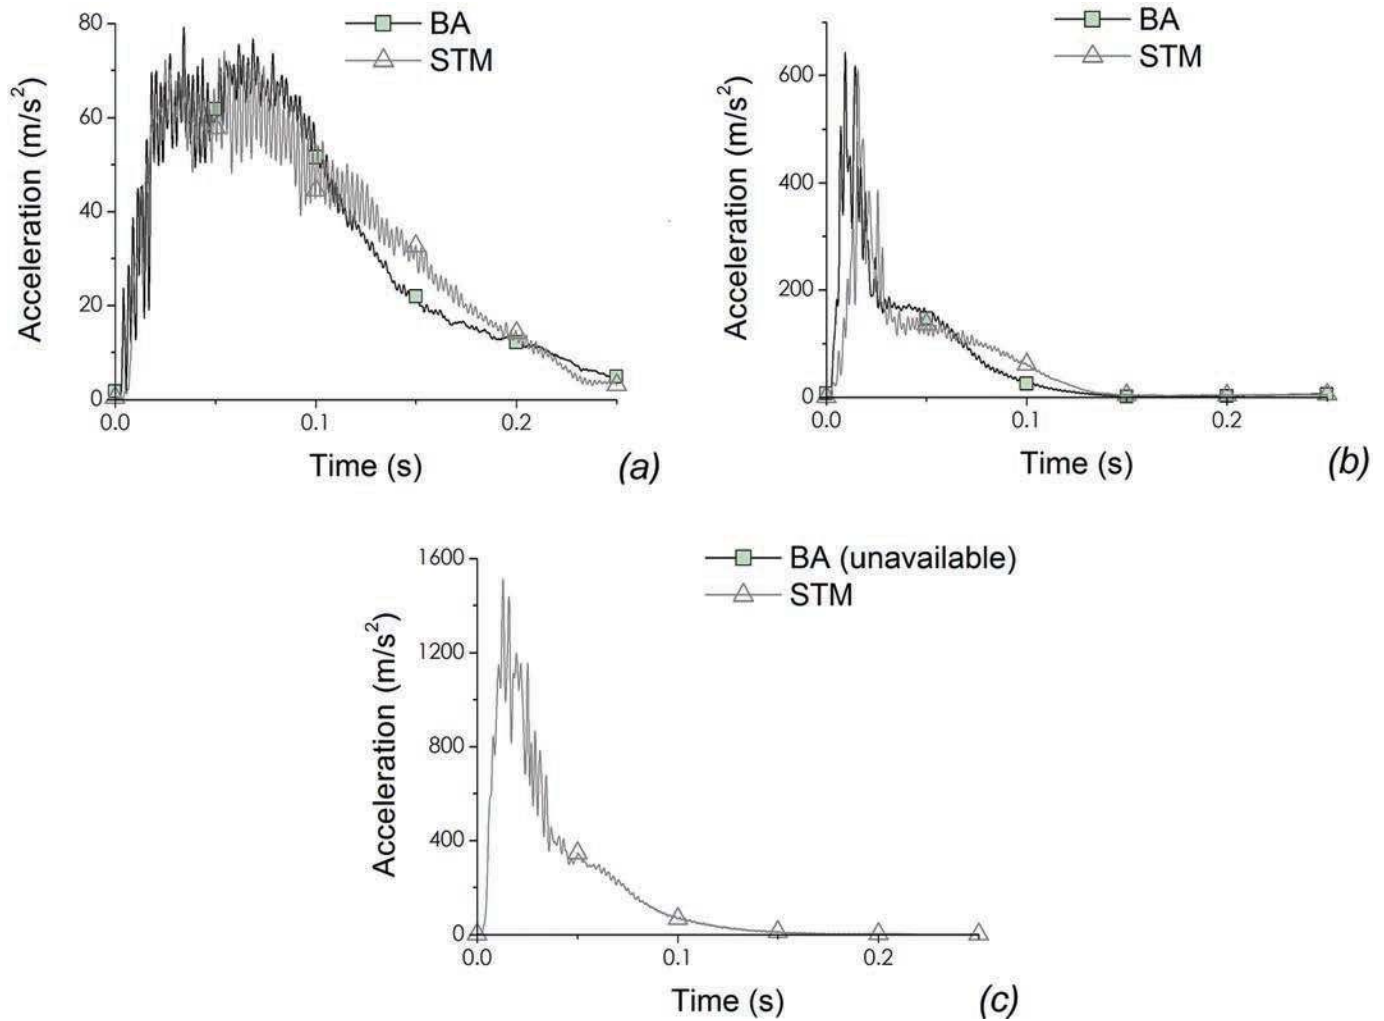
Fig. 7. Projectile acceleration recorded during the (a) 200 kJ, (b) 500 kJ, and (c) 2000 kJ impact tests on structures BA and STM. [Colour online.]

(Fig. 7), the opposite trend is observed; the ratio between peak values went from 50% for test 1 to 15% for test 3.

When comparing the projectile acceleration (Fig. 7) with the acceleration at the first interface and at the back face of the structure (Fig. 8), it is observed that the increase in acceleration during the test series is much less within the structure. Indeed, the projectile acceleration peak is multiplied by 20, from test 1 to test 3, while it is multiplied by 2 and 6, approximately, at the first interface and at the back face.

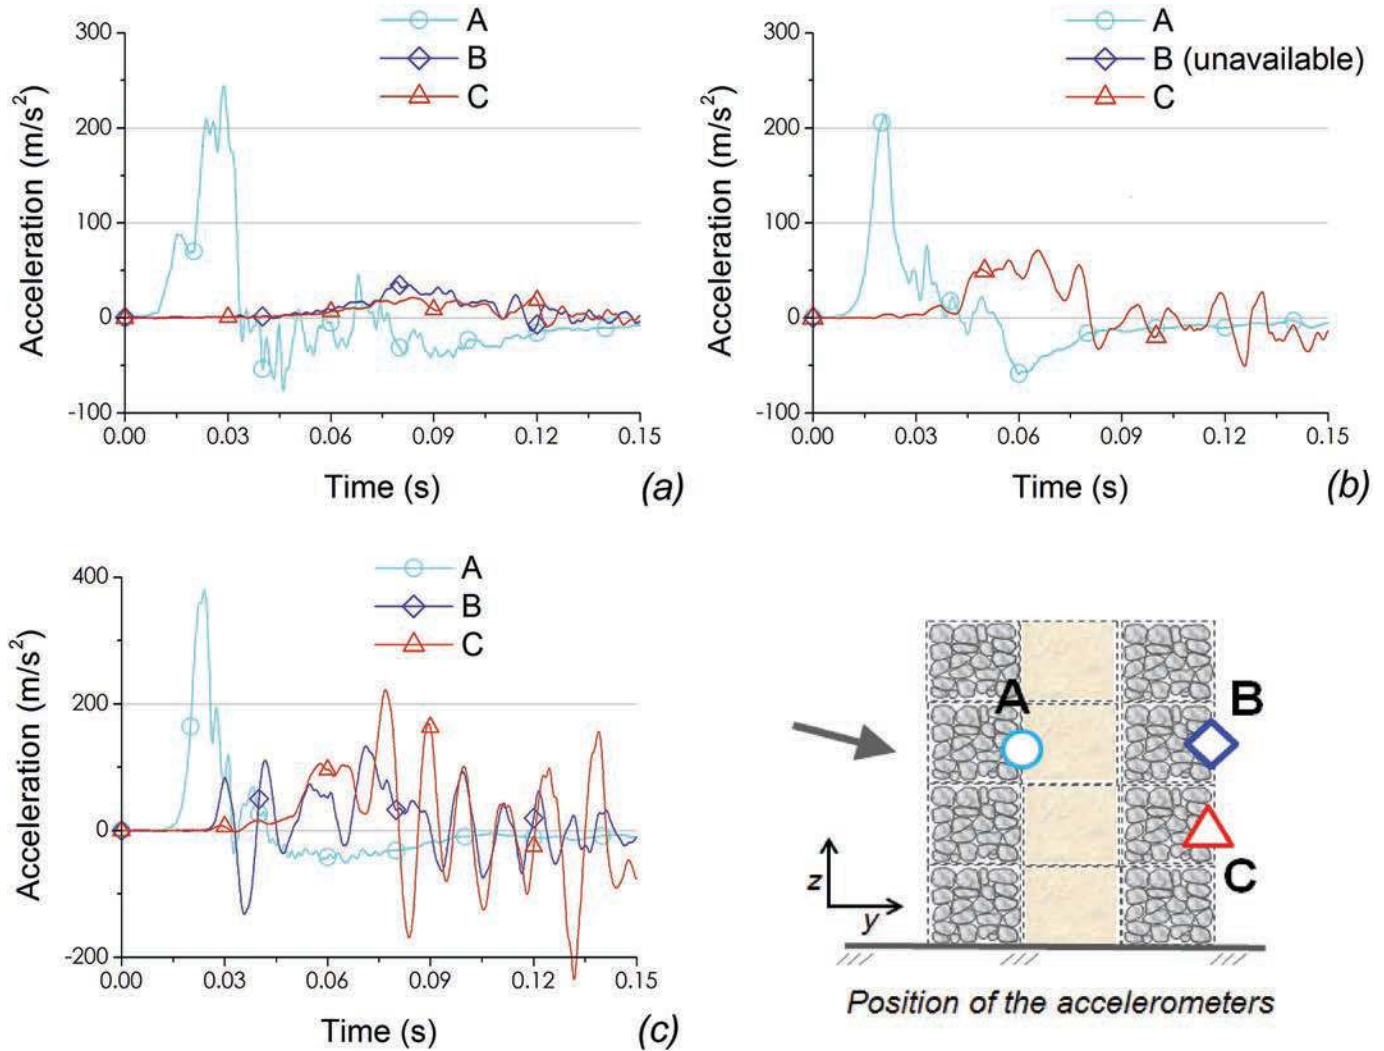
Fig. 8. Structure BA. Acceleration in the impact plane and along the y axis at the first interface (point A) and on the downhill face (points B and C). Impact tests were at (a) 200 kJ, (b) 500 kJ, and (c) 2000 kJ. [Colour online.]

Figure 8 shows the acceleration measured along the y axis in different points in the impact plane. For symmetry reasons, no acceleration measurement was made along the x axis, corresponding to the longitudinal axis of the structure. The high-amplitude fluctuations observed during tests BA-3 for sensors placed on the back face were attributed to the displacement of the wire mesh to which the sensors were attached.

Figure 8 also reveals that for test 3 the back face higher acceleration was observed below the impact point, the green curve being above the blue one. A similar trend was mentioned in other studies concerning vertical gabion structures leaned against a rigid wall and exposed to normal-to-the-face impacts (Heymann 2012; Ng et al. 2016). In these cases, this trend was attributed to the increase in fill material density and consequently confining stress from the crest to the base. An additional explanation in the presented case could be the downward orientation of the projectile at impact.

Comparing curves plotted in Fig. 8 also reveals that the acceleration attenuation from the first interface to the back face decreased with the impact energy; the ratio of the maximum acceleration at the back face of the structure to that at the first interface increased from 10% during test 1 to 60% for test 3. This reveals that test 1 induced substantial displacement at limited distance from the impacted area, while in test 3 there were substantial displacements in all the structure, due to higher impact energy. This is in line with the schematic description of the structure impact response proposed in Lambert and Bourrier (2013) and in Lambert and Kister (2018). By contrast, when comparing the back face acceleration (Fig. 8) with the projectile acceleration

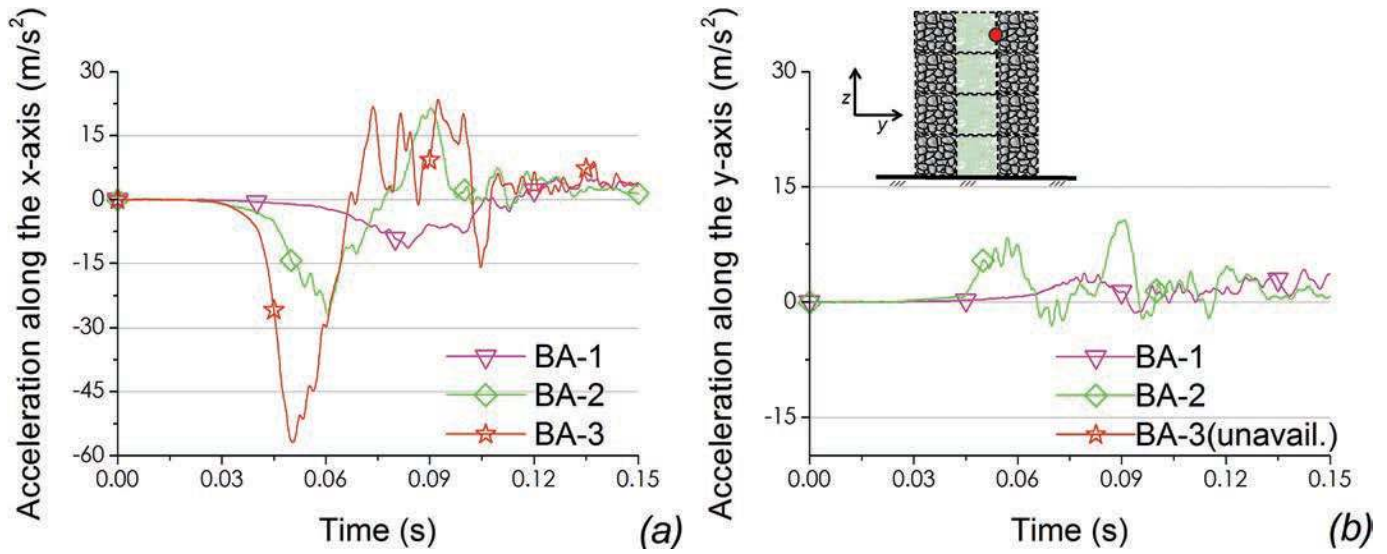
Fig. 9. Structure BA. Acceleration in the distant plane at the second interface and 3.5 m from the ground along the x and y axes (*a* and *b*, respectively). [Colour online.]

To investigate the lateral diffusion of the stress, out of the impact plane, the acceleration measured in the distant plane at the second interface is shown in Fig. 9. The acceleration was measured at 3.5 m from the ground and along two axes (x and y). Along the x axis, a first acceleration peak typically lasting 30 ms is observed. It is oriented outward from the structure in the direction perpendicular to the impact plane. A peak value as high as 55 m/s^2 was reached during BA-3. A reverse acceleration is also observed,

in a second time. At this measurement point, the acceleration was mainly oriented along the x -axis direction. For tests BA-1 and BA-2, the maximum values of the acceleration were three times higher along this axis than that along the y axis. Peak values of the acceleration along the x axis represented 15%, 4%, and 4% of the projectile acceleration peaks for tests 1, 2, and 3, respectively. A strong attenuation was observed between the first interface (Fig. 8) and the distant plane, with peak values along the x axis in the distant plane of 5%, 12%, and 15% of that at the first interface along the y -axis direction for tests 1 to 3, respectively. This attenuation was significantly higher than between the first interface and the back face in the impact plane (Fig. 8), while both measuring points were at similar distances from the first interface measuring point.

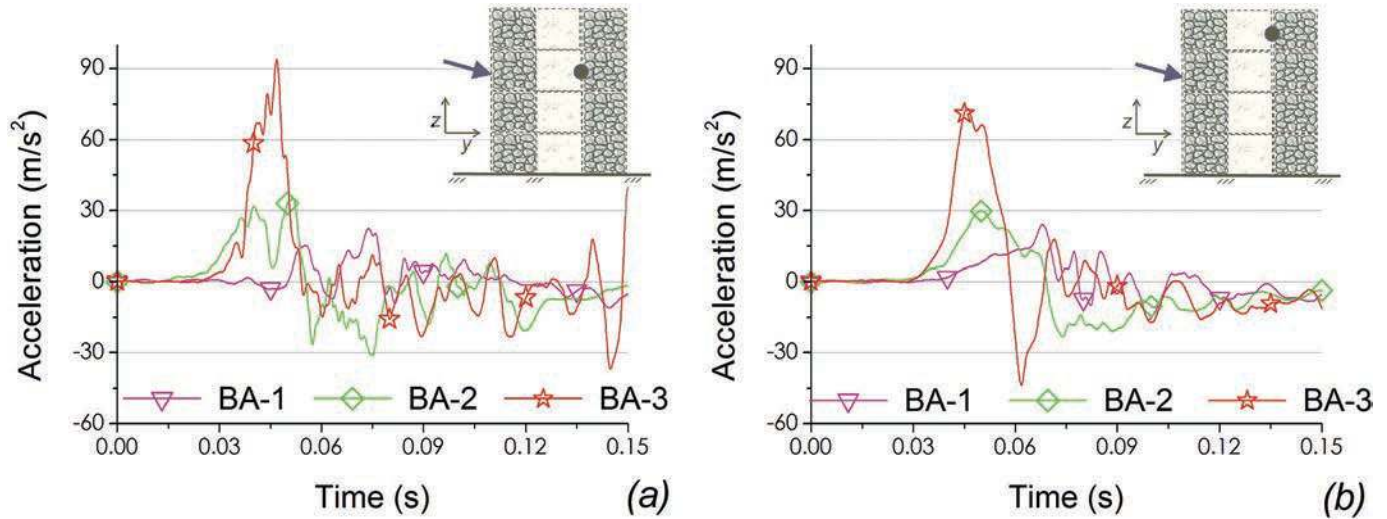
Fig. 10. Structure BA. Acceleration along the z axis in the impact plane and at the second interface, 2.5 and 3.5 m from the ground (*a* and *b*, respectively). [Colour online.]

Uplift of the upper part of the structure was observed during the experiments. This was confirmed in Fig. 10, which presents the acceleration along the z axis at 2.5 and 3.5 from the ground and at the second interface. The six curves were characterized by an upward acceleration, over durations as long as 30 ms for test BA-3. This peak was followed by a major downward acceleration with maximum amplitude higher than gravity for tests BA-2 and BA-3. The main difference between the two measuring points was a lower peak value measured at 3.5 m from the ground with a

20 m/s² difference in the case of BM-3. The stress wave reached the second interface at a similar time for all three impact tests, about 25 ms after the impact beginning.

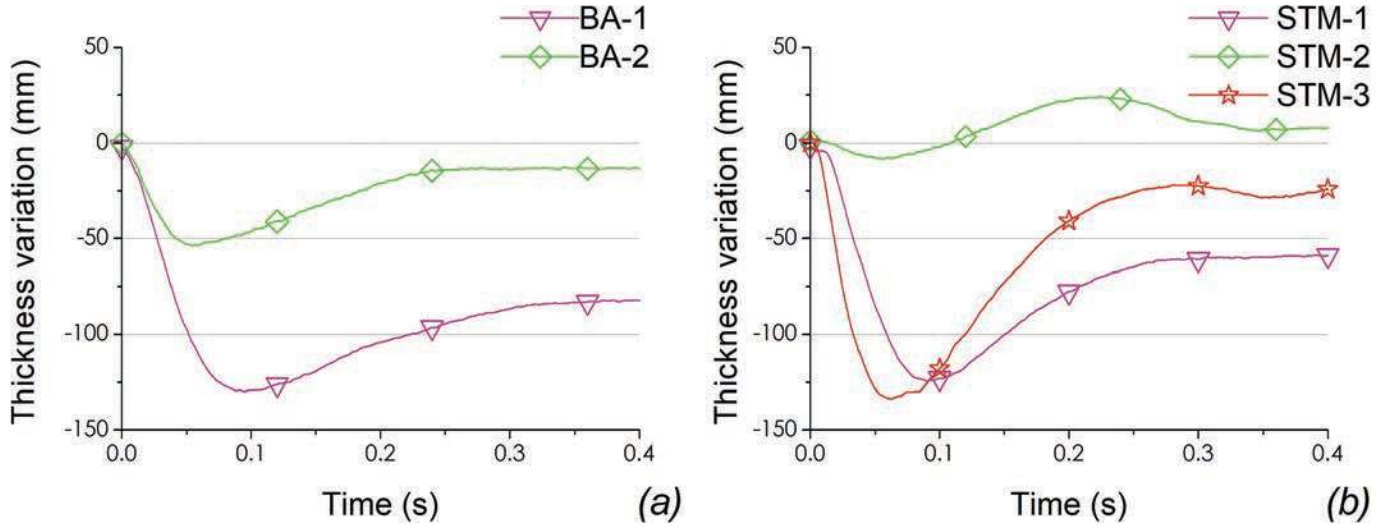
Fig. 15. Middle layer thickness variation during the impact tests for structures (a) BA and (b) STM. [Colour online.]

Using the displacements measured in D3 and D4, it is possible to investigate the middle layer width variation with time at the impact height. Two main conclusions are drawn from Fig. 15. During the first test, the middle layer width decreases down to a minimum value, reached at $t = 0.06$ to 0.1 s, depending on the test, followed by a width recovery lasting about 0.2 s. During the second tests a smaller width decrease was observed for structure BA as compared with the first test, and a slight increase was observed for structure STM. The notable difference between the two structures is that the post-peak width recovery during the first impact test was higher for structure STM compared with structure BA (50% vs. 34%, respectively). This difference is attributed to the difference in middle layer fill material characteristics. The recovery is even higher during test STM-3 with a value of 80%. This is in line with the conclusions drawn by Lambert et al. (2014), suggesting the effect of the sand–tire mixture elasticity. Sections 4.3 and 4.4 will discuss these observations in more detail.

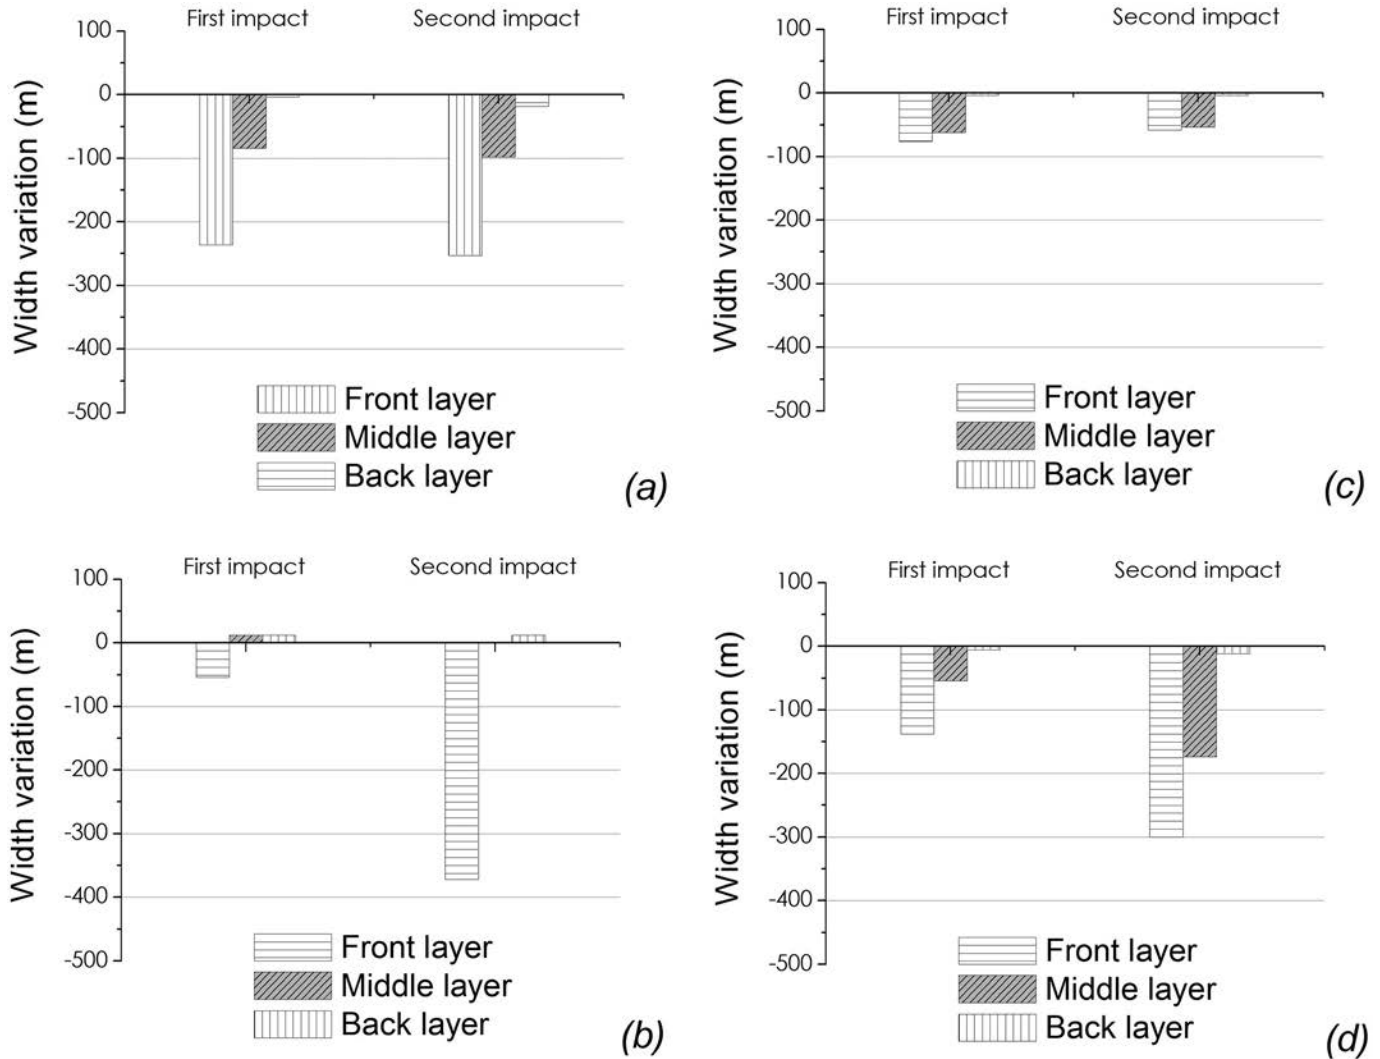
Fig. 16. Cumulative evolution of the residual thickness of each layer of structures BA (left column) and STM (right column) at 1.5 and 2.5 m from the ground (bottom and top rows, respectively).

Combining data obtained from the topographical survey with those from the displacement sensors made it possible to compare the variation of the width of each of the three layers and in the impact plane when at-rest after the impact (Fig. 16). Plotting these curves until test 3 was not possible due to the severe damages observed in the impacted area, making structure width measurements unreliable at its mid-height. Figures concerning structure BA (left column) revealed that most of the structure width decrease was imputable to the decrease in front face layer width. After the second impact, the front face layer width reduction was 75% and almost 100% that of the structure width at 2.5 and 1.5 m from the ground, respectively. These values reduced to 50% and

60% for structure STM (Fig. 16, right column). The contribution of the middle layer in the structure width decrease was much higher when using the sand–tire mixture as fill material. By contrast, using ballast tended to favor decrease in width of the front layer, associated with damage to the crushed quarry limestone filling this layer. The back layer width of the two structures remained almost constant during the two impact tests.
