An experimental investigation of the response of slender protective structures to rockfall impacts

Stéphane Lambert, Franck Bourrier, P. Gotteland, François Nicot

Key words: rockfall, embankment, gabion, structure design, impact, plastic deformation.

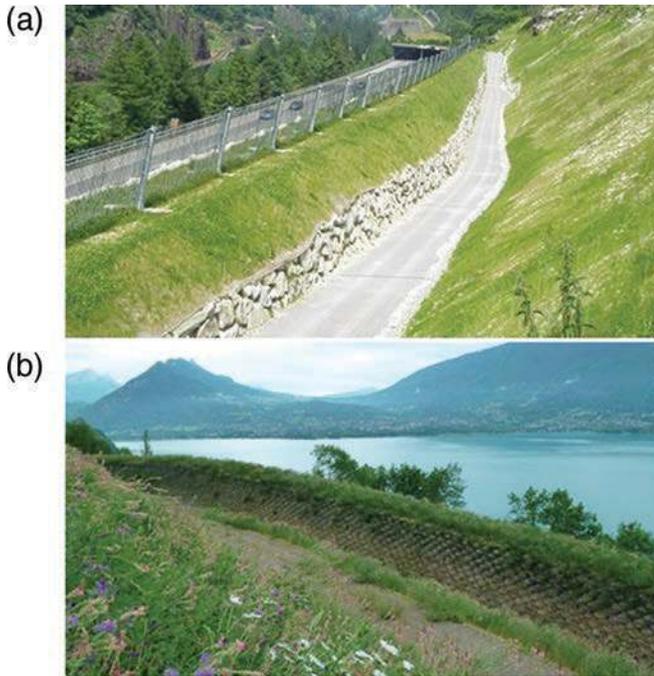
Fig. 1. Two classical rockfall protection embankments in (a) Switzerland and (b) France (© S. Lambert). [Colour online.]

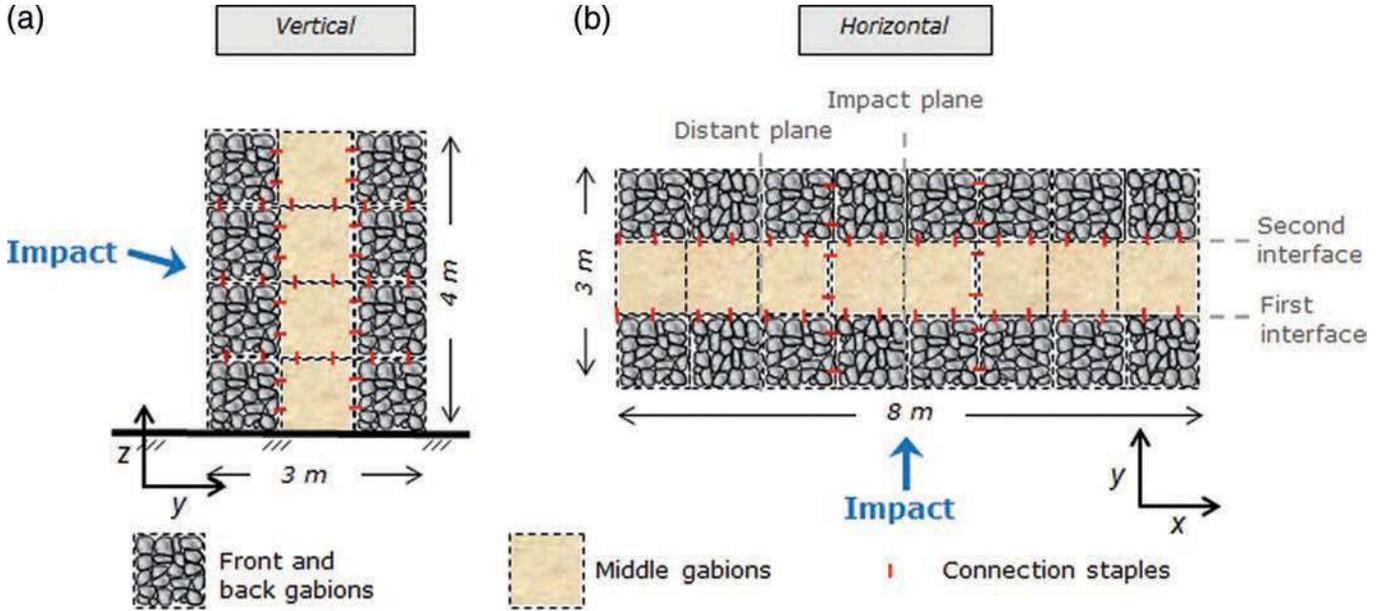
Fig. 2. (a) Vertical and (b) horizontal structure cross-sections. [Colour online.]

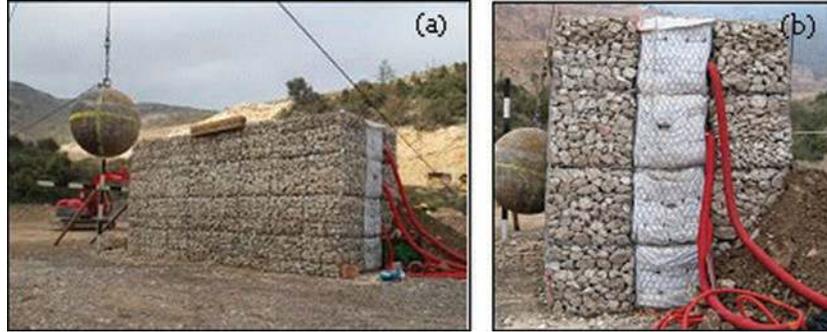
Fig. 3. (a) Uphill face and (b) side views of structure STM (i.e., sand-tire mixture) showing the projectile hanged up on the cableway. The wood pile and the ducts respectively protecting the uphill face top and the sensor cables are also visible. [Colour online.]

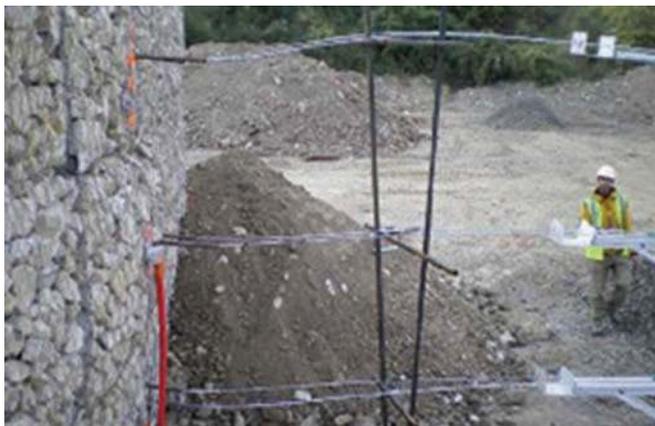
Fig. 4. Deformation of displacement sensor extension rods after the third impact on structure BA (i.e., ballast). [Colour online.]

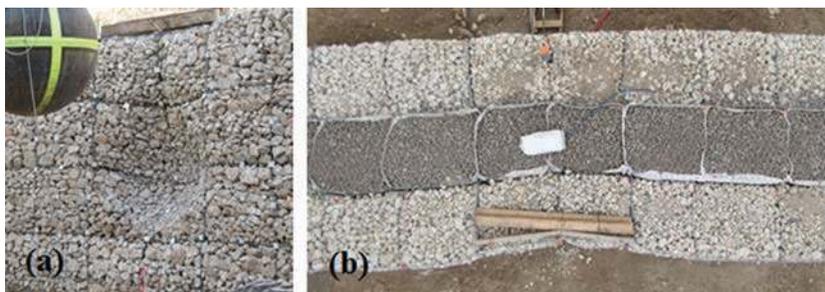
Fig. 5. The 500 kJ impact resulted in (a) a large crater on the uphill face and (b) structure deformation along its transverse axis (illustration for structure BA). [Colour online.]

Both BA and STM structures succeeded in stopping the three impacts up to 2000 kJ in kinetic energy without collapsing. Impacts resulted in deformation and damage, which increased with the impact energy. The main visible change after the first impacts was a spherical crater in the impacted area, with moderate depth. No other change was clearly visible, except a few cases of stone breakage in the impacted area. Increasing the impact energy up to 500 kJ led to higher face deformation and damage, in terms of penetration and stones breakage. In addition, a few metal wires were cut in the impacted area. Deformation of the whole structure along its longitudinal axis together with displacement of the back face were also observed (Fig. 5b).

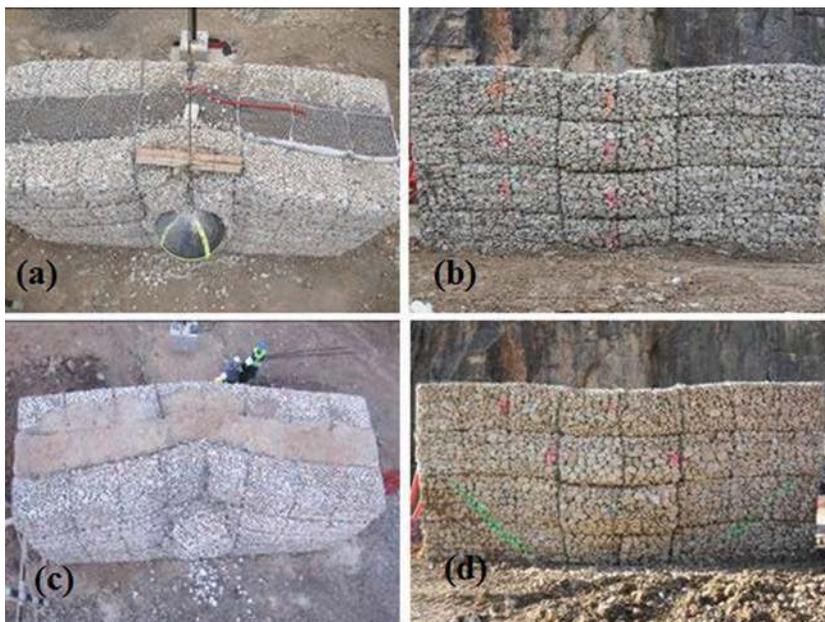
Fig. 6. Views of (a, c) the uphill face and crest and (d, b) the downhill face of structures (a, b) BA and (c, d) STM after the 2000 kJ kinetic energy impact test. [Colour online.]

The 2000 kJ impacts led to much more deformation and damage to the structures. In the impacted area, stone crushing was generalized and gabion cages were torn open, resulting in gravity-driven dump of the fill material after projectile removal (Fig. 6c). The back face post-impact displacement was substantial, combining outward translation and settlement of the gabion cages in the middle section (Figs. 6b and 6d). During the impact tests, an uplift of the crest above the impacted area was clearly observed.

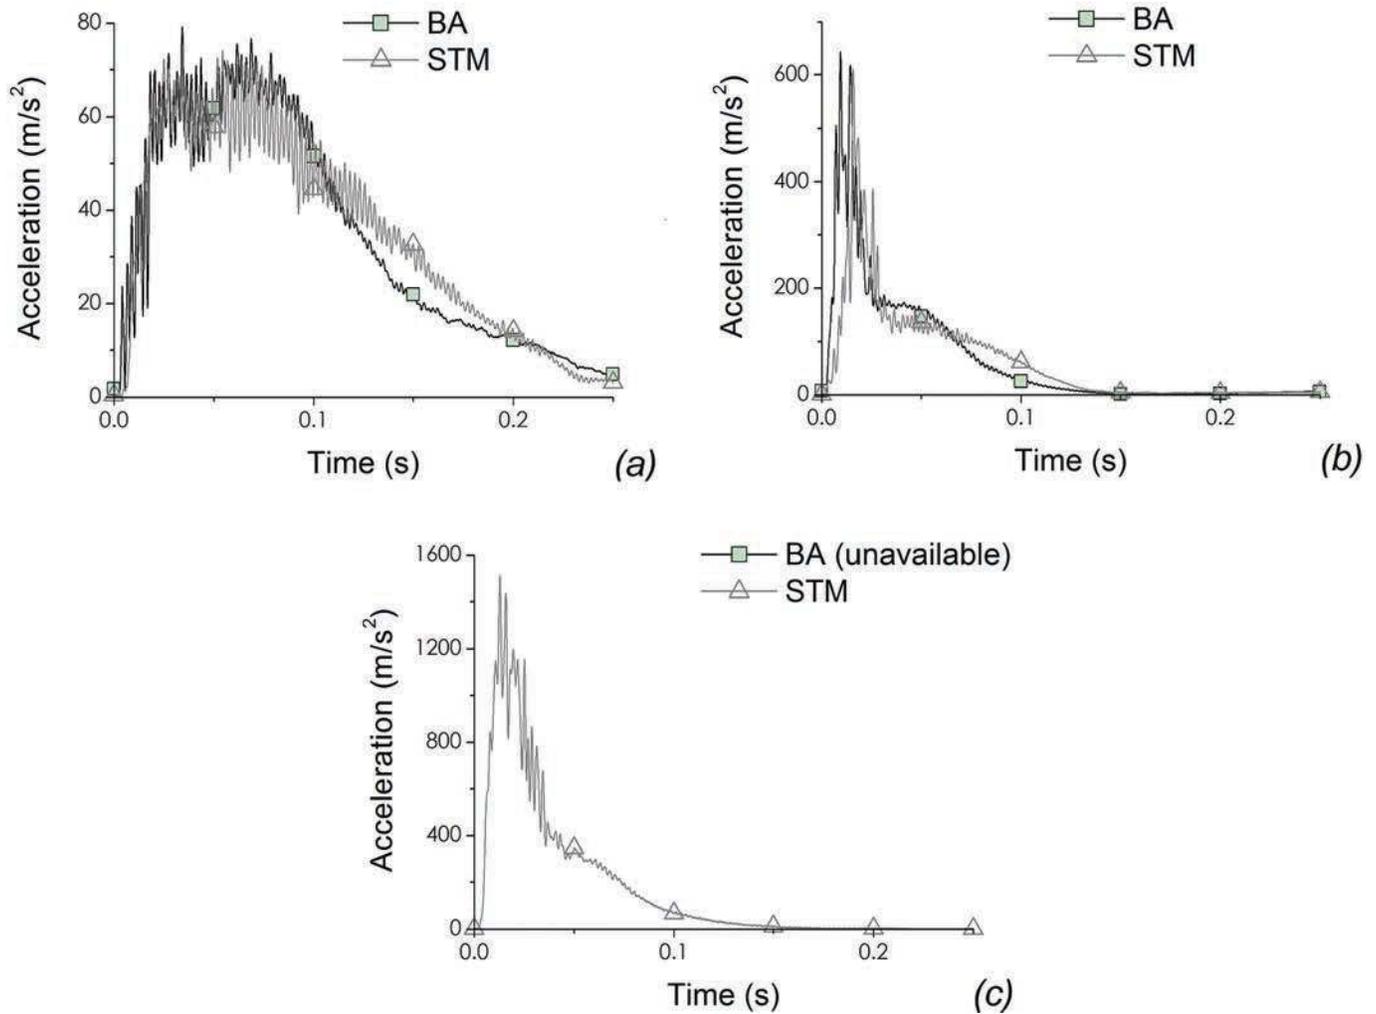
Fig. 7. Projectile acceleration recorded during the (a) 200 kJ, (b) 500 kJ, and (c) 2000 kJ impact tests on structures BA and STM. [Colour online.]

(Fig. 7), the opposite trend is observed; the ratio between peak values went from 50% for test 1 to 15% for test 3.

When comparing the projectile acceleration (Fig. 7) with the acceleration at the first interface and at the back face of the structure (Fig. 8), it is observed that the increase in acceleration during the test series is much less within the structure. Indeed, the projectile acceleration peak is multiplied by 20, from test 1 to test 3, while it is multiplied by 2 and 6, approximately, at the first interface and at the back face.

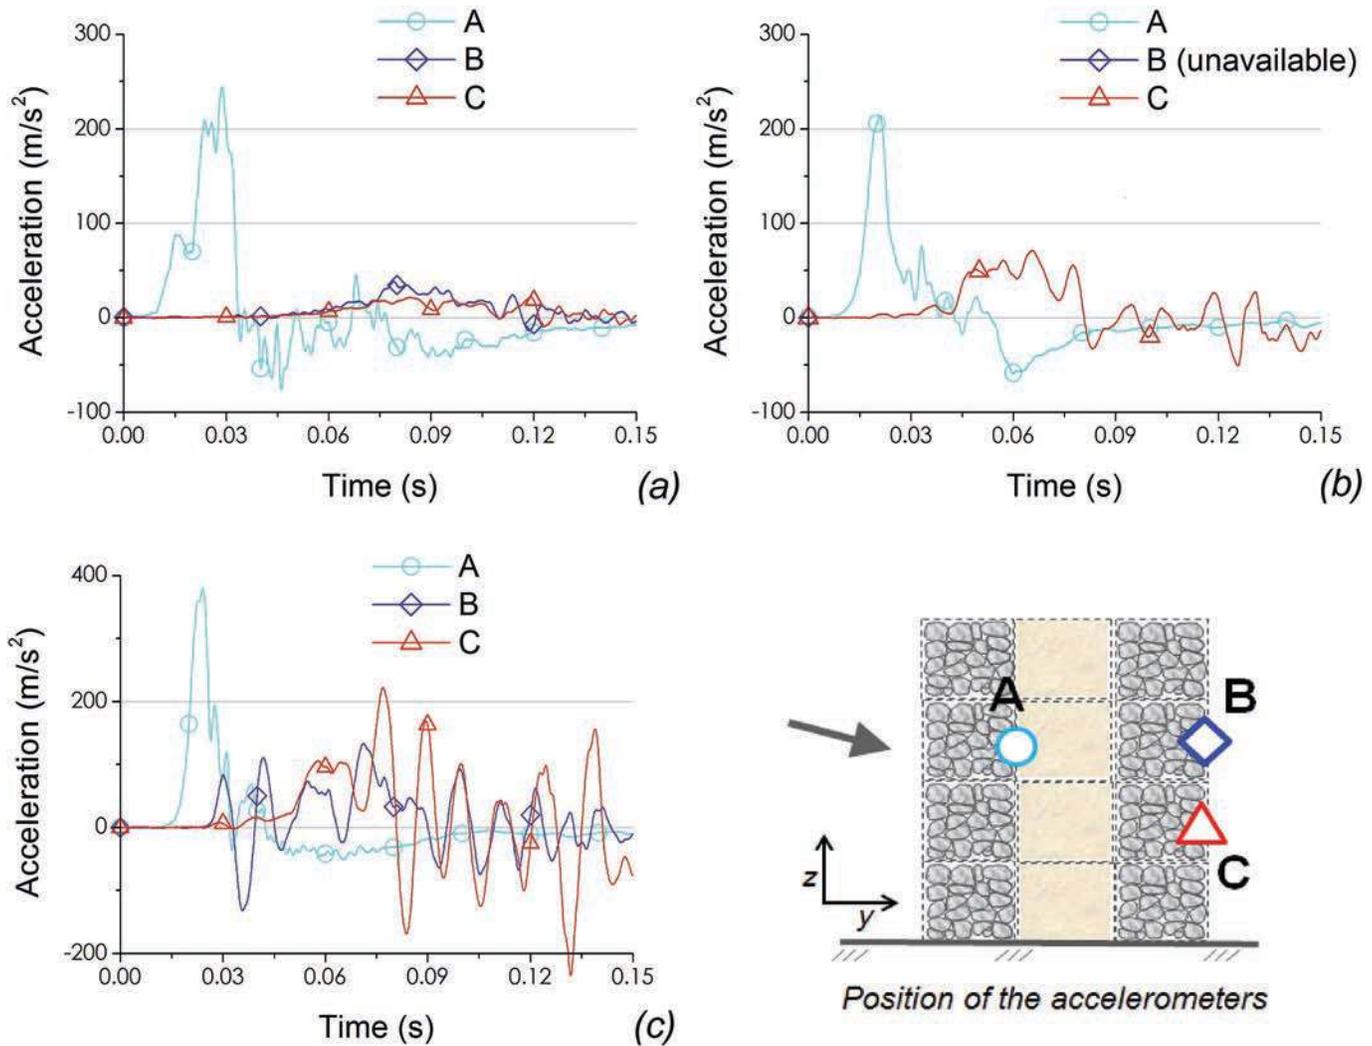
Fig. 8. Structure BA. Acceleration in the impact plane and along the y axis at the first interface (point A) and on the downhill face (points B and C). Impact tests were at (a) 200 kJ, (b) 500 kJ, and (c) 2000 kJ. [Colour online.]

Figure 8 shows the acceleration measured along the y axis in different points in the impact plane. For symmetry reasons, no acceleration measurement was made along the x axis, corresponding to the longitudinal axis of the structure. The high-amplitude fluctuations observed during tests BA-3 for sensors placed on the back face were attributed to the displacement of the wire mesh to which the sensors were attached.

Figure 8 also reveals that for test 3 the back face higher acceleration was observed below the impact point, the green curve being above the blue one. A similar trend was mentioned in other studies concerning vertical gabion structures leaned against a rigid wall and exposed to normal-to-the-face impacts (Heymann 2012; Ng et al. 2016). In these cases, this trend was attributed to the increase in fill material density and consequently confining stress from the crest to the base. An additional explanation in the presented case could be the downward orientation of the projectile at impact.

Comparing curves plotted in Fig. 8 also reveals that the acceleration attenuation from the first interface to the back face decreased with the impact energy; the ratio of the maximum acceleration at the back face of the structure to that at the first interface increased from 10% during test 1 to 60% for test 3. This reveals that test 1 induced substantial displacement at limited distance from the impacted area, while in test 3 there were substantial displacements in all the structure, due to higher impact energy. This is in line with the schematic description of the structure impact response proposed in Lambert and Bourrier (2013) and in Lambert and Kister (2018). By contrast, when comparing the back face acceleration (Fig. 8) with the projectile acceleration

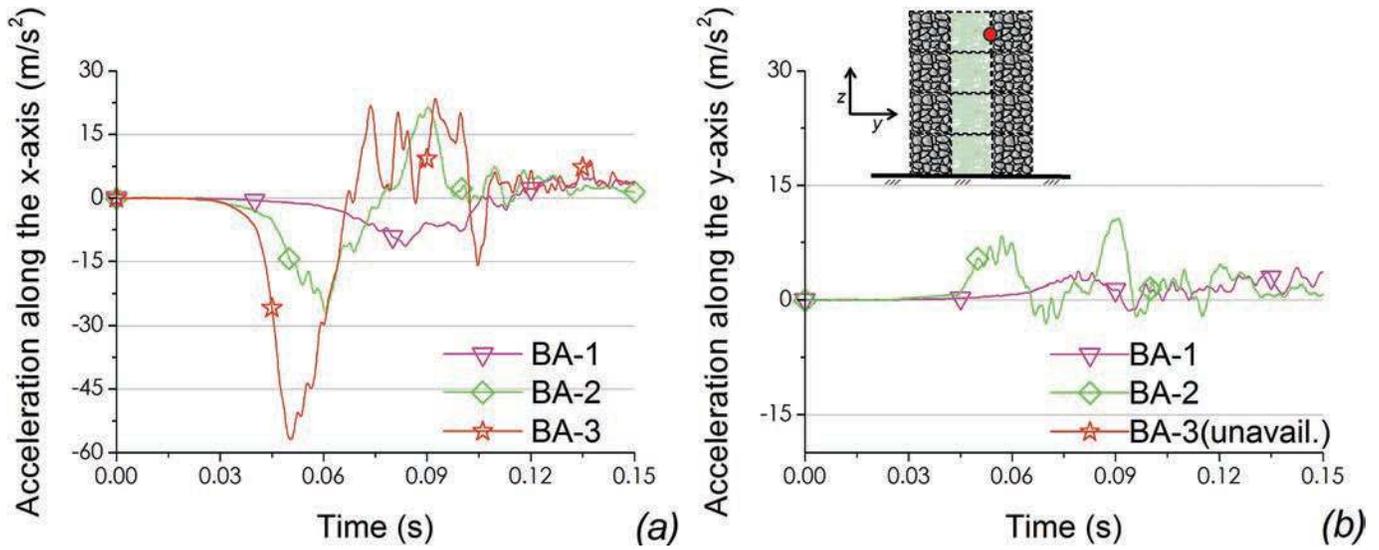
Fig. 9. Structure BA. Acceleration in the distant plane at the second interface and 3.5 m from the ground along the x and y axes (*a* and *b*, respectively). [Colour online.]

To investigate the lateral diffusion of the stress, out of the impact plane, the acceleration measured in the distant plane at the second interface is shown in Fig. 9. The acceleration was measured at 3.5 m from the ground and along two axes (x and y). Along the x axis, a first acceleration peak typically lasting 30 ms is observed. It is oriented outward from the structure in the direction perpendicular to the impact plane. A peak value as high as 55 m/s^2 was reached during BA-3. A reverse acceleration is also observed,

in a second time. At this measurement point, the acceleration was mainly oriented along the x -axis direction. For tests BA-1 and BA-2, the maximum values of the acceleration were three times higher along this axis than that along the y axis. Peak values of the acceleration along the x axis represented 15%, 4%, and 4% of the projectile acceleration peaks for tests 1, 2, and 3, respectively. A strong attenuation was observed between the first interface (Fig. 8) and the distant plane, with peak values along the x axis in the distant plane of 5%, 12%, and 15% of that at the first interface along the y -axis direction for tests 1 to 3, respectively. This attenuation was significantly higher than between the first interface and the back face in the impact plane (Fig. 8), while both measuring points were at similar distances from the first interface measuring point.

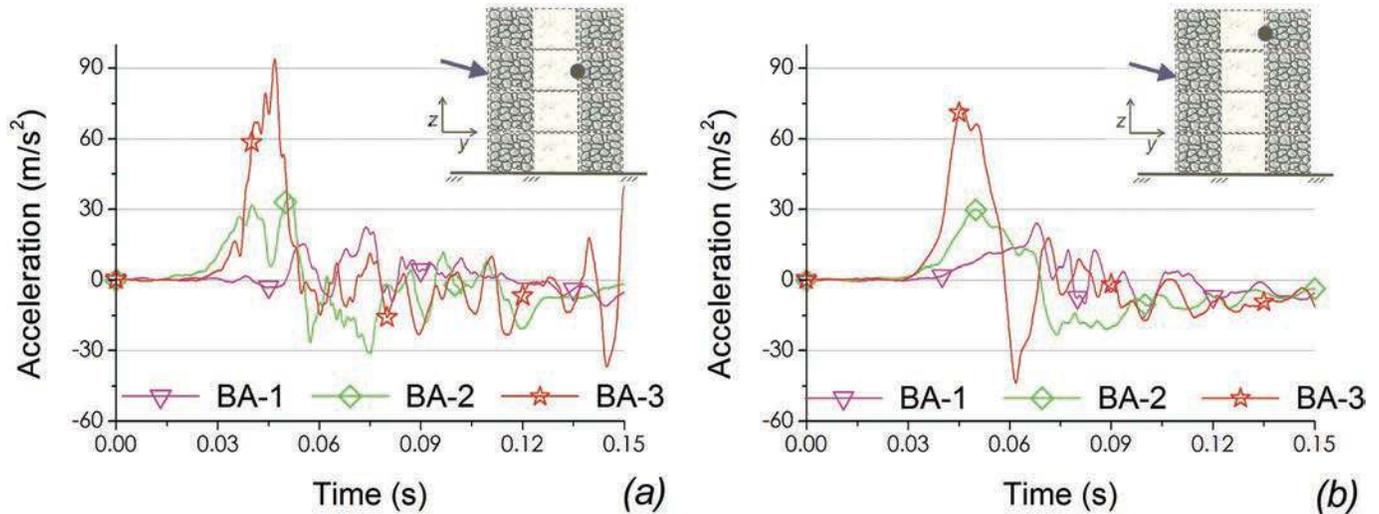
Fig. 10. Structure BA. Acceleration along the z axis in the impact plane and at the second interface, 2.5 and 3.5 m from the ground (*a* and *b*, respectively). [Colour online.]

Uplift of the upper part of the structure was observed during the experiments. This was confirmed in Fig. 10, which presents the acceleration along the z axis at 2.5 and 3.5 from the ground and at the second interface. The six curves were characterized by an upward acceleration, over durations as long as 30 ms for test BA-3. This peak was followed by a major downward acceleration with maximum amplitude higher than gravity for tests BA-2 and BA-3. The main difference between the two measuring points was a lower peak value measured at 3.5 m from the ground with a

20 m/s² difference in the case of BM-3. The stress wave reached the second interface at a similar time for all three impact tests, about 25 ms after the impact beginning.

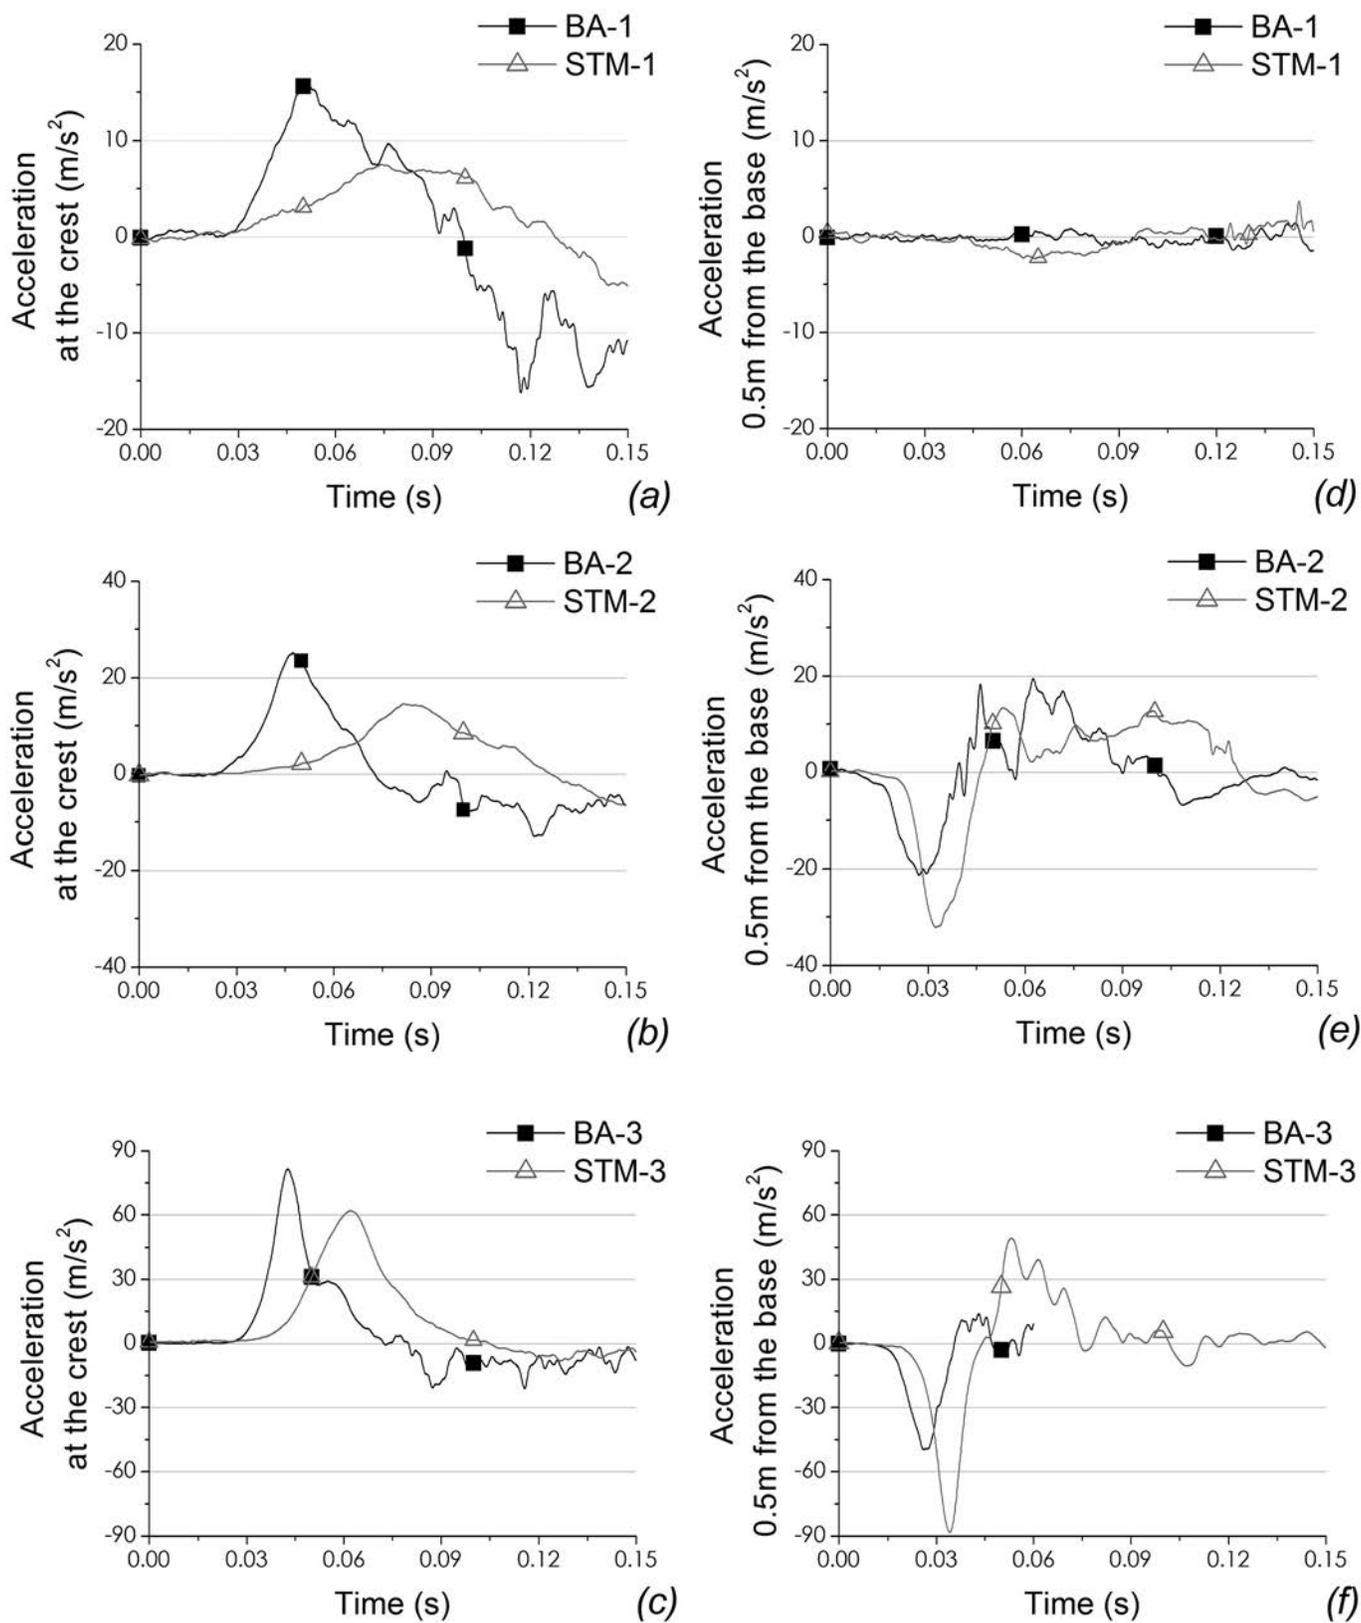
Fig. 11. Structures BA and STM. Acceleration along the z axis, in the middle of the middle layer in the impact plane, (a, b, and c) at the structure crest and (d, e, and f) 0.5 m from the ground during the three impact tests.

Figure 11 also shows the difference in response depending on the middle layer fill material. For structure STM, the upward acceleration peak arrived 20 to 35 ms later and reached a value 25% to 50% less than that of structure BA, suggesting different structure uplifts. This really contrasted with the downward acceleration measured 0.5 m from the structure foundation, in the center

of the middle layer (Fig. 11, right column). While the acceleration at this point was negligible for both structures during the first test, the two other graphs revealed that structure STM experienced higher accelerations close to the foundation, with peak values almost twice that of structure BA for the third test. Note that the curve for test BA-3 is truncated because the signal was lost due to damage to the wire. In addition, the acceleration peak value measured close to the foundation of structure STM during tests 2 and 3 was about 1.7 times that measured at the crest, compared with about 0.7 for structure BA. Finally, the difference in acceleration peak arrival time between the two structures was only 10 ms compared with 20–35 ms at the crest. This reveals a strong difference in middle layer response between the two structures as well as different stress evolution patterns during the test series.

At the structure crest, the acceleration is always higher for structure BA than for structure STM, which would suggest that the amplitude of the incoming stress is higher in the former case (Fig. 11, left column). Nevertheless, the opposite trend is observed at the structure base with higher values measured for structure STM (Fig. 11, right column). As the distance to the wave source and the materials through which the wave travels are similar in both cases (crest and base), similar trends should have been observed, but this is not the case. This discrepancy is attributed to the difference in boundary conditions. On one side, the structure boundary is free to move, while on the other side the structure foundation can be considered rigid. Consequently, a similar incoming stress wave results in different displacements and, thus, accelerations. Conversely, this conclusion shows that acceleration measurements cannot be directly used to address the evolution of the stress wave amplitude with time and space in such a context.

The second point to consider is the higher lateral spreading of the load in structure BA. This phenomenon is in particular observed at the crest and in the distant plane (Fig. 11, left column; and Fig. 12). It is attributed to the shear resistance of this material, with cohesion and friction angles higher than 60 kPa and 50 degrees, respectively. By contrast, the lower shear characteristics of the sand-tire mixture results in a lower lateral spreading of the load. This means that the volume of structure associated with the impact response is higher for structure BA.

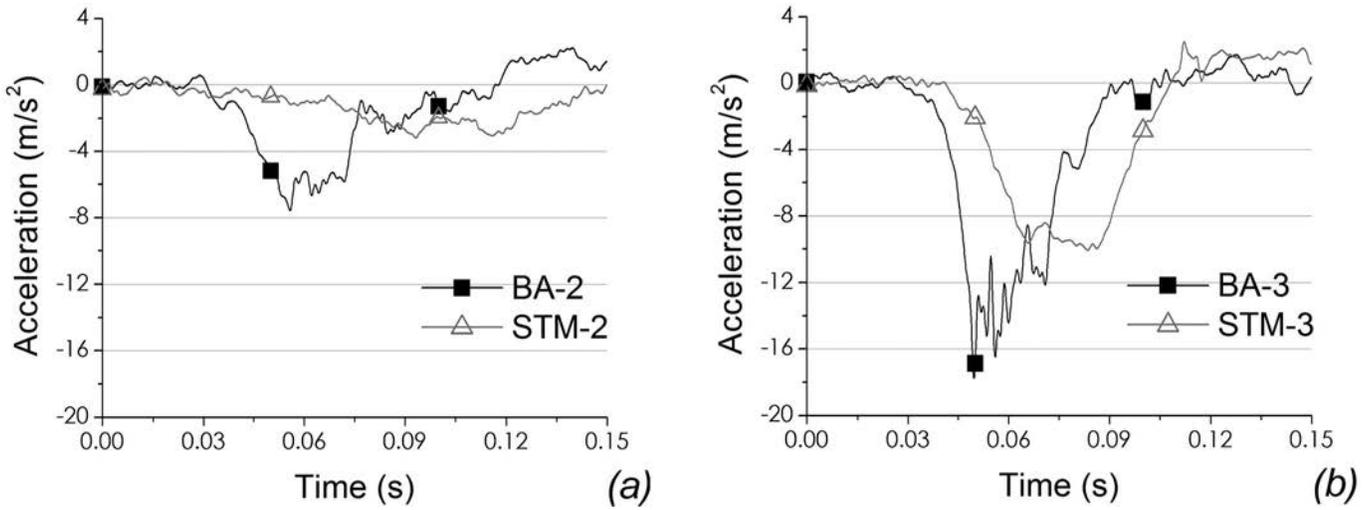
Fig. 12. Structures BA and STM. Acceleration along the x axis in the middle of the middle layer in the distant plane and 3.5 m from the ground during the second and third impacts tests (*a* and *b*, respectively).

The difference in middle layer fill material also affected the acceleration along the x axis (i.e., along the longitudinal axis of the structure) measured in the middle of the middle layer in the distant plane and at 3.5 m from the ground (Fig. 12). The acceleration

was oriented outward, and a much higher and earlier peak was observed for structure BA. The maximum acceleration was reached during BA-3, with a value of about 17 m/s^2 . This value was much less than the 55 m/s^2 peak value measured at the second interface during BA-3, in the distant plane along the same axis (Fig. 9a). This strong difference, while the distance between the two sensors is less than 0.5 m, was attributed to the fact that the latter sensor is connected to the wire mesh at the second interface, separating two layers with different mechanical characteristics.

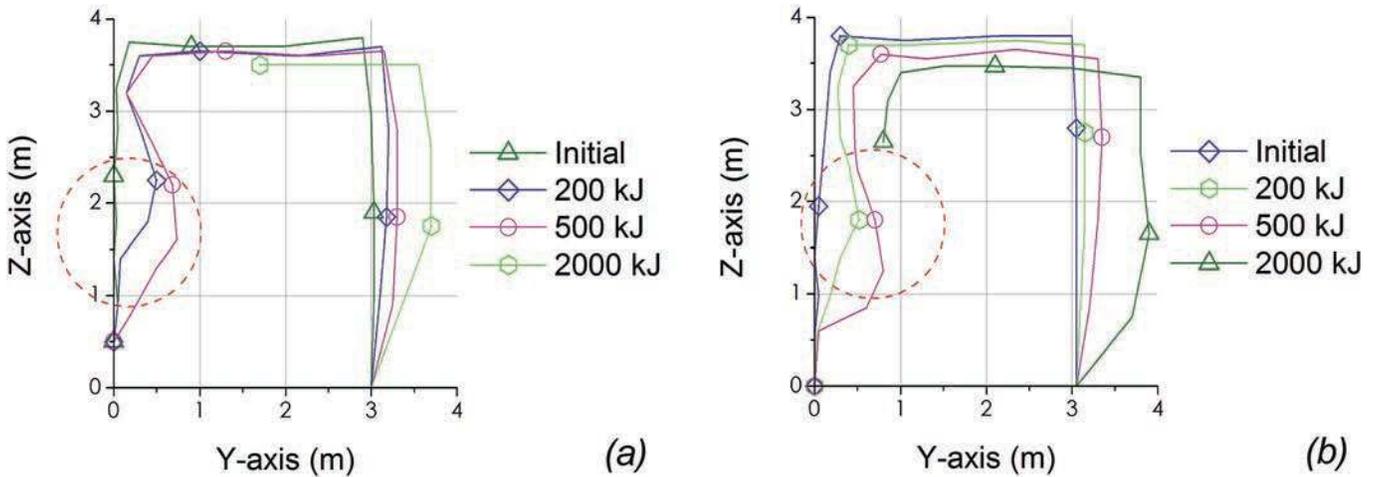
Fig. 13. Evolution of the cross-section of structures (a) BA and (b) STM during the test campaign. The position of the projectile while at rest after the third impact is also shown. [Colour online.]

The topographical survey allowed tracking the changes in structure geometry after each impact. Substantial differences were observed between the two structures, in particular in the impact plane (Fig. 13). For both structures, post-impact bending and crest

settlement were observed. On the back face, the maximum horizontal displacement after the three tests are 0.2 m larger for structure STM than for structure BA (0.9 vs. 0.7 m). Differences also concern the position of the projectile while at rest and before removal after the third impact, with a penetration ~ 0.5 m higher for structure STM than for structure BA. These trends are globally in accordance with observations made in the impact plane by Lambert et al. (2014). On the contrary, in this study, no displacement opposite to the impact direction was observed in the distant plane, 2 m aside. This difference was attributed to the fact that in this study the structure is freestanding, while in the previous one the structure was leaned against a levee, acting as buttress favoring the reverse displacement of the whole gabion sandwich structure. Differences in deformation from one structure to the other were also observed in the distant plane (results not detailed here). The displacement measured 2 m from the ground after test 3 was much less for structure BA than for structure STM at the front face (0.15 and 35 m, respectively) as well as on the back face (0.3 and 0.4 m, respectively).

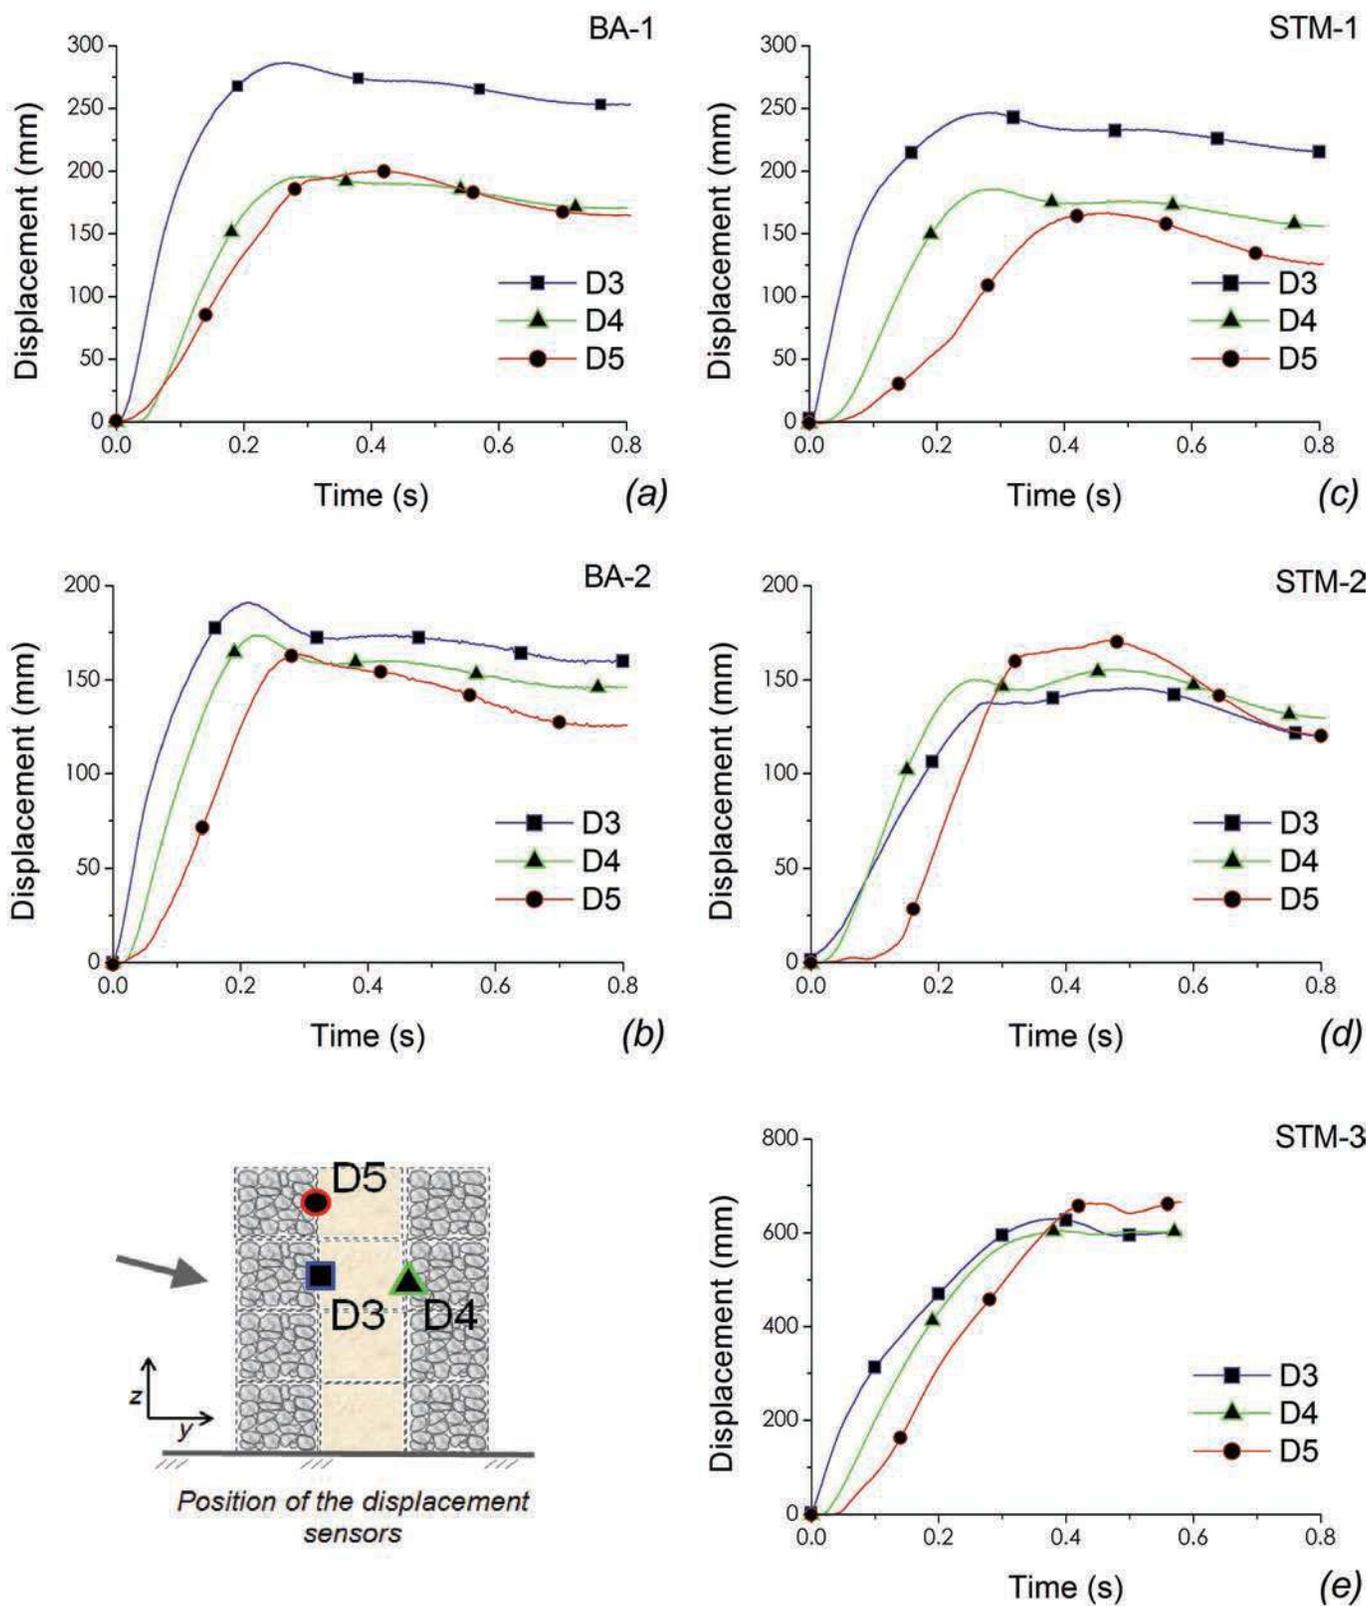
Fig. 14. Displacement with time of three points located in the impact plane during each impact test for structures (a and b) BA and (c, d, and e) STM. The location of the three points is shown in the bottom left panel. [Colour online.]

The displacements within the two structures with time are illustrated focusing on data from three displacement sensors out of five located in the impact plane (Fig. 14). Results for test STM-3 are

not available. The structures moved for more than 500 ms, much longer than the impact duration (less than 200 ms). The time reference considered for plotting the curves is the moment when displacement was detected at D3, the first to experience displacement. D3 was located at the first interface and 2.5 m from the ground. Point D5, located 1 m above D3, was always the last to move. For example, the maximum displacement was reached at $t = 0.4$ s during BA-1. For both structures, the displacement of D3 was much higher during the first impact than during the second one. The difference in displacement among the three points tended to vanish between test 1 and test 2. This clearly indicates a global structure displacement during the second test compared with the first test. This is confirmed by the fact that very similar curves are observed during test STM-3 for the three points. A slight reverse displacement was observed for both structures (almost 50 mm for point D5 during test STM-2).

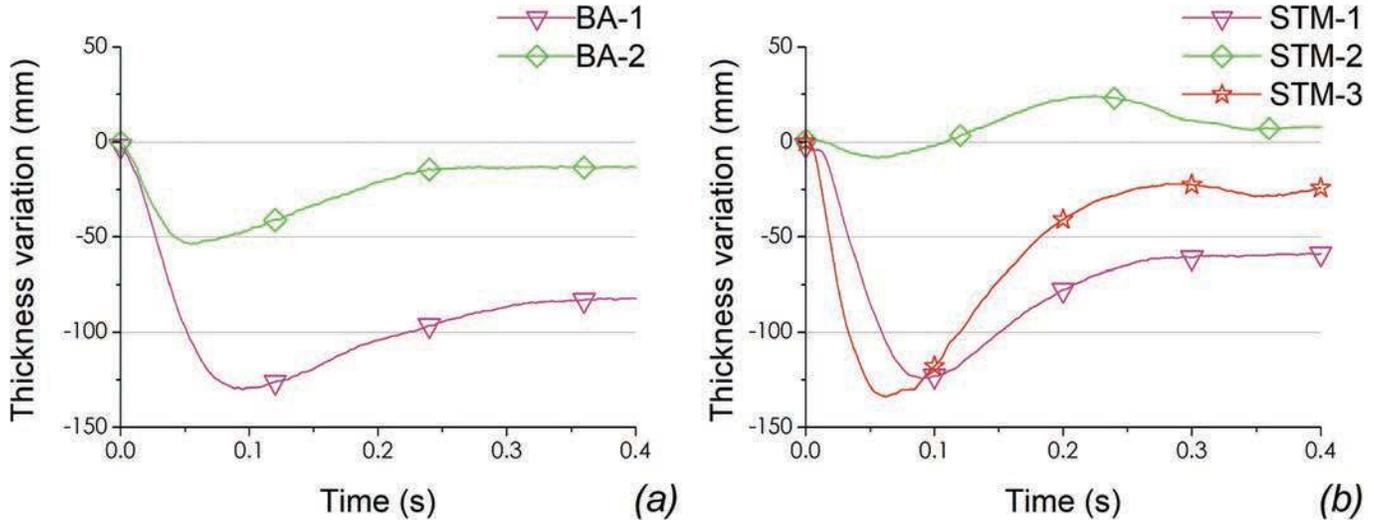
Fig. 15. Middle layer thickness variation during the impact tests for structures (a) BA and (b) STM. [Colour online.]

Using the displacements measured in D3 and D4, it is possible to investigate the middle layer width variation with time at the impact height. Two main conclusions are drawn from Fig. 15. During the first test, the middle layer width decreases down to a minimum value, reached at $t = 0.06$ to 0.1 s, depending on the test, followed by a width recovery lasting about 0.2 s. During the second tests a smaller width decrease was observed for structure BA as compared with the first test, and a slight increase was observed for structure STM. The notable difference between the two structures is that the post-peak width recovery during the first impact test was higher for structure STM compared with structure BA (50% vs. 34%, respectively). This difference is attributed to the difference in middle layer fill material characteristics. The recovery is even higher during test STM-3 with a value of 80%. This is in line with the conclusions drawn by Lambert et al. (2014), suggesting the effect of the sand–tire mixture elasticity. Sections 4.3 and 4.4 will discuss these observations in more detail.

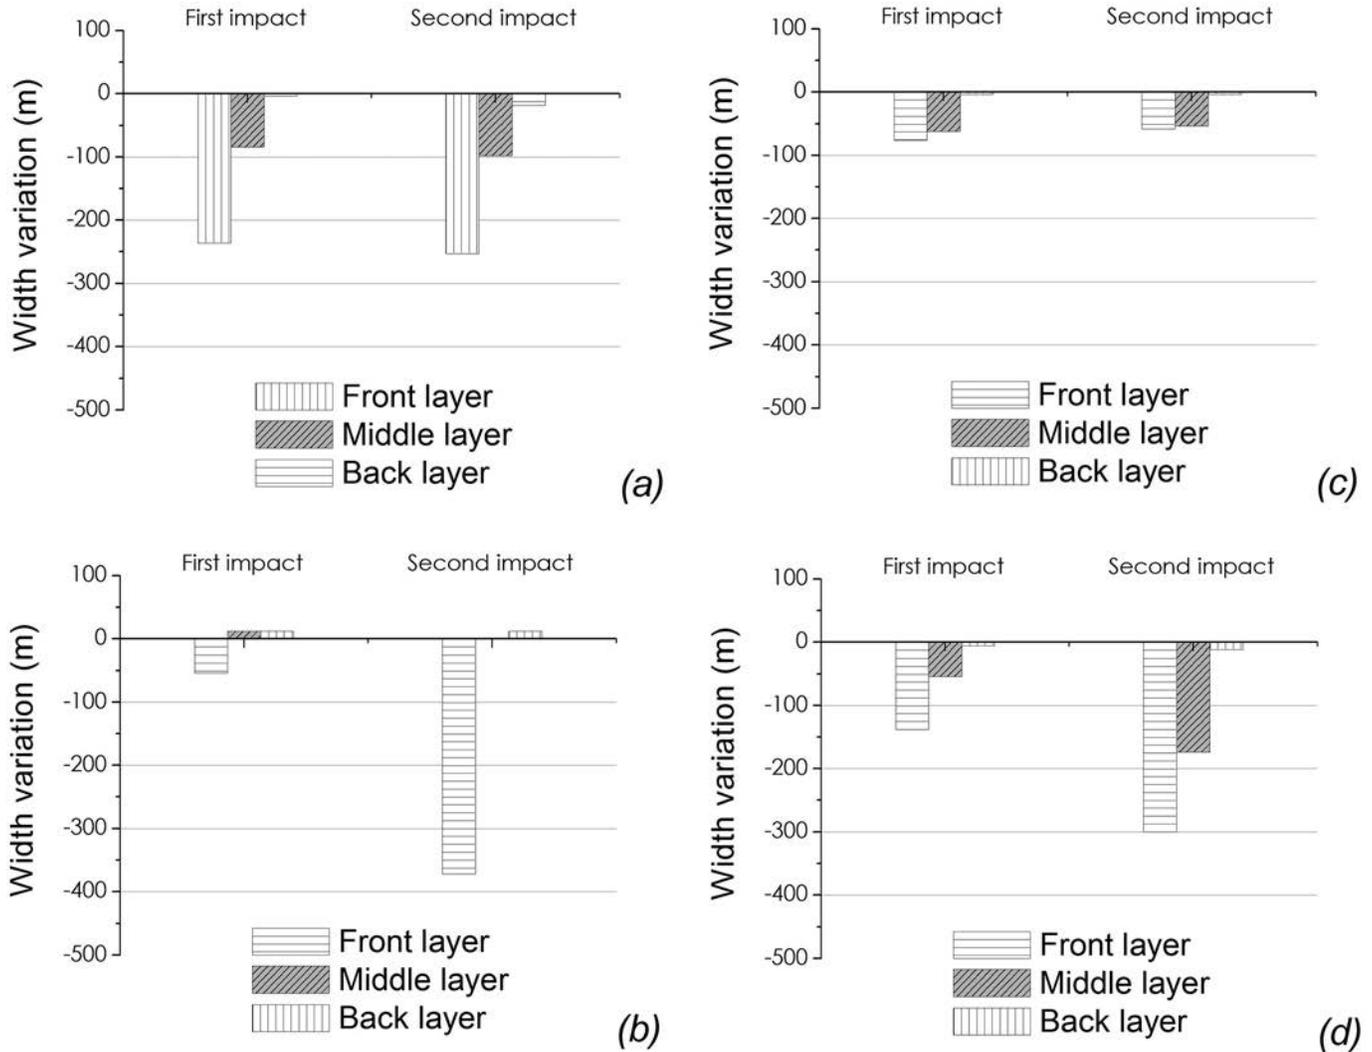
Fig. 16. Cumulative evolution of the residual thickness of each layer of structures BA (left column) and STM (right column) at 1.5 and 2.5 m from the ground (bottom and top rows, respectively).

Combining data obtained from the topographical survey with those from the displacement sensors made it possible to compare the variation of the width of each of the three layers and in the impact plane when at-rest after the impact (Fig. 16). Plotting these curves until test 3 was not possible due to the severe damages observed in the impacted area, making structure width measurements unreliable at its mid-height. Figures concerning structure BA (left column) revealed that most of the structure width decrease was imputable to the decrease in front face layer width. After the second impact, the front face layer width reduction was 75% and almost 100% that of the structure width at 2.5 and 1.5 m from the ground, respectively. These values reduced to 50% and

60% for structure STM (Fig. 16, right column). The contribution of the middle layer in the structure width decrease was much higher when using the sand–tire mixture as fill material. By contrast, using ballast tended to favor decrease in width of the front layer, associated with damage to the crushed quarry limestone filling this layer. The back layer width of the two structures remained almost constant during the two impact tests.
