Technical note on the evaluation of physical and ecological effects of river restoration works, Buëch and Upper Drac rivers

D.T3.3.1 Technical note on the evaluation of physical and ecological effects of river restoration works

Case study: Buëch and Upper Drac rivers, France

Deliverable: D.T3.3.1. Technical notes on the evaluation of physical and ecological effects of river restoration works

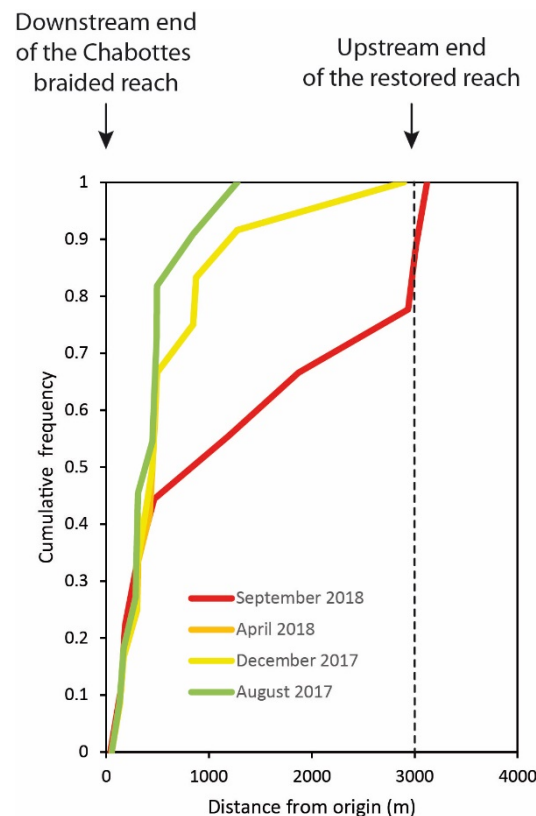
Fig. 15. Cumulative distributions of transport distances of RFID tracers deployed in the Chabottes plain
