Technical note on the evaluation of physical and ecological effects of river restoration works, Buëch and Upper Drac rivers

D.T3.3.1 Technical note on the evaluation of physical and ecological effects of river restoration works

Case study: Buëch and Upper Drac rivers, France

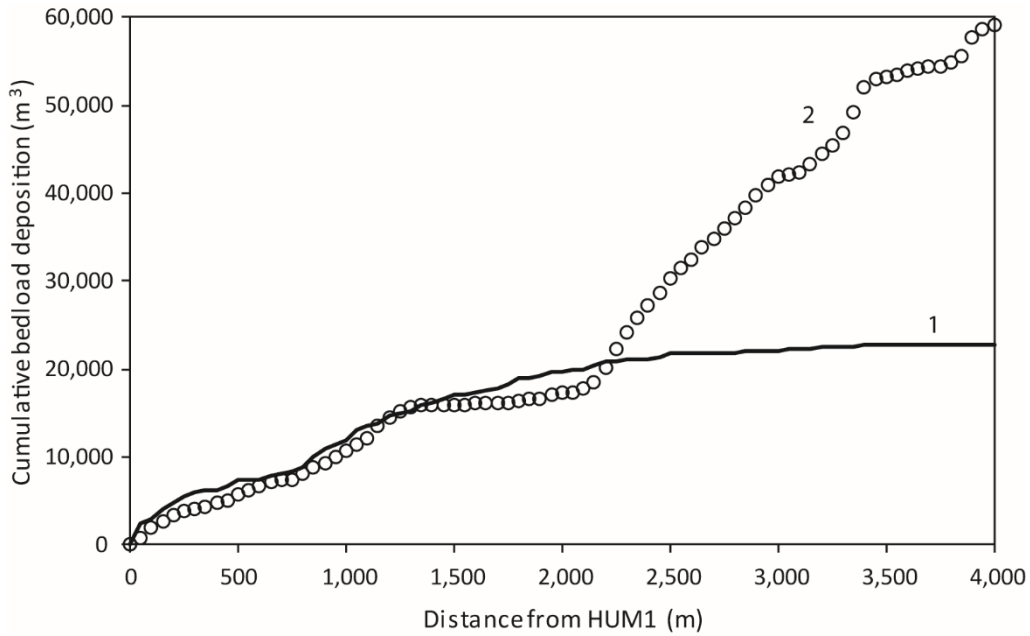
Fig. 5. Cumulative bedload deposition downstream of the replenishment reach (HUM1); 1: Reconstruction of bedload deposition from tracer CDF; 2: Observed deposition using sequential LiDAR surveys (Brousse *et al.*, in press)

The application of the sediment balance equation along the reach where significant net deposition is observed provides a way to reconstruct sediment transfers of the Buëch downstream of the dam during the November 2016 flood (Fig. 6). The only term of the equation that has been constrained is the storage change along the reach (net deposition of 20 700 m³). By considering bedload transport computation using the flood hydrograph at the downstream end of this reach (12 000 m³), it is possible to evaluate bedload inputs at 32 700 m³. Inputs are divided into (i) berm erosion (22 650 m³), (ii) bank erosion (2800 m³), and (iii) the back-calculated bedload passing through the dam (7250 m³). Since a deposited volume of 7600 m³ is observed along the replenishment reach, it should be added to the 7250 m³ that passed through to dam, giving a total bedload transport crossing the sluice gates during the flood of 14 850 m³. This value corresponds to 35% of the mean annual bedload yield upstream of the dam and 74% of the mean bedload yield downstream of the dam.

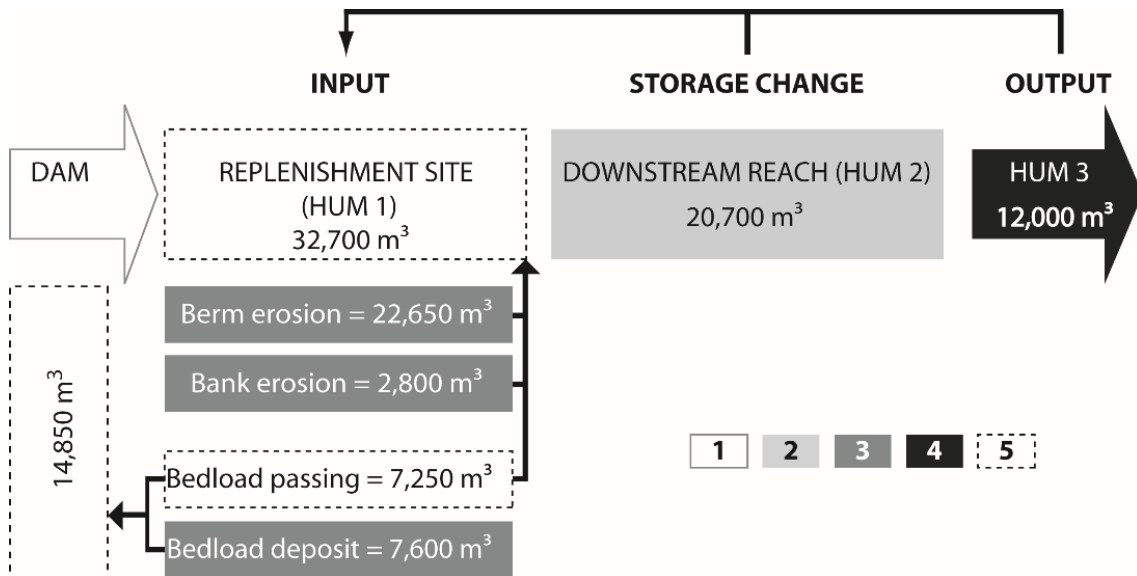
Fig. 6. Buëch River sediment balance of the November 2016 flood; 1: unknown volume; 2: DoD after LoD subtraction then exclusion; 3: bedload calculation; 4: back-calculated volume (Brousse *et al.*, in press)

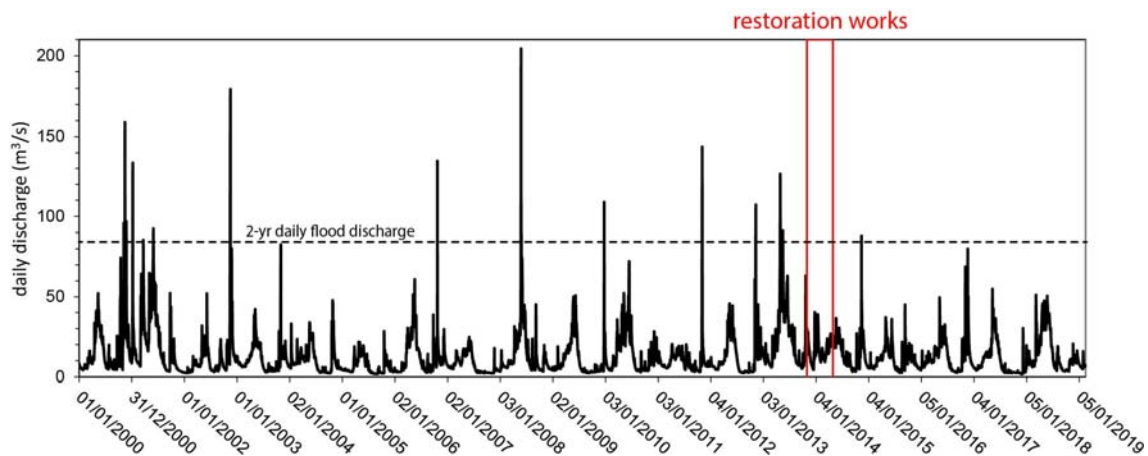
Fig. 10. Upper Drac River hydrology at the Guinguette gauging station (510 km^2) from January 2000 to February 2019 (data from EDF)

The hydrological sequence of the Upper Drac since the restoration works has only showed some low intensity snowmelt or autumn rainfall-induced flow events (Fig. 10). The only event exceeding the 2-yr daily flood discharge is the November 2014 peak discharge ($88 \text{ m}^3 \text{ s}^{-1}$). The November 2016 flood, which has been particularly intense in the Buëch (5-yr return period), has been much lower in the Upper Drac. Bankfull discharge conditions along the restored reach have not yet been observed until now.

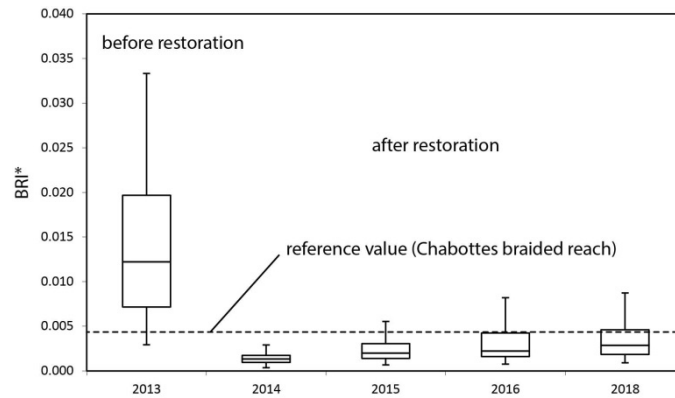
Fig. 12. Bed Relief Index (BRI*) evolution in the restored reach before and after restoration

The spontaneous braiding recovery along the restored reach has been documented using the normalized bed relief index (BRI*), which can be considered as a good proxy of the sediment regime of braided channels (Hoey and Sutherland, 1991; Liébault *et al.*, 2013). It is calculated as the standard deviation of channel elevation along a cross-section of the active channel, normalized by the active channel width. Low values of the BRI* tend to sign transport-limited conditions, whereas high-values tend to sign supply-limited conditions. A linear increase of the BRI* is observed for the restored reach since 2014 (Fig. 12). This clearly shows a spontaneous braiding recovery related to the formation of a network of anabranches (main and secondary low-flow channels) in the restored reach. This morphodynamics is clearly visible on DEM differencing as well as on aerial pictures of the restored reach (Fig. 13 and 14). By considering the BRI* value of the Chabottes braided reach (0.0045) as a reference for braiding conditions of the Upper Drac environmental setting, it can be seen that the BRI* of the restored reach get closer through time to this reference, but the braided morphology has not totally recovered 4 years after the restoration.

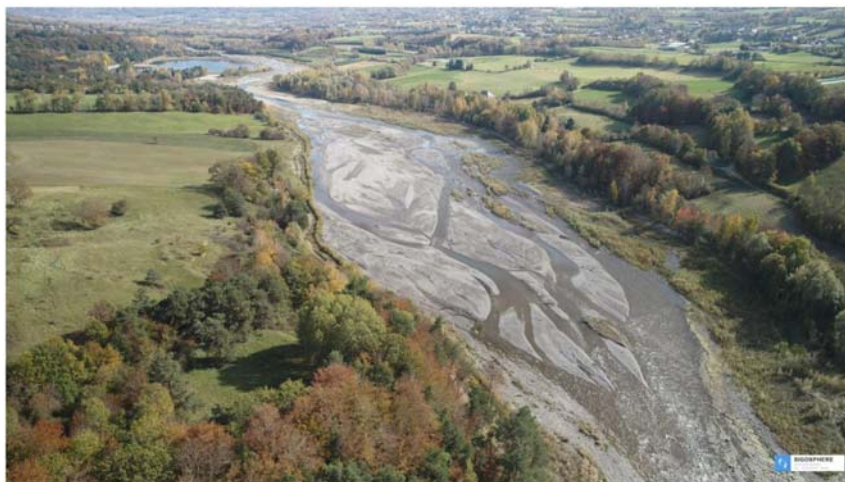
Fig. 14. Drone view of the restored reach of the Upper Drac in 2018, showing the spontaneous recovery of the braided channel morphology (@SIGosphere)

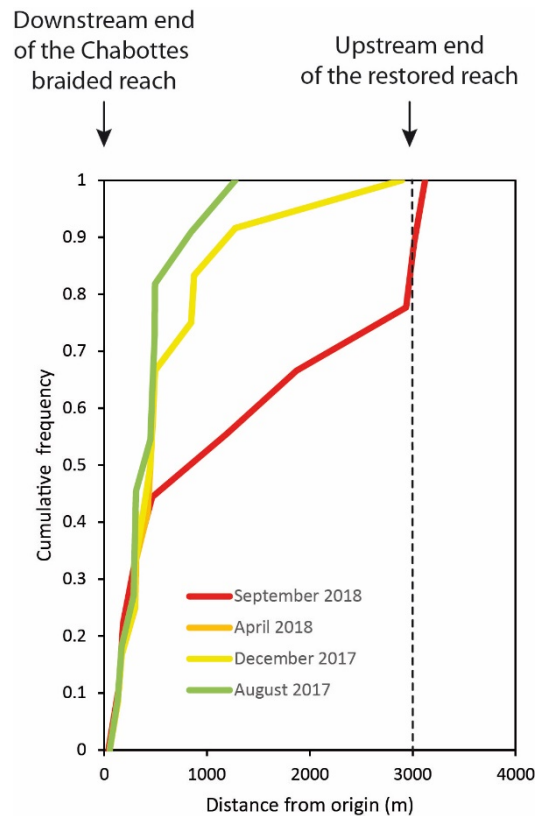
Fig. 15. Cumulative distributions of transport distances of RFID tracers deployed in the Chabottes plain

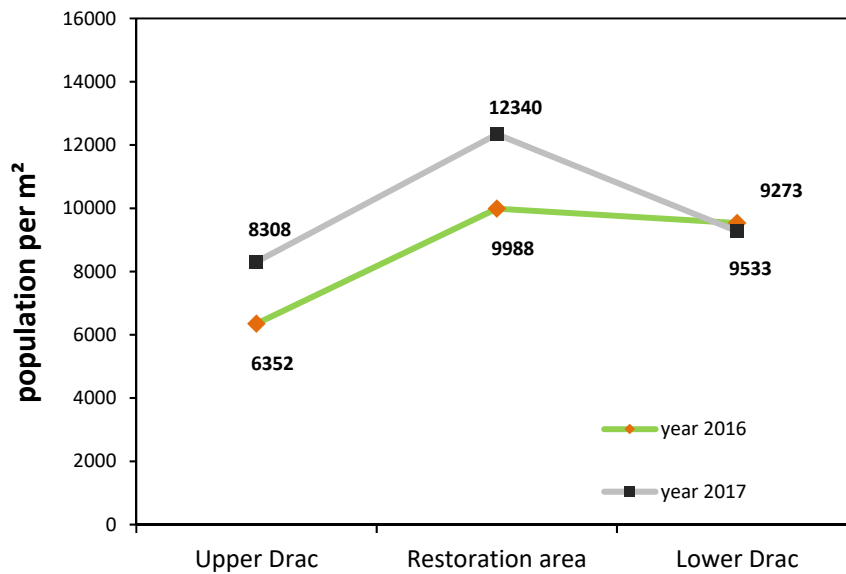
Fig. 20. Evolution of faunal densities from upstream to downstream in the three monitoring stations in 2016 and 2017 (after restoration)

Using the data of Département des Hautes-Alpes and French Water Agency (Agence de l'Eau RMC), the main results show an increase of benthic invertebrate density and species richness, mainly as the result of high nutrient of upper basin loading (Fig. 20 and 21).

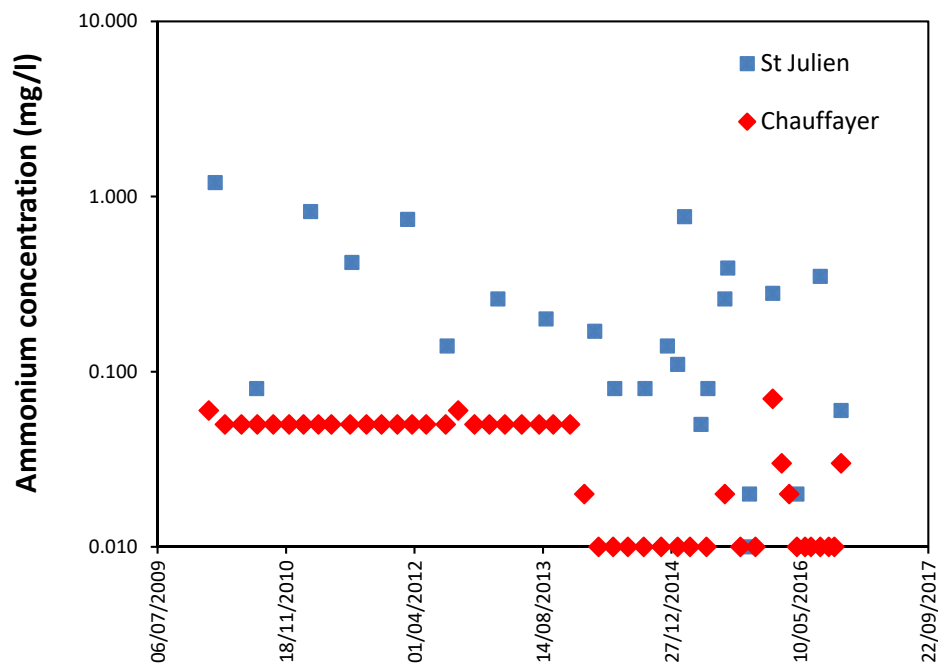
Fig. 22. Illustration of the self-purification along the Drac River on the ammonium parameter.

- ✓ Monitoring data from the Water Agency in St Julien-en-Champsaur shows that, despite a peak of pollution in February 2015, an overall improvement in the quality of water in the area studied is noted. It is linked to the better functioning of sanitation systems on the upper Drac during the period under consideration.
- ✓ The comparison between the St Julien station (upstream restored zone) and the Chauffayer station (remote downstream restored zone) shows an effective self-purification of the watercourse before and after restoration (Fig. 22).

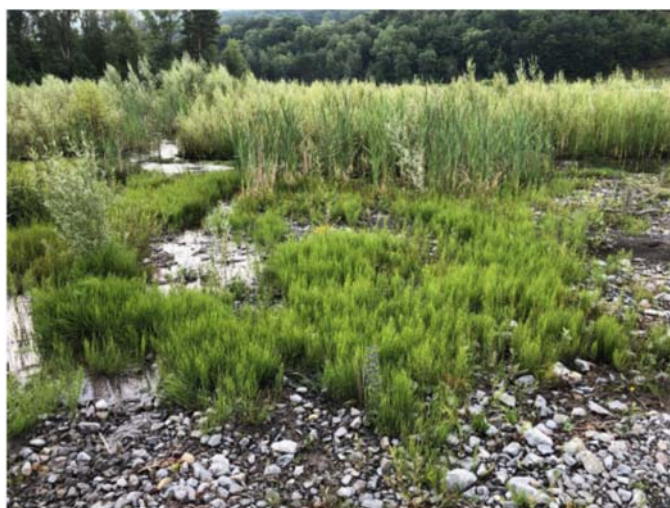
Fig. 24. Illustration of the recovery of the different layers of vegetation (©Delphine Gramond, Sorbonne University)

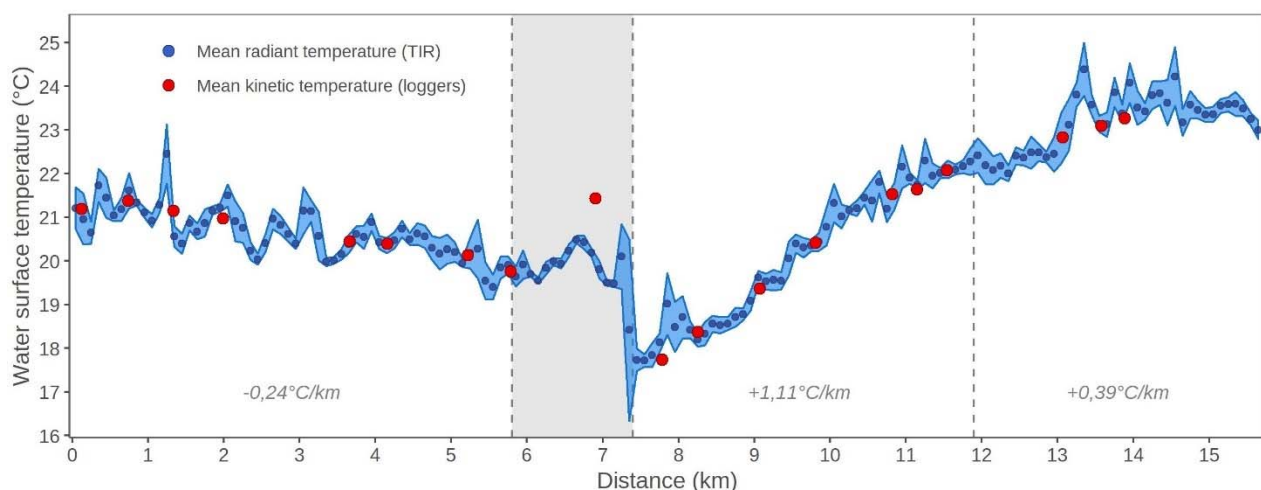
Fig. 27. Longitudinal profile of the Buëch surface temperature and temperature gradients calculated over homogeneous sections; in grey, the St Sauveur reservoir (from the report by Baptiste Marteau, CNRS, December 2018).

Airborne TIR was used to investigate the evolution of temperature along the river wetted channel. According to the work of the CNRS, the following temperature profile is related around the restored area (Fig. 27):

- ✓ Surface temperature: the reservoir of Saint-Sauveur influences the thermal behavior of the entire section by delivering a 'buffered' water (i.e. colder than temperature upstream), less subject to short-term variations in air temperature (i.e. lower diurnal variability) although it is influenced by atmospheric conditions (i.e. higher maximum temperature in the summer).
- ✓ Groundwater inflow is non-existent or insufficient in the restored area to limit the rapid warming of the water downstream of the dam (at least in the summer). Although this cannot be proved, it is
