On Internal Erosion of the Pervious Foundation of Flood Protection Dikes

Laurence Girolami, Stéphane Bonelli, Rémi Valois, Naïm Chaouch, Jules Burgat

Laurence Girolami, Stéphane Bonelli, Rémi Valois, Naïm Chaouch, Jules Burgat. On Internal Erosion of the Pervious Foundation of Flood Protection Dikes. *Water*, 2023, 15 (21), pp.3747. 10.3390/w15213747. hal-04293233

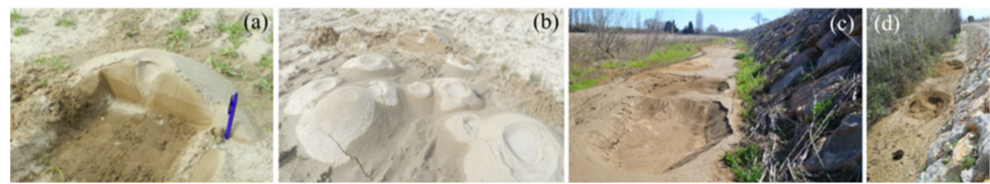
Figure 1. (a,b) Sand boils in the protected area, (c,d) Sinkholes observed around the levee toe.

After each of the six floods reported from 1992 to 2014, leaks, sand boils and sinkholes were observed around dikes (Figure 1). Sand boils formed very regular cones of up to 1 m in diameter and were observed along two sections: a 700 m long section located down the northern bank; and a 500 m long section located down the southern bank, at up to around 60 m from the levee toe (Figures 1 and 2a). Additionally, sinkholes often assimilated

to collapsed sand boils, were observed close to the levee toe, and exposed an irregular ellipsoidal shape of around 0.5 to 3 m long with an almost flat basement (Figure 1).
