## Back analysis of a building collapse under snow and rain loads in a Mediterranean area

Isabelle Ousset, Guillaume Evin, Damien Raynaud, Thierry Faug

Isabelle Ousset, Guillaume Evin, Damien Raynaud, Thierry Faug. Back analysis of a building collapse under snow and rain loads in a Mediterranean area. *Natural Hazards and Earth System Sciences*, 2023, 23 (11), pp.3509-3523. 10.5194/nhess-23-3509-2023 . hal-04313168

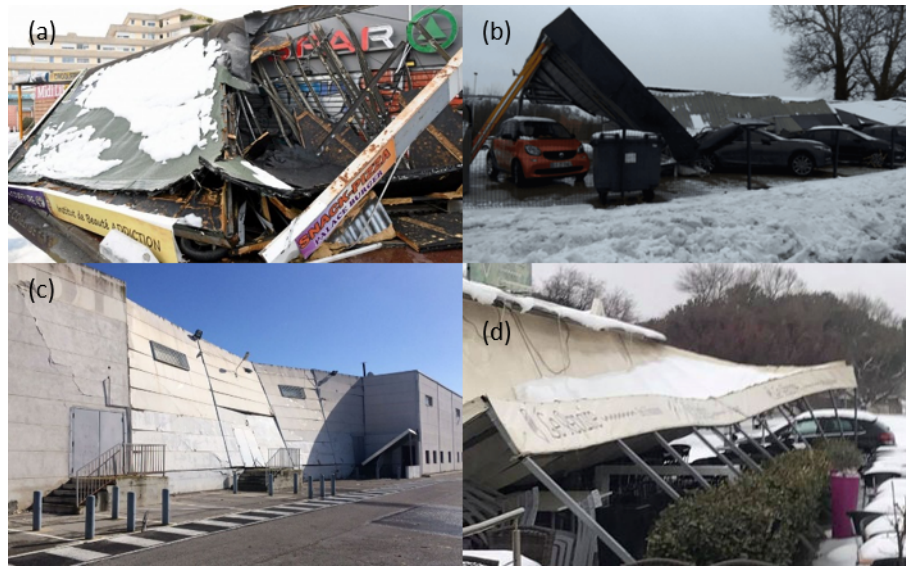
**Figure 1.** Roof collapses due to heavy snowfalls that occurred on 28 February and 1 March 2018 in the surroundings of Montpellier, France: collapses of (a) the Estanove shopping center in Montpellier (photo credit: © Jean-Michel Mart), (b) a car wash station in Lattes (photo credit: © Le Petit Journal de Lattes), (c) the Darty store in Pérols (photo credit: © France 3 LR/Sébastien Banus) and (d) a restaurant in La Grande-Motte (photo credit: © France 3).

- in France, the collapse of the roof of a warehouse in Satolas-et-Bonce in the department of Isère and of a supermarket in Bricquebec in the department of Manche (January 2010); several collapses of roofs in western France (at least nine store roofs in the department of Manche) in March 2013; and a lot of damage to shops in the department of Hérault at the end of February 2018 in the cities of Béziers, Lattes, Montpellier and Pérols (see examples shown in Fig. 1);

The current paper reports a detailed and specific case study of a roof collapse of a scientific laboratory (formerly Irstea, now INRAE, the Institut National de Recherche pour l'Agriculture, l'alimentation et l'Environnement) which occurred on 1 March around 18:00 LT following an intense rain-on-snow event in a Mediterranean area. Several roof collapses took place in this area in the same period (see Fig. 1).

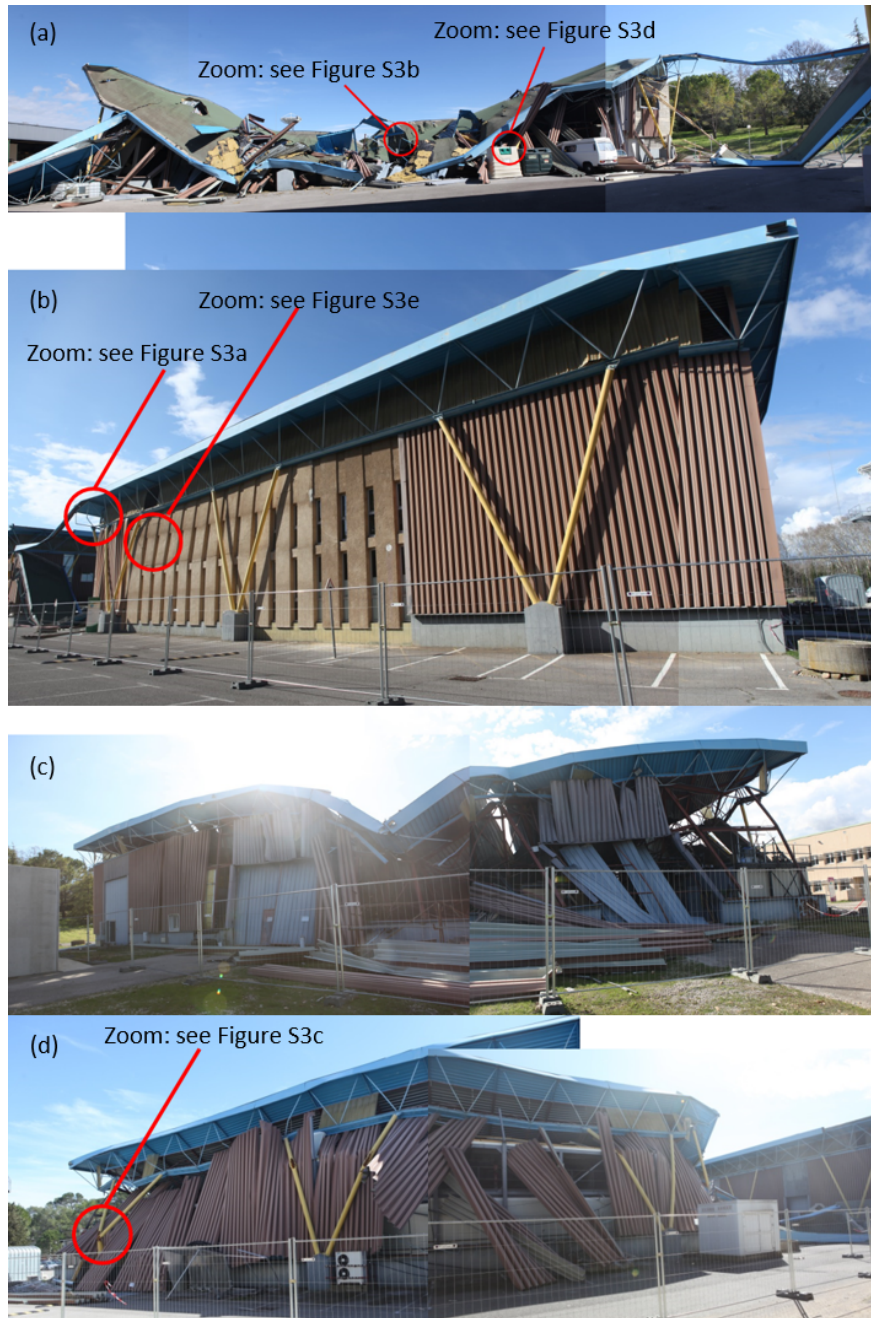
**Figure 2.** Different pictures showing the extent of damage as observed on 18 March 2018 on the western (a), southern (b), eastern (c) and northern (d) facades of the Irstea Cévennes building.

Figure 2 shows the main damage observed during a field visit on 18 March 2018, shortly after the collapse of the experimental hall of the Irstea Cévennes building in the central part of the structure, in the east–west direction. The western and eastern facades were heavily damaged, as seen in Fig. 2a and c. On the contrary, the other two facades (see Fig. 2b and d) were much less damaged due to the presence of the inner concrete walls of the offices and the inner metal frames of the laboratory rooms along the southern and northern facades, respectively. Local damage observed on structural elements consists of (i) buckling and bending of the roof tubular profiles, (ii) bending and shear of the tubular supporting py-

lons, and (iii) cracking on the walls of the offices (see close-up views of the damage shown in Fig. S3 in the Supplement).

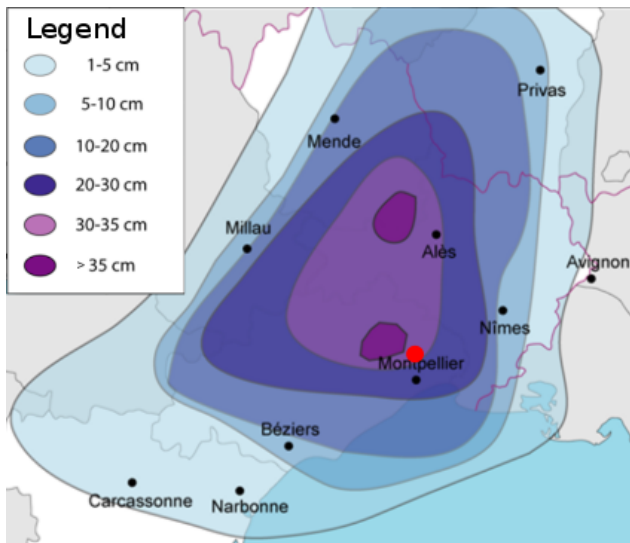
**Figure 4.** Snow accumulation during the snow event of 28 February 2018, based on 5000 testimonies. The red marker shows the position of the collapsed building. Source: Météo Languedoc.

(<https://www.meteolanguedoc.com/evenements-majeurs-en-languedoc-roussillon/episode-neigeux-du-28-fevrier-2018-jusqu-a-35-cm-pres-de-montpellier/p513>, last access: 5 September 2023) and include different types of information about the meteorological event, including photos from amateurs following their Facebook page (<https://fr-fr.facebook.com/MeteoLanguedoc/>, last access: 5 September 2023). Through their Facebook page, Météo Languedoc asked their 120 000 followers to provide observations and photos supporting these observations. Thanks to the collection of 5000 responses, a robust estimation of the depth of the snowpack at the end of the snow event was obtained, leading to the interpolated field of snow accumulation provided in Fig. 4. The data clearly show that the snow

depth was more important north of Montpellier, likely due to a hill separating the city center from the Lavalette site.

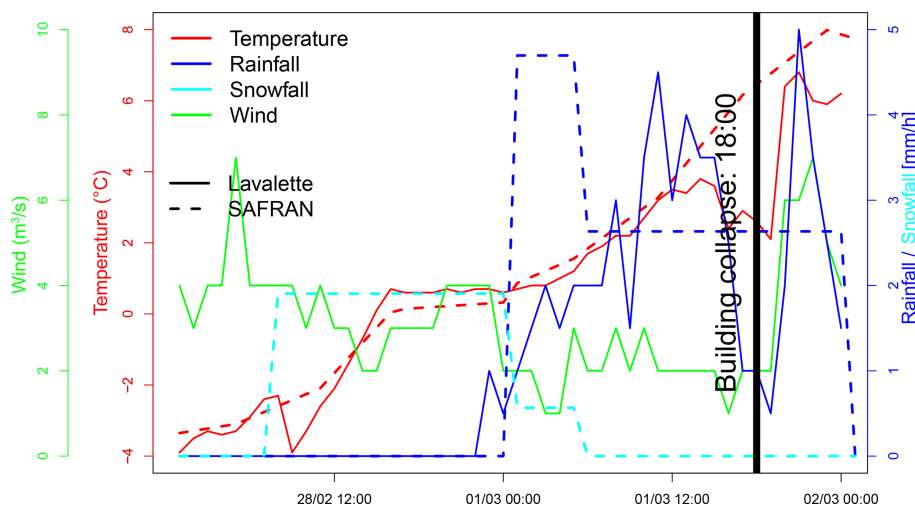
**Figure 5.** Weather observations at the station of Lavalette (solid lines) and SAFRAN reanalysis at the grid point covering the Irstea building (dashed lines).

Figure 5 shows the evolution of the temperature and rain and snow amounts according to two different and independent sources of information:

- Just next to the center of Irstea in Montpellier, a weather station (the Lavalette station) records various meteorological parameters, including temperature and rain. For this station, the tipping-bucket rain gauge is not heated,

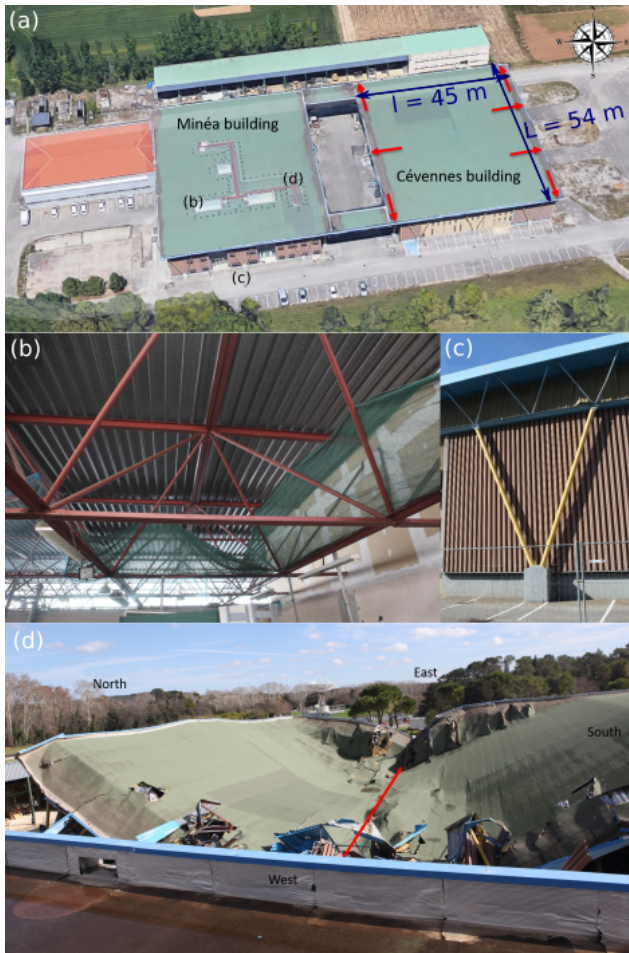
**Figure 6.** (a) Overview of the Irstea Cévennes building before the damage, with rainwater drainage points indicated by the red arrows. The dimensions of the roof are given in blue, and the height of the building is 10 m. The letters indicate where the photos of the other subplots were taken (photo credit: © Google Earth 2014, adapted by Isabelle Ousset). (b and c) View of the supporting structure of the Irstea Cévennes building before its damage: (b) red-colored metal roof frame and (c) supporting tubular pylons (in yellow) along the facades. (d) Overview of the damaged Irstea Cévennes building. The red line indicates the direction perpendicular to the direction of the main deflection of the roof after the collapse.

both sides of the east–west axis along which the structure collapsed, as shown in Fig. 6d. Thus, it is very likely that buckling was involved at some stage in the roof collapse.

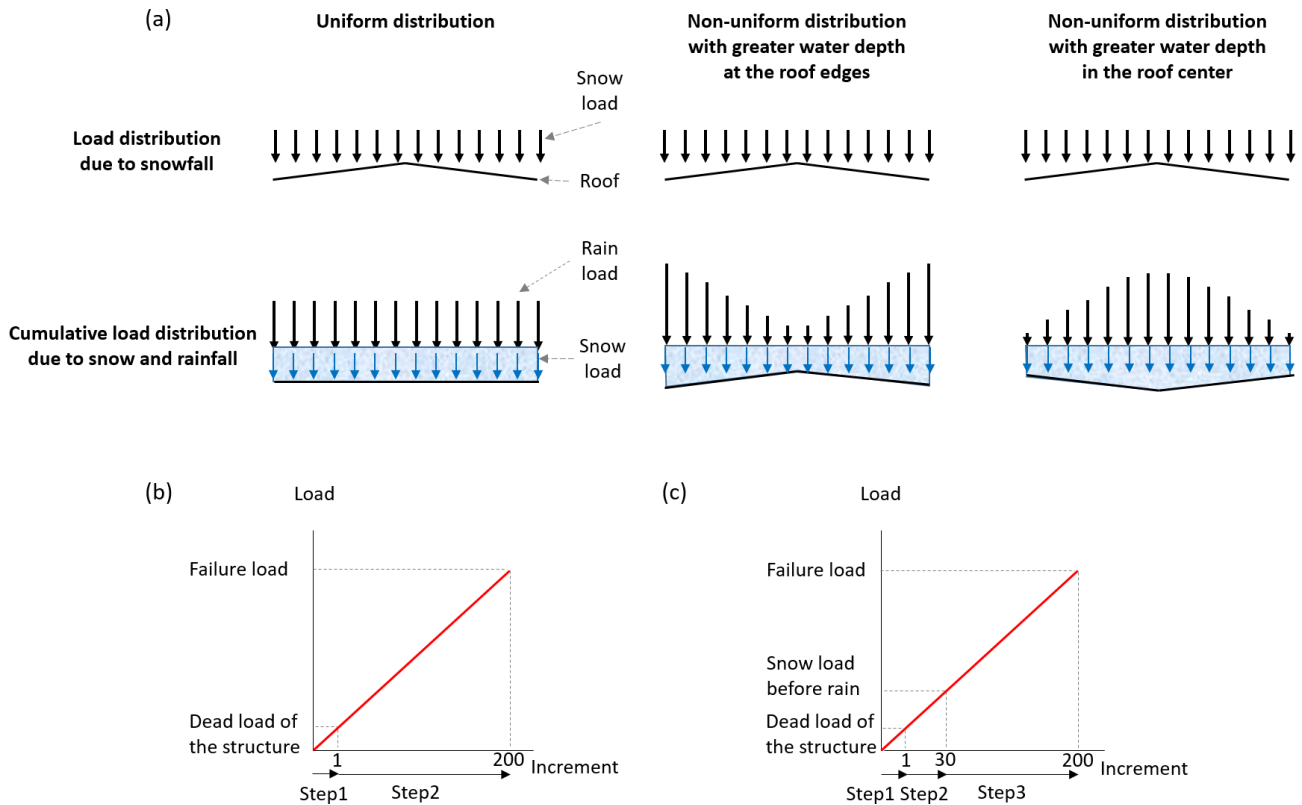
**Figure 7.** (a) Different assumptions made for the spatial distribution of snow and rain loads and (b) and (c) load evolution by incrementation for pushover analyses in the cases of a uniform distribution (b) and a non-uniform distribution (c) of rain loads. Note that the increment numbers of steps 2 and 3 are given here as examples only.

Pushover analyses are quasi-static analyses (without dynamic effects) that determine how far the building can go before it collapses completely or partially. Figure 7 illustrates the main steps of this analysis. The first step (step 1 in Fig. 7b and c) takes into account the self-weight of the structure. Then the snow and rain pressure on the structure is gradually and linearly incremented to mimic the load increase during the rain-on-snow event until the structure fails by reaching either the elastic limit of the material or the ultimate limit of the material for a snow and rain pressure equal to the failure force. This linear increase is performed in one step for uniform loads (step 2 in Fig. 7b) and two steps for non-uniform loads (steps 2 and 3 in Fig. 7c). In the latter case, step 2 corresponds to the increase in the uniform load of snow before the rain, whereas step 3 corresponds to the increase in the non-uniform load of water on the snowpack.

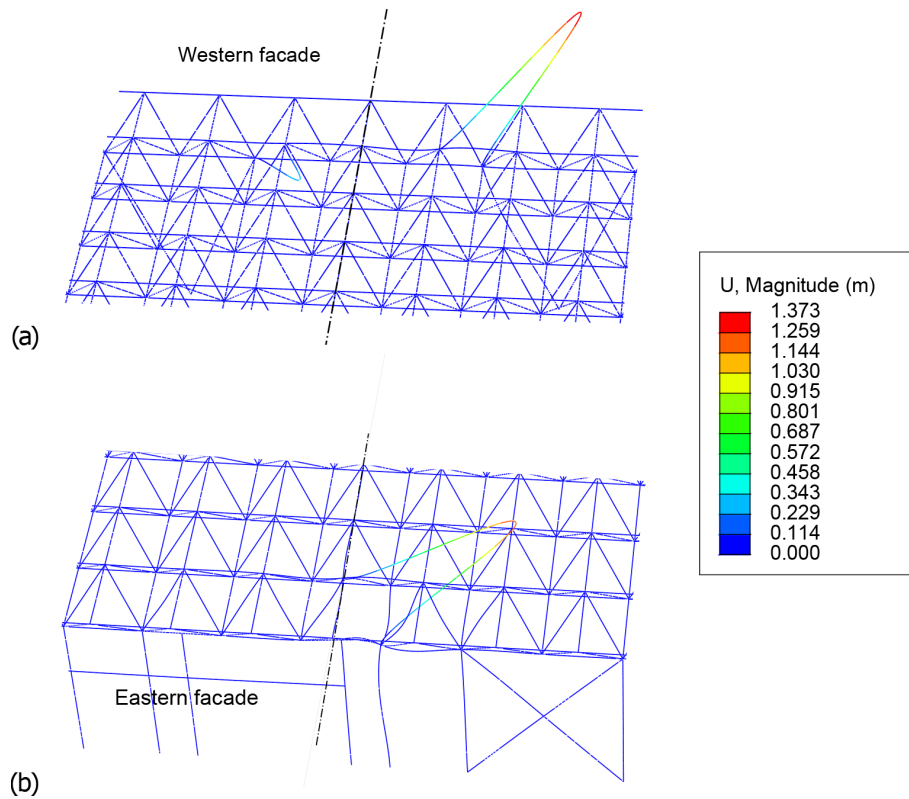
**Figure 8.** Buckling mode shapes of the structure under a uniform snow and rain pressure field (deformation scale factor = 5.4): (a) first mode, above the western facade, and (b) fifth mode, above the eastern facade.

The minimum of  $645 \text{ Nm}^{-2}$  (in brown) corresponds to the non-linear buckling load. This value is just below the uniform initial snow load before the rain ( $736 \text{ Nm}^{-2}$ ) (in teal) and does not depend on the assumption made for the distribution of the rain load. In contrast, the linear buckling analysis gives higher values for the load corresponding to the first eigenvalue mode (from  $935$  to  $945 \text{ Nm}^{-2}$ ). All of these critical buckling loads (in beige) are well below the snow and rain load estimates. This means that this failure could have occurred with the observed snow and rain load. In addition, although it should be noted that the buckling failures remained localized (on a few crossbars located at the eastern and western edges, as shown in Sect. 3 and Fig. 8), they occur on

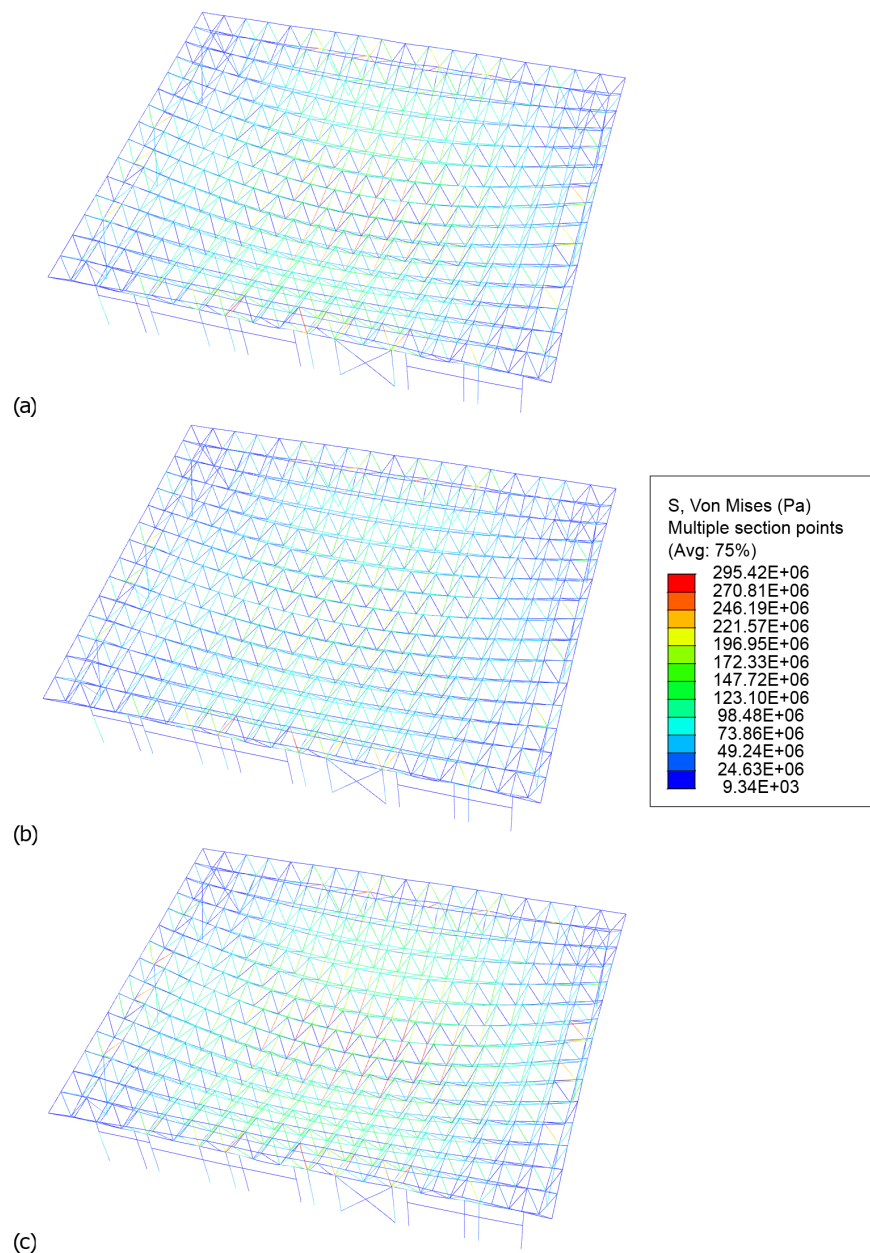
**Figure 9.** Von Mises stress field (Pa) inside the structure at the real snow and rain load of  $1325 \text{ N m}^{-2}$ , given by the FE model simulation for the different assumptions made for the spatial distribution of snow and rain: (a) uniform, (b) non-uniform with greater water depth at the edges and (c) non-uniform with greater water depth in the center (a deformation scale factor of 25 is applied to highlight the contrasts).

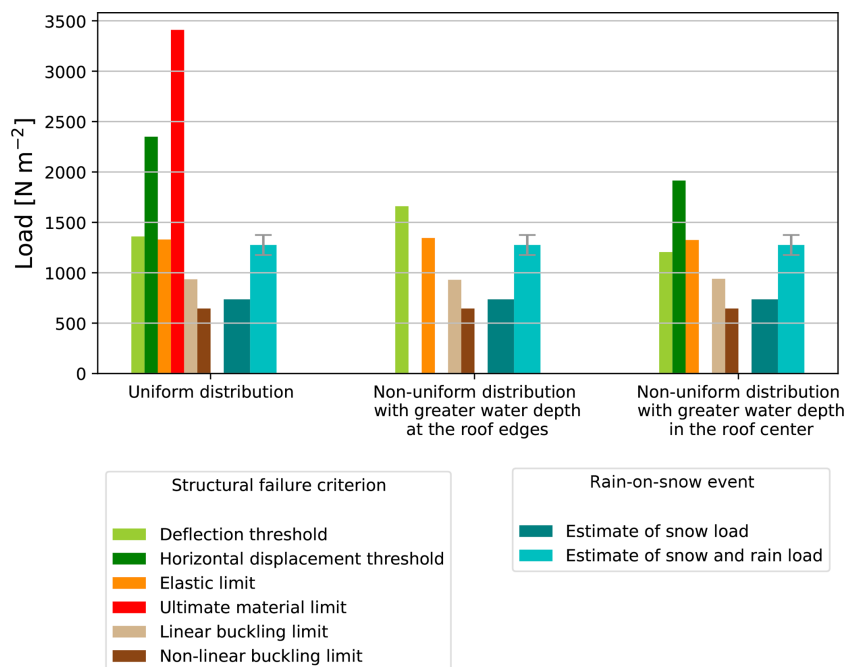
**Figure 10.** Comparison of the snow loads leading to different failure criteria of the Cévennes building, as calculated by FE model simulations, with the estimated scenario for the rain-on-snow event of 2018, as back analyzed in Sect. 2, in the different cases of snow and rain pressure fields. The structure fails when the observed snow and rain load (on the right, for each assumption of snow and rain distribution) is greater than the calculated failure load (on the left). The latter calculated failure load could not be obtained when code divergence was observed, thus explaining the empty bars in the case of non-uniform rain distributions (see Table 1).

Figure 10 compares the critical loads that would cause a failure according to the FE simulations (Table 1) with the initial snow load of  $736 \text{ Nm}^{-2}$  before the rain and the final snow and rain load values of  $1226$  to  $1325 \text{ Nm}^{-2}$  estimated from different sources of observations in Sect. 2.

The maximum critical load of  $3410 \text{ Nm}^{-2}$  (in red in Fig. 10) corresponds to the ultimate limit of the material under uniform pressure distribution and is well above the estimated value for the snow and rain load of  $1226$ – $1325 \text{ Nm}^{-2}$  (in cyan). Note that for non-uniform snow pressure fields, the ultimate material limit is not reached due to numerical instabilities (lack of convergence). The values obtained from the horizontal displacement criterion are also well above the estimated range of  $1226$ – $1325 \text{ Nm}^{-2}$ . The pushover FE simulations thus suggest that neither the ultimate material limit nor the critical horizontal displacement was reached at the time just before the collapse, regardless of the scenario for rain load spatial distribution.
