Back analysis of a building collapse under snow and rain loads in a Mediterranean area

Isabelle Ousset, Guillaume Evin, Damien Raynaud, Thierry Faug

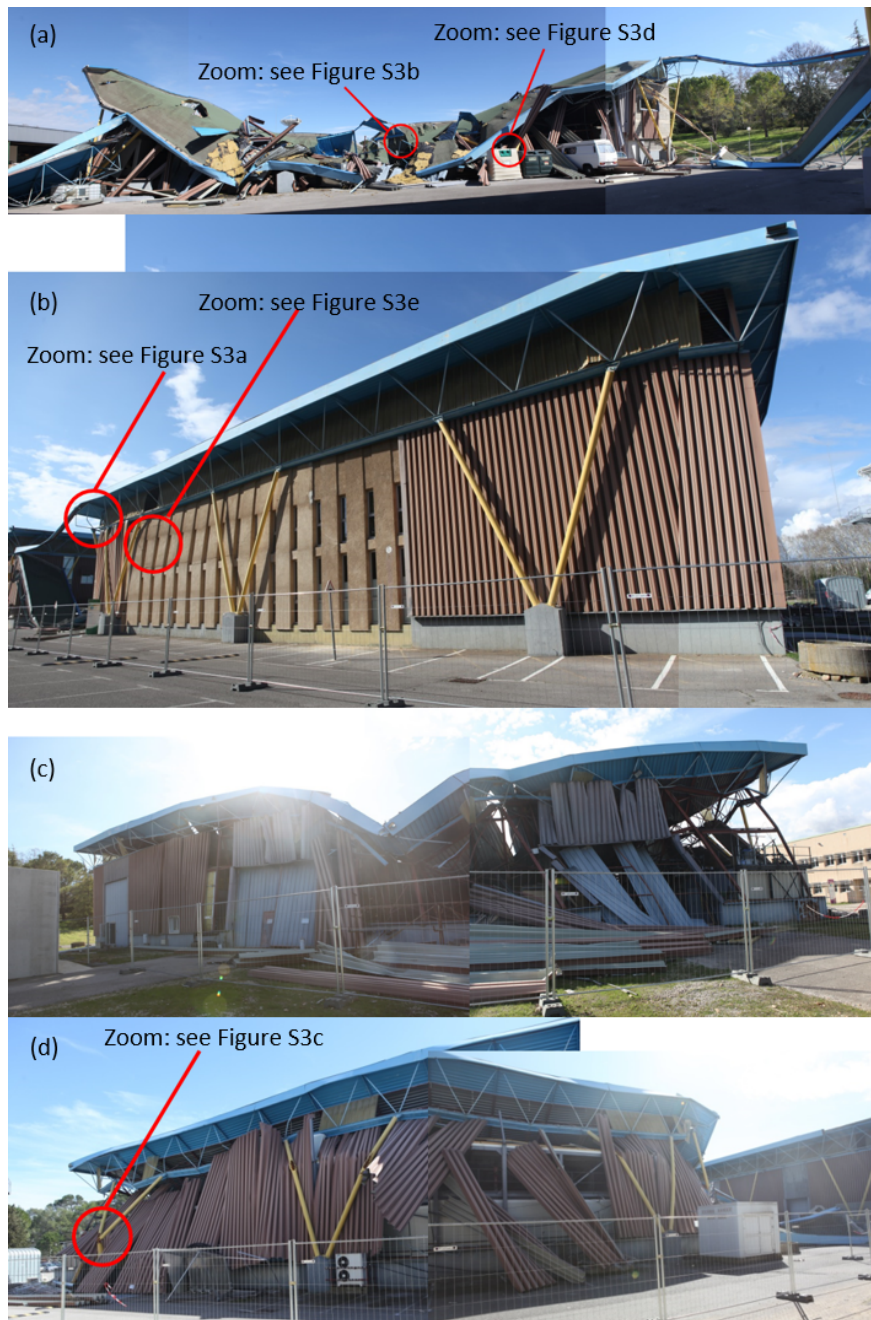
Figure 2 shows the main damage observed during a field visit on 18 March 2018, shortly after the collapse of the experimental hall of the Irstea Cévennes building in the central part of the structure, in the east–west direction. The western and eastern facades were heavily damaged, as seen in Fig. 2a and c. On the contrary, the other two facades (see Fig. 2b and d) were much less damaged due to the presence of the inner concrete walls of the offices and the inner metal frames of the laboratory rooms along the southern and northern facades, respectively. Local damage observed on structural elements consists of (i) buckling and bending of the roof tubular profiles, (ii) bending and shear of the tubular supporting py-

lons, and (iii) cracking on the walls of the offices (see close-up views of the damage shown in Fig. S3 in the Supplement).

Figure 2. Different pictures showing the extent of damage as observed on 18 March 2018 on the western (a), southern (b), eastern (c) and northern (d) facades of the Irstea Cévennes building.

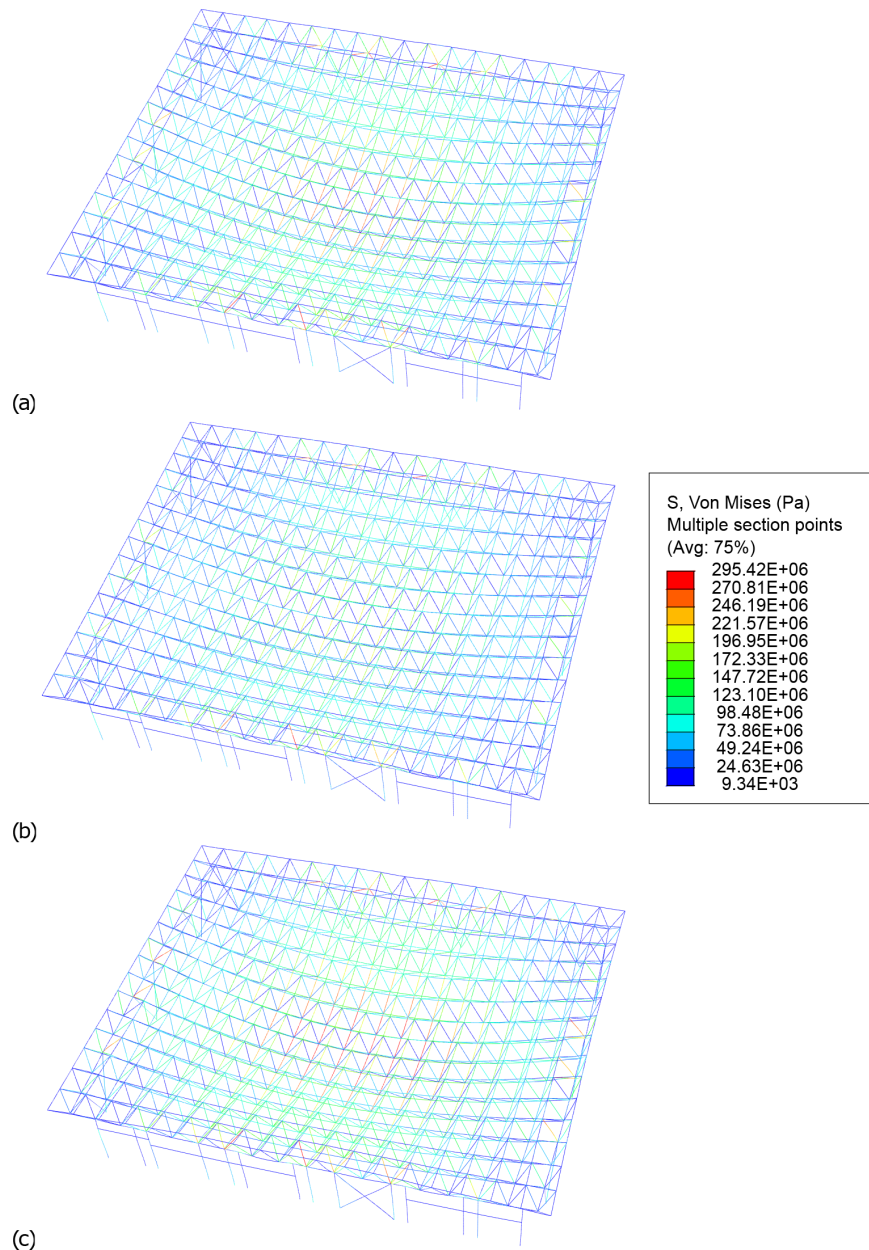
Figure 9. Von Mises stress field (Pa) inside the structure at the real snow and rain load of 1325 N m^{-2} , given by the FE model simulation for the different assumptions made for the spatial distribution of snow and rain: (a) uniform, (b) non-uniform with greater water depth at the edges and (c) non-uniform with greater water depth in the center (a deformation scale factor of 25 is applied to highlight the contrasts).
