Back analysis of a building collapse under snow and rain loads in a Mediterranean area

Isabelle Ousset, Guillaume Evin, Damien Raynaud, Thierry Faug. Back analysis of a building collapse under snow and rain loads in a Mediterranean area. *Natural Hazards and Earth System Sciences*, 2023, 23 (11), pp.3509-3523. 10.5194/nhess-23-3509-2023 . hal-04313168

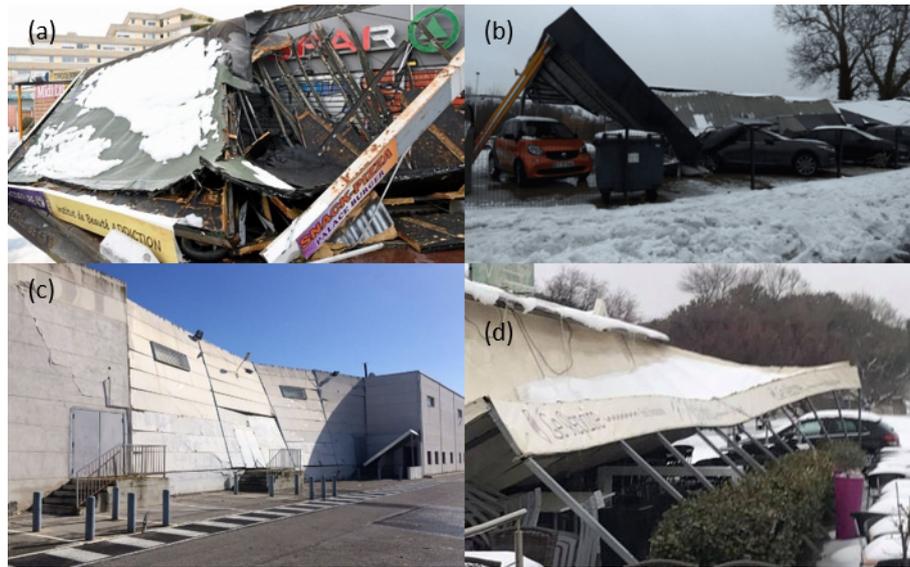
Figure 1. Roof collapses due to heavy snowfalls that occurred on 28 February and 1 March 2018 in the surroundings of Montpellier, France: collapses of (a) the Estanove shopping center in Montpellier (photo credit: © Jean-Michel Mart), (b) a car wash station in Lattes (photo credit: © Le Petit Journal de Lattes), (c) the Darty store in Pérols (photo credit: © France 3 LR/Sébastien Banus) and (d) a restaurant in La Grande-Motte (photo credit: © France 3).

- in France, the collapse of the roof of a warehouse in Satolas-et-Bonce in the department of Isère and of a supermarket in Bricquebec in the department of Manche (January 2010); several collapses of roofs in western France (at least nine store roofs in the department of Manche) in March 2013; and a lot of damage to shops in the department of Hérault at the end of February 2018 in the cities of Béziers, Lattes, Montpellier and Pérols (see examples shown in Fig. 1);

The current paper reports a detailed and specific case study of a roof collapse of a scientific laboratory (formerly Irstea, now INRAE, the Institut National de Recherche pour l'Agriculture, l'alimentation et l'Environnement) which occurred on 1 March around 18:00 LT following an intense rain-on-snow event in a Mediterranean area. Several roof collapses took place in this area in the same period (see Fig. 1).

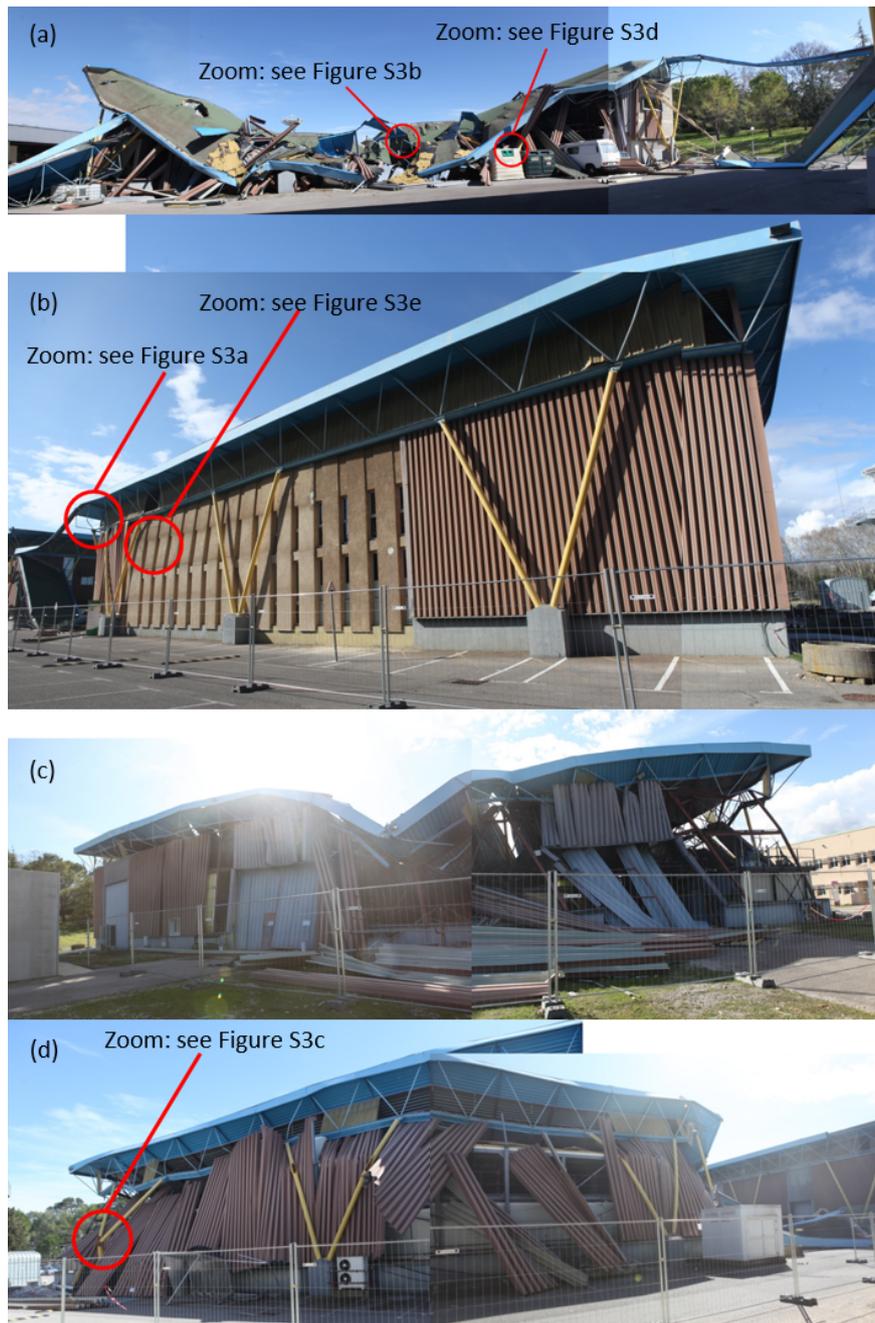
Figure 2. Different pictures showing the extent of damage as observed on 18 March 2018 on the western (a), southern (b), eastern (c) and northern (d) facades of the Irstea Cévennes building.

Figure 2 shows the main damage observed during a field visit on 18 March 2018, shortly after the collapse of the experimental hall of the Irstea Cévennes building in the central part of the structure, in the east–west direction. The western and eastern facades were heavily damaged, as seen in Fig. 2a and c. On the contrary, the other two facades (see Fig. 2b and d) were much less damaged due to the presence of the inner concrete walls of the offices and the inner metal frames of the laboratory rooms along the southern and northern facades, respectively. Local damage observed on structural elements consists of (i) buckling and bending of the roof tubular profiles, (ii) bending and shear of the tubular supporting py-

lons, and (iii) cracking on the walls of the offices (see close-up views of the damage shown in Fig. S3 in the Supplement).

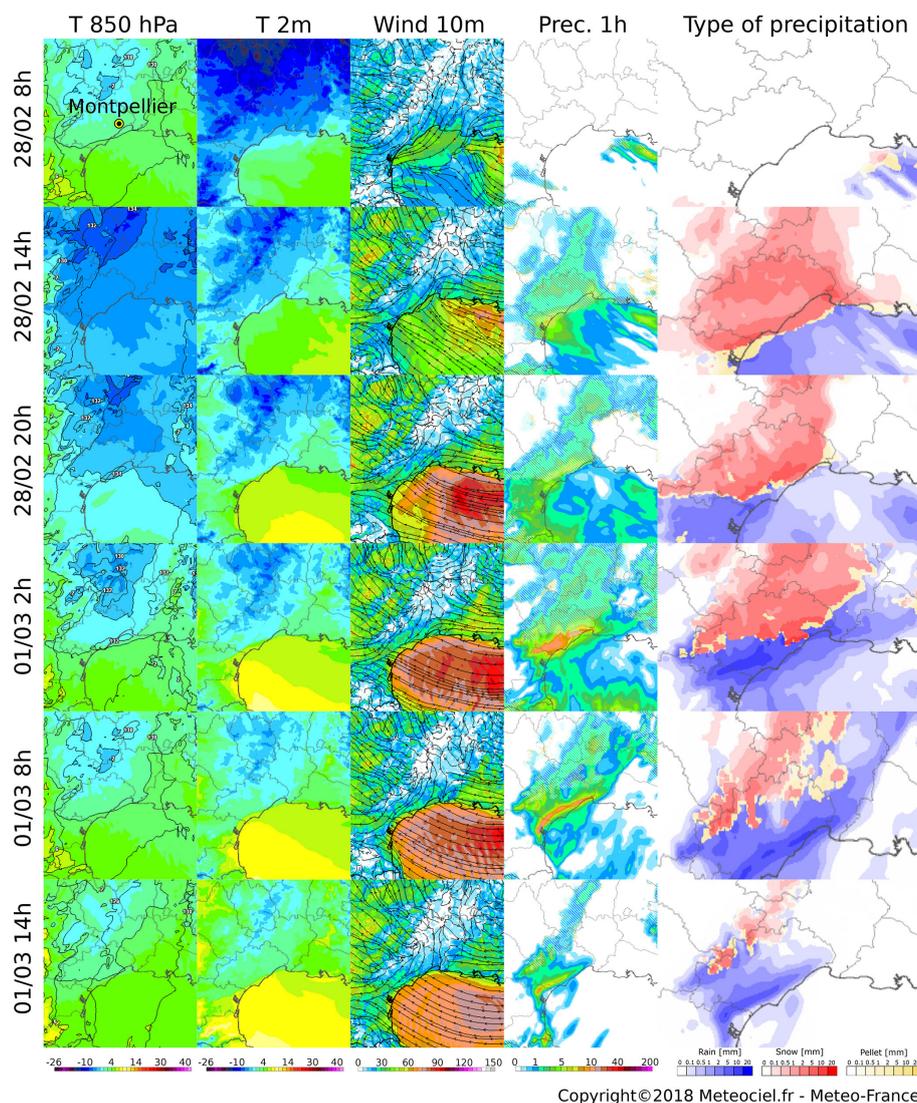
Figure 3. Outputs of the high-resolution AROME model for the following parameters: temperature at 850 hPa [$^{\circ}\text{C}$], temperature at 2 m [$^{\circ}\text{C}$], wind at 10 m [km h^{-1}], precipitation amount accumulated in 1 h [mm] and the corresponding type of precipitation (rain, snow or ice pellet). The maps shown in each row correspond to different runs for a 1 h lead time, from 28 February at 08:00 LT to 1 March at 14:00 LT. Source: Météo-France.

Figure 3 presents the outputs of the high-resolution AROME model for different times and lead times. The regional AROME model assimilates various types of observations (radar, ground measurement data, radio, satellite radiances; see Bouttier and Roulet, 2008) and must be interpreted with care. AROME outputs provide interesting information regarding the spatiotemporal dynamics of the meteorological event. Four parameters are represented: temperature at 850 hPa, temperature at 2 m, wind at 10 m, and precipitation amount accumulated in 1 h.

The last column of Fig. 3 presents the evolution of the type of precipitation simulated by the AROME model for a 1 h lead time. AROME clearly simulates an intense snow event from 28 February 2018 at 14:00 LT until the end of the day, followed by a rain-on-snow event during the night. An in-

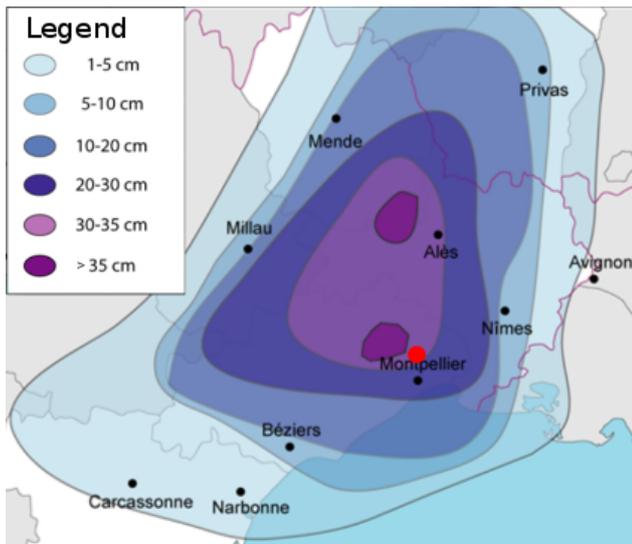
Figure 4. Snow accumulation during the snow event of 28 February 2018, based on 5000 testimonies. The red marker shows the position of the collapsed building. Source: Météo Languedoc.

(<https://www.meteolanguedoc.com/evenements-majeurs-en-languedoc-roussillon/episode-neigeux-du-28-fevrier-2018-jusqu-a-35-cm-pres-de-montpellier/p513>, last access: 5 September 2023) and include different types of information about the meteorological event, including photos from amateurs following their Facebook page (<https://fr-fr.facebook.com/MeteoLanguedoc/>, last access: 5 September 2023). Through their Facebook page, Météo Languedoc asked their 120 000 followers to provide observations and photos supporting these observations. Thanks to the collection of 5000 responses, a robust estimation of the depth of the snowpack at the end of the snow event was obtained, leading to the interpolated field of snow accumulation provided in Fig. 4. The data clearly show that the snow

depth was more important north of Montpellier, likely due to a hill separating the city center from the Lavalette site.

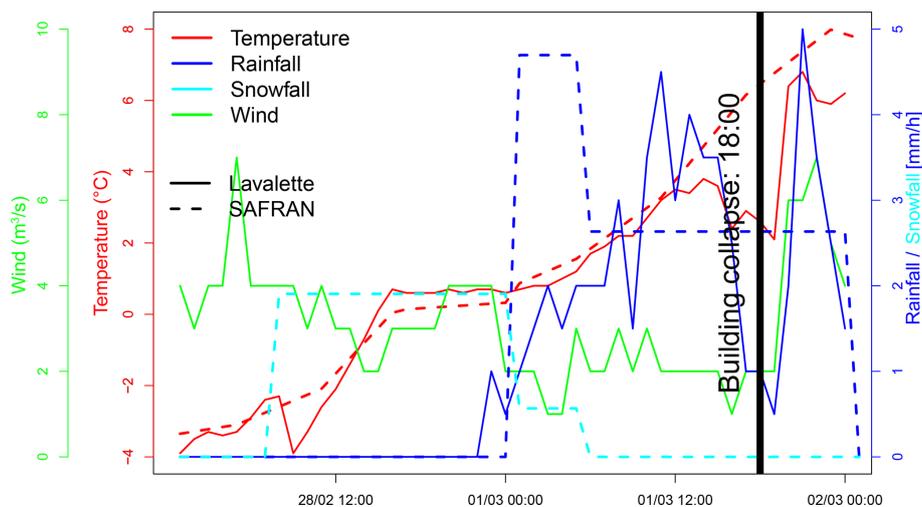
Figure 5. Weather observations at the station of Lavalette (solid lines) and SAFRAN reanalysis at the grid point covering the Irstea building (dashed lines).

Figure 5 shows the evolution of the temperature and rain and snow amounts according to two different and independent sources of information:

- Just next to the center of Irstea in Montpellier, a weather station (the Lavalette station) records various meteorological parameters, including temperature and rain. For this station, the tipping-bucket rain gauge is not heated,

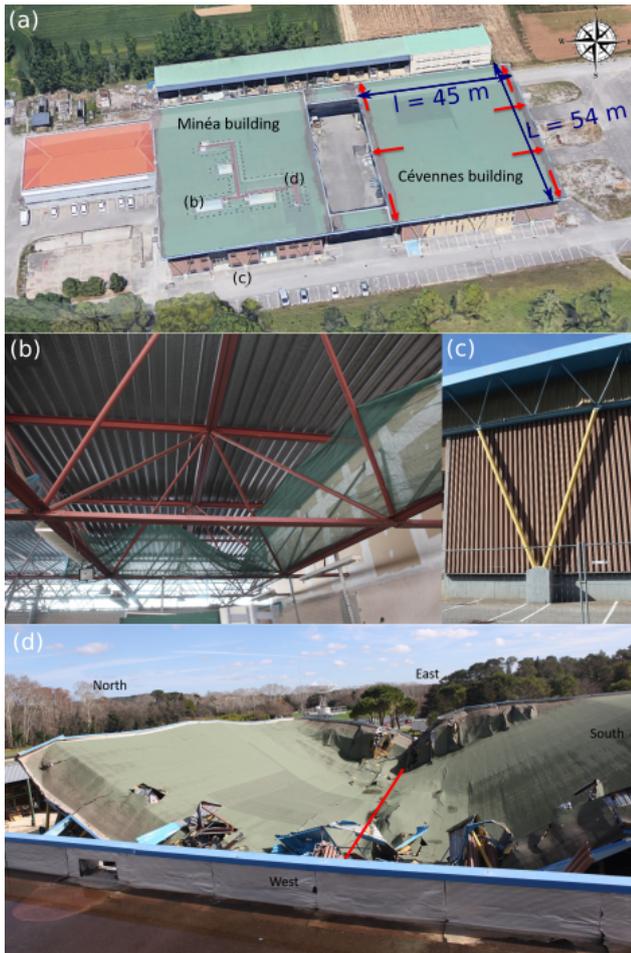
Figure 6. (a) Overview of the Irstea Cévennes building before the damage, with rainwater drainage points indicated by the red arrows. The dimensions of the roof are given in blue, and the height of the building is 10 m. The letters indicate where the photos of the other subplots were taken (photo credit: © Google Earth 2014, adapted by Isabelle Ousset). (b and c) View of the supporting structure of the Irstea Cévennes building before its damage: (b) red-colored metal roof frame and (c) supporting tubular pylons (in yellow) along the facades. (d) Overview of the damaged Irstea Cévennes building. The red line indicates the direction perpendicular to the direction of the main deflection of the roof after the collapse.

both sides of the east–west axis along which the structure collapsed, as shown in Fig. 6d. Thus, it is very likely that buckling was involved at some stage in the roof collapse.

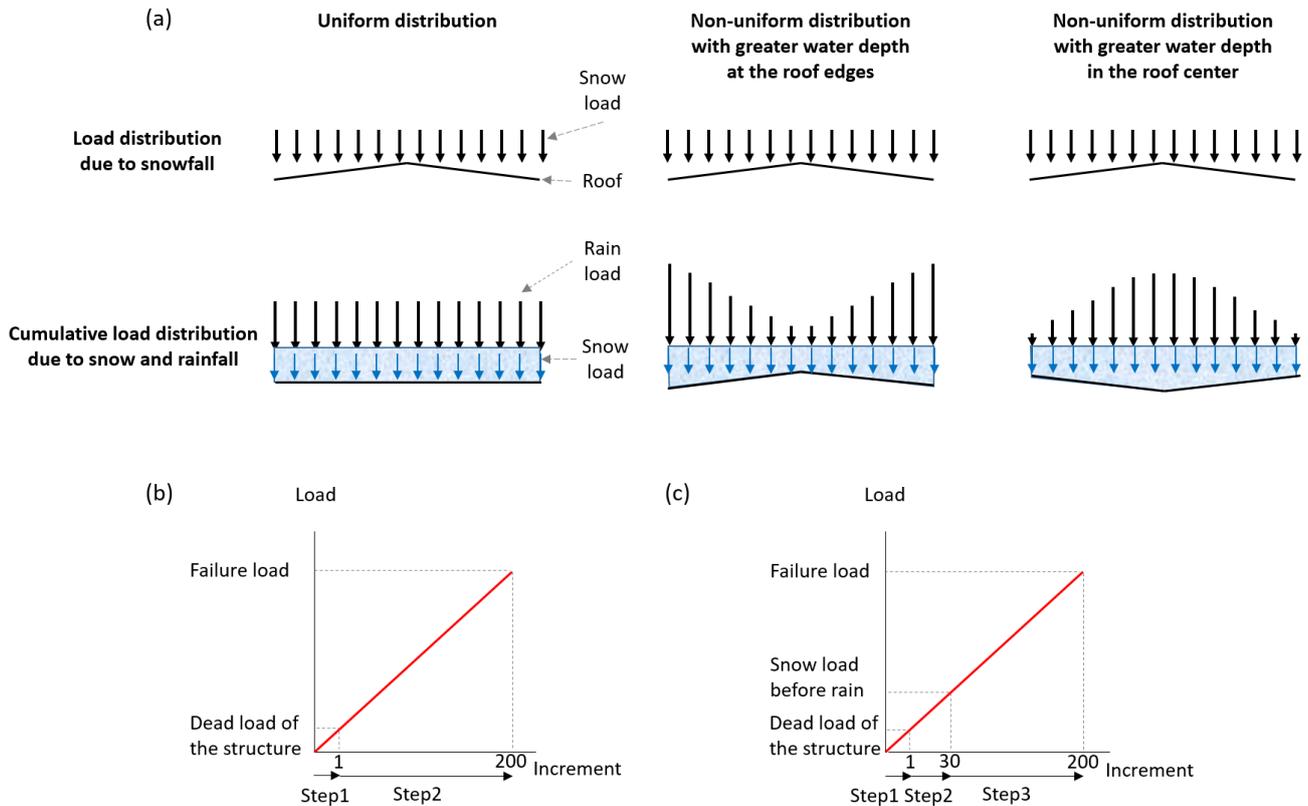
Figure 7. (a) Different assumptions made for the spatial distribution of snow and rain loads and (b) and (c) load evolution by incrementation for pushover analyses in the cases of a uniform distribution (b) and a non-uniform distribution (c) of rain loads. Note that the increment numbers of steps 2 and 3 are given here as examples only.

Pushover analyses are quasi-static analyses (without dynamic effects) that determine how far the building can go before it collapses completely or partially. Figure 7 illustrates the main steps of this analysis. The first step (step 1 in Fig. 7b and c) takes into account the self-weight of the structure. Then the snow and rain pressure on the structure is gradually and linearly incremented to mimic the load increase during the rain-on-snow event until the structure fails by reaching either the elastic limit of the material or the ultimate limit of the material for a snow and rain pressure equal to the failure force. This linear increase is performed in one step for uniform loads (step 2 in Fig. 7b) and two steps for non-uniform loads (steps 2 and 3 in Fig. 7c). In the latter case, step 2 corresponds to the increase in the uniform load of snow before the rain, whereas step 3 corresponds to the increase in the non-uniform load of water on the snowpack.

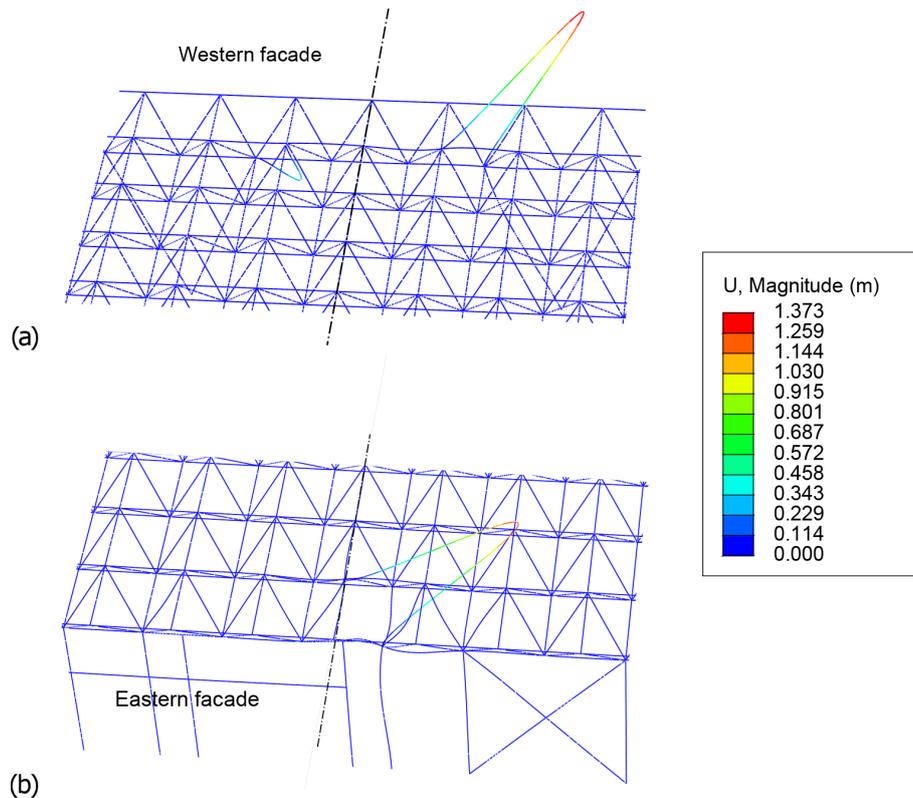
Figure 8. Buckling mode shapes of the structure under a uniform snow and rain pressure field (deformation scale factor = 5.4): **(a)** first mode, above the western facade, and **(b)** fifth mode, above the eastern facade.

The minimum of 645 Nm^{-2} (in brown) corresponds to the non-linear buckling load. This value is just below the uniform initial snow load before the rain (736 Nm^{-2}) (in teal) and does not depend on the assumption made for the distribution of the rain load. In contrast, the linear buckling analysis gives higher values for the load corresponding to the first eigenvalue mode (from 935 to 945 Nm^{-2}). All of these critical buckling loads (in beige) are well below the snow and rain load estimates. This means that this failure could have occurred with the observed snow and rain load. In addition, although it should be noted that the buckling failures remained localized (on a few crossbars located at the eastern and western edges, as shown in Sect. 3 and Fig. 8), they occur on

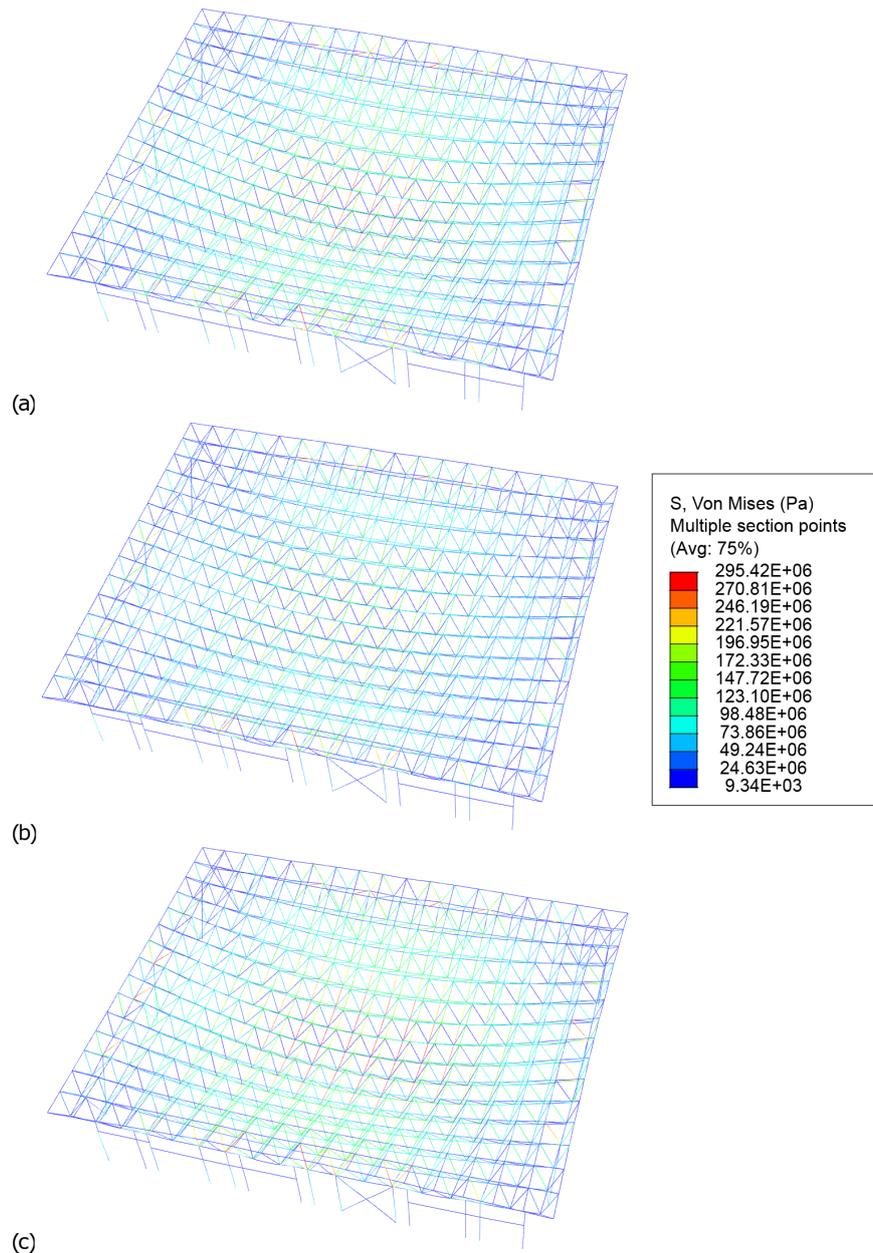
Figure 9. Von Mises stress field (Pa) inside the structure at the real snow and rain load of 1325 N m^{-2} , given by the FE model simulation for the different assumptions made for the spatial distribution of snow and rain: (a) uniform, (b) non-uniform with greater water depth at the edges and (c) non-uniform with greater water depth in the center (a deformation scale factor of 25 is applied to highlight the contrasts).

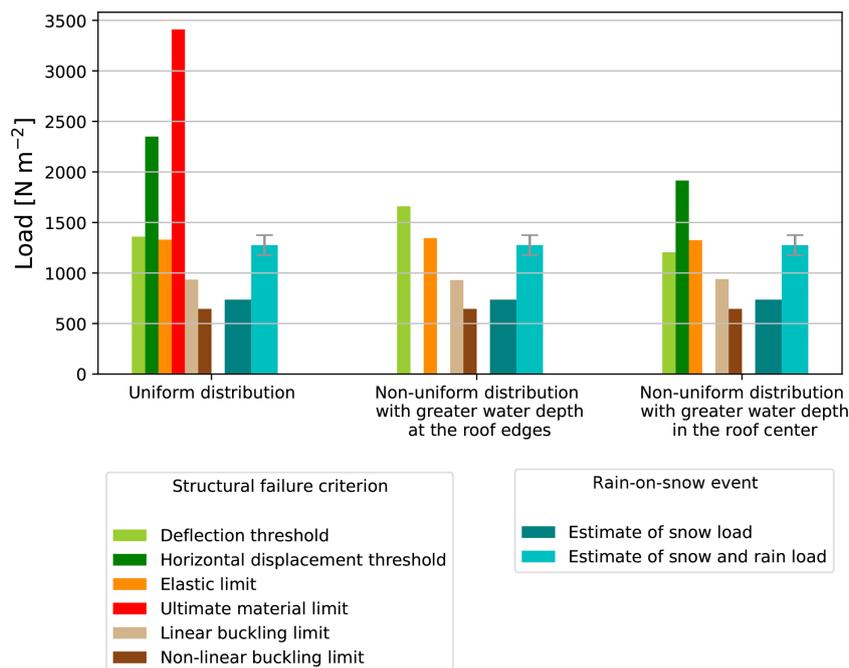
Figure 10. Comparison of the snow loads leading to different failure criteria of the Cévennes building, as calculated by FE model simulations, with the estimated scenario for the rain-on-snow event of 2018, as back analyzed in Sect. 2, in the different cases of snow and rain pressure fields. The structure fails when the observed snow and rain load (on the right, for each assumption of snow and rain distribution) is greater than the calculated failure load (on the left). The latter calculated failure load could not be obtained when code divergence was observed, thus explaining the empty bars in the case of non-uniform rain distributions (see Table 1).

Figure 10 compares the critical loads that would cause a failure according to the FE simulations (Table 1) with the initial snow load of 736 Nm^{-2} before the rain and the final snow and rain load values of 1226 to 1325 Nm^{-2} estimated from different sources of observations in Sect. 2.

The maximum critical load of 3410 Nm^{-2} (in red in Fig. 10) corresponds to the ultimate limit of the material under uniform pressure distribution and is well above the estimated value for the snow and rain load of 1226 – 1325 Nm^{-2} (in cyan). Note that for non-uniform snow pressure fields, the ultimate material limit is not reached due to numerical instabilities (lack of convergence). The values obtained from the horizontal displacement criterion are also well above the estimated range of 1226 – 1325 Nm^{-2} . The pushover FE simulations thus suggest that neither the ultimate material limit nor the critical horizontal displacement was reached at the time just before the collapse, regardless of the scenario for rain load spatial distribution.
