Experimental study of riverbank protection with bio-engineering techniques

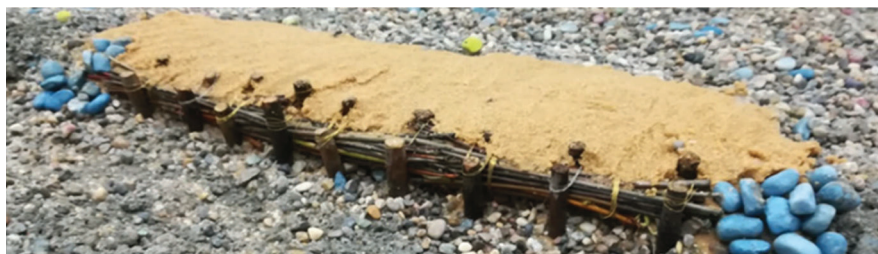
Fig.2A fascine with ripraps upstream and downstream

The bank protection technique tested was fascines, which consists in an arrangement of materials made with *salix* and fixed in the river bed against the erodible bank with wood sticks (Fig. 2).

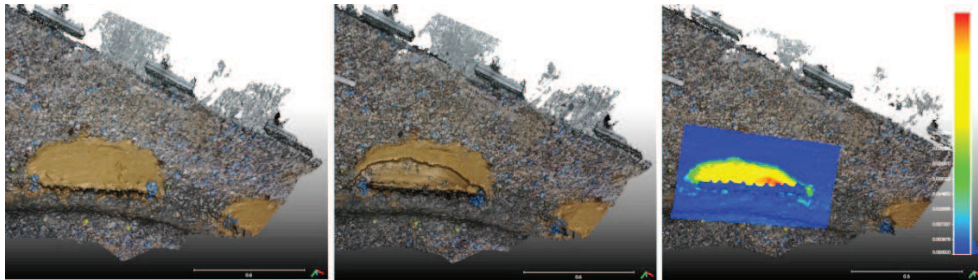
Fig.4 Example of diachronic analysis a) before the run, b) after the run, and c) difference The color scale varies from blue (absence of erosion) to red (maximum erosion).

The quantity of material eroded could be measured with a diachronic analysis of photogrammetry.

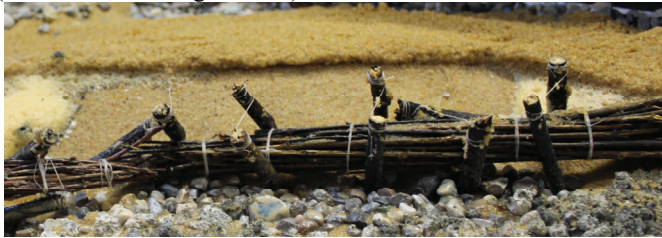
Fig.5 Top erosion (test: connection present, high discharge, full protection).

- Top erosion due to a flow overtopping the fascine when the water depth is sufficiently high (Fig. 5);
- Erosion at the base of the fascine leading to scouring and local bank collapse (Fig. 6).
- Back erosion affecting the downstream part of the erodible bank (Fig.7);
- Total collapse when back erosion is combined with local bank collapse caused by basal scouring (combination of Fig.6 and 7)

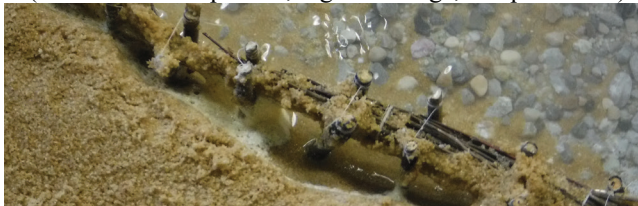
Fig.6 Basal erosion (test: connection absent, medium discharge, no rip rap upstream).

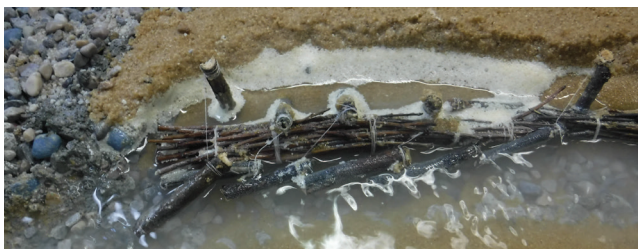
Fig. 7 Downstream back erosion (test: connection present, high discharge, no rip rap downstream).
