Sara Posi, Lucas Montabonnet, Alain Recking, André Evette, Hervé Bellot, et al.. Experimental study of riverbank protection with bio-engineering techniques. 3rd European Conference on Flood Risk Management (FLOODrisk 2016), Oct 2016, Lyon, France. pp.1-8, 10.1051/e3sconf/20184005023 . hal-04687593

Experimental study of riverbank protection with bio-engineering techniques

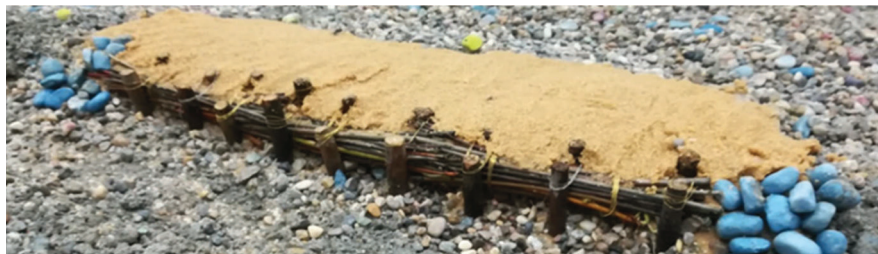
Fig.2A fascine with ripraps upstream and downstream

The bank protection technique tested was fascines, which consists in an arrangement of materials made with *salix* and fixed in the river bed against the erodible bank with wood sticks (Fig. 2).
