Failure paths for levees

February 2022

PREPARED BY
Technical Committee on
Geotechnical Aspects of Dikes and Levees
(TC201)

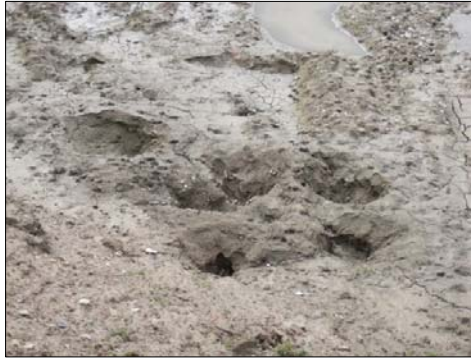
The presence of an old field drain beneath the levee is believed to have influenced the failure. The alignment of the drain can be seen on the LiDAR image and evidence of seepage was found during the post-breach inspections.

Possible evidence of piping failure on landward side of levee at the location of the breach appears to coincide with the location of historic land drain. This seepage may have led to softening of the toe or possibly uplift beneath the landward slope of the embankment.

Figure 3.5 Close-up of the situation.

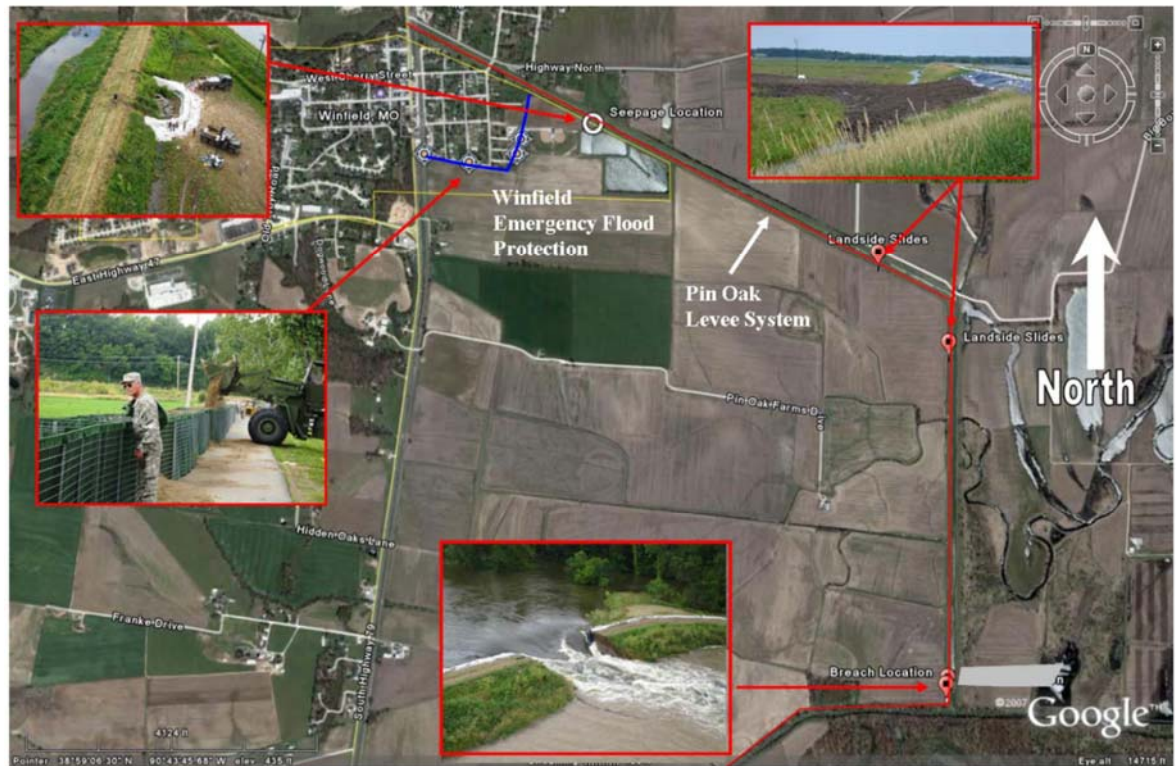
As shown in Figure 3.8, the Pin Oak Levee system experienced significant distress and subsequent breach during the Spring 2008 Flood. The Spring 2008 Flood lasted approximately three weeks and ended in a breach of the system on 27 June. Based on information provided by the USACE St. Louis District, the flood event was considered to be a 50-year event at the Pin Oak Levee system.

Figure 3.8 Aerial view of the Pin Oak Levee system.

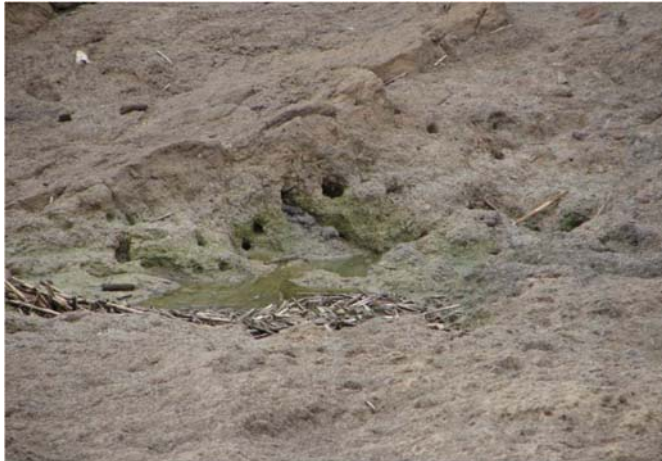
Along the alignment of the levee, the breach scour depth only extended down to the foundation level. However, rodent holes (ranging from 5 to 7 cm in diameter) were found around the perimeter of the levee and at the water side toe of the breached levee section. There were also indications of rodent holes about 1.3 m below the flood side mid-slope near the base of the levee (see Figure 3.11).

Figure 3.11 View of animal burrows beneath water side mid-slope of breach section (22 July 2008).

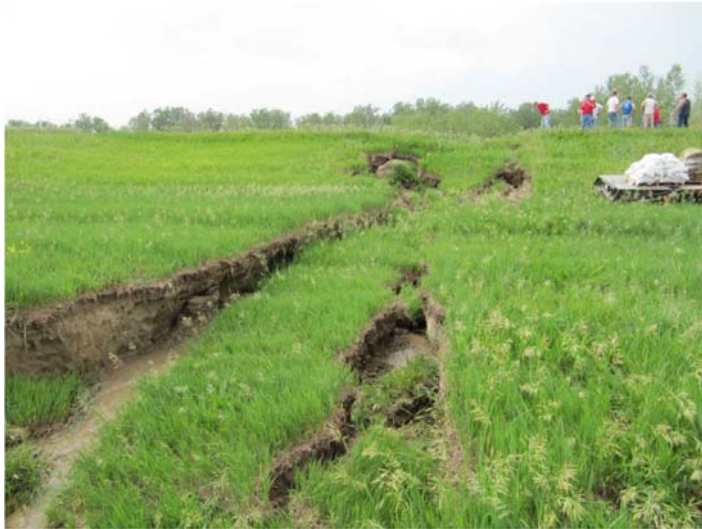
One of the breaches that occurred during the Missouri River flooding of 2011 occurred in the L-575 levee district which protects a large area of agriculture along with the city of Hamburg in southwest Iowa. The breach occurred in an area that had demonstrated several incidents of levee underperformance. Initial distresses, as shown in Figure 3.13 and Figure 3.14, narrowly avoided a full breach as the levee collapsed on itself, sealing off the underseepage path. Emergency repairs were initiated to reinforce this section of levee. The contractor and levee personnel were on site when the next distress appeared. There was a report of a “gurgling” sound, and then the levee collapsed on itself beginning from the protected side (land side) seepage berm and continuing toward the water side. As seen in Figure 3.14, an alluvial fan appeared at the protected side toe of the seepage berm. One additional incident (for 3 total) like this occurred before the final section of the levee breached. For all of these incidents, including the breach, there were a few meters of freeboard on the levee at that time.

Figure 3.13 The initial distress in the levee L-575.

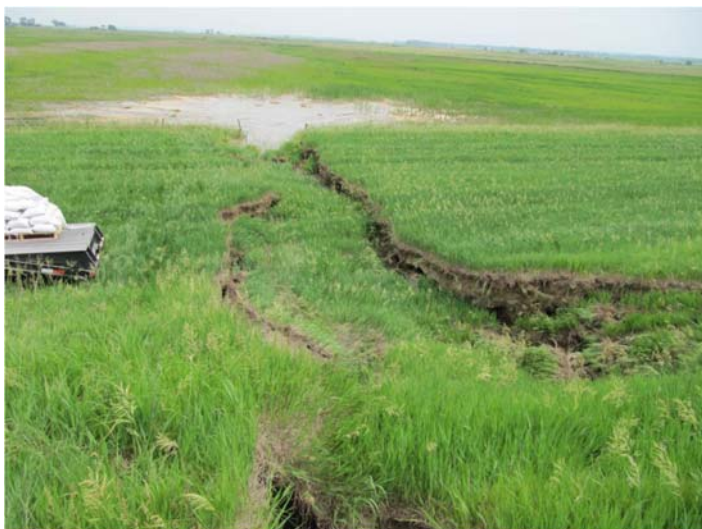
Figure 3.14 Initial distress in levee L-575 showing alluvial fan.

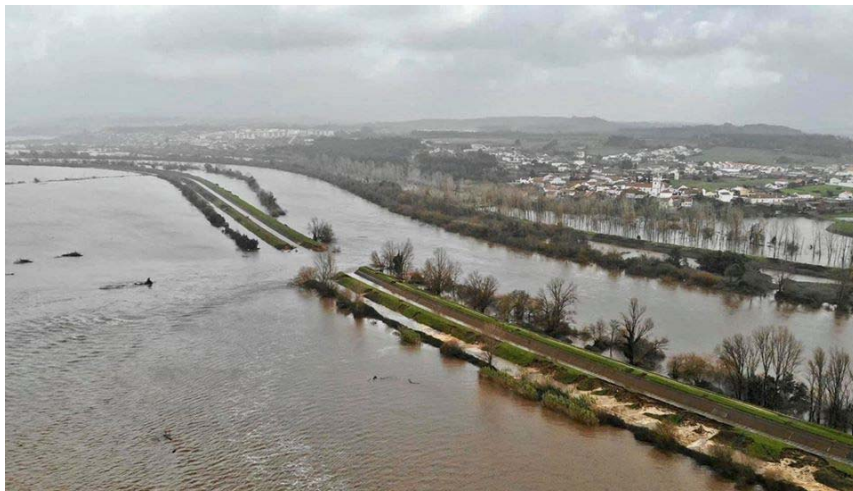
The causes of the failure are still being studied. Available information indicates that there was overtopping before the collapse.

The collapse led to the flooding of the fields in the Central Valley of the Lower Mondego and the cutting of communication routes. Infrastructure was severely damaged, not only the embankment but also the road and the conducting channel at the right bank, for the water supply of agriculture and industries.

Figure 3.21 View of Santo Varão after collapse of the embankment ⁵.

A plan is currently under development to reinforce the Mondego embankments. This plan will consist of integrated solutions, to be implemented in the coming years.

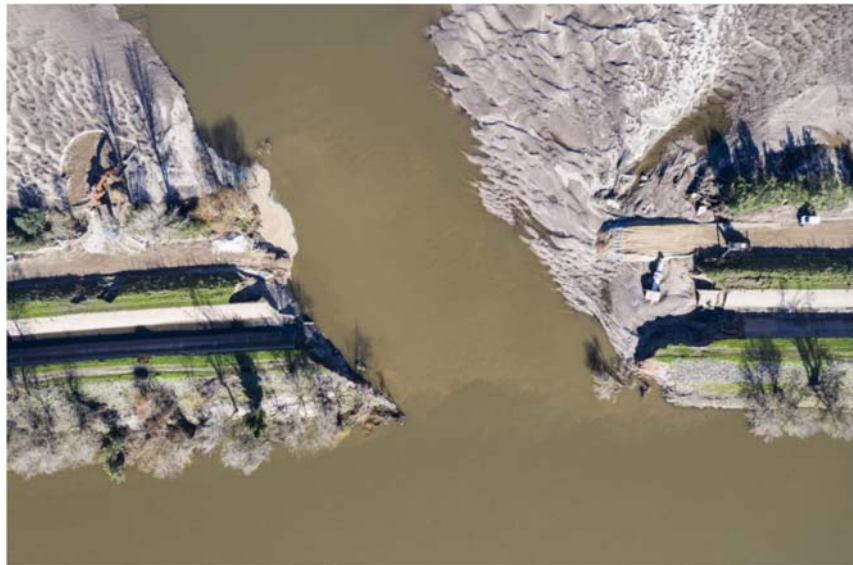
Figure 3.22 Top view of collapsed embankment in Santo Varão ⁶.

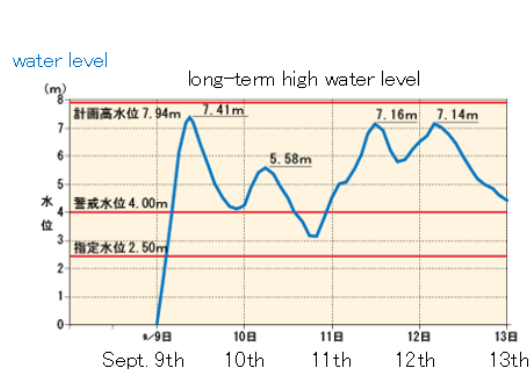
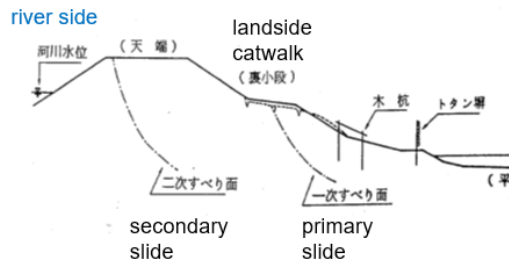
Failure time tree and the process were written down; from cracking to secondary large slide.

- ✓ Sept. 12th, 06:30 --- crack in landside catwalk
- ✓ Sept. 12th, 07:40 --- a crack line in the center of landside catwalk, paralleled to levee
- ✓ Sept. 12th, 08:10 --- two crack lines of landside catwalk: the lengths of 40cm, 60cm and the width of 5-10cm
- ✓ Sept. 12th, 09:10 --- herbicidal works
- ✓ Sept. 12th, 09:30 --- levee protection works with pile driving. Growth of cracks with level difference of 50cm on landside catwalk
- ✓ Sept. 12th, 10:20 --- Primary slide on landside catwalk, and then secondary slide from levee crown in a couple of minutes.
- ✓ Secondary slide and inflow of river water....breach

Figure 3.24 Example of slope slide from the presentation 'Picture-Card Show Project' in JGS-JSCE by K. Maeda, M. Ishihara and H. Mori, using materials from the Ministry of Land, Infrastructure, Transport and Tourism in Japan.

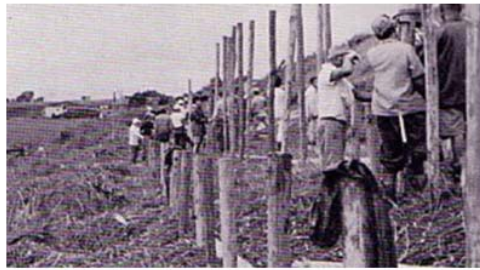
Figure 3.25 illustrates the protection works that were installed as well as the situation following the breach.

levee protection

Just after
breach

Figure 3.25 Example of slope slide from the presentation 'Picture-Card Show Project' in JGS-JCES', contribution by K. Maeda, M. Ishihara and H. Mori, using materials from the Ministry of Land, Infrastructure, Transport and Tourism in Japan.

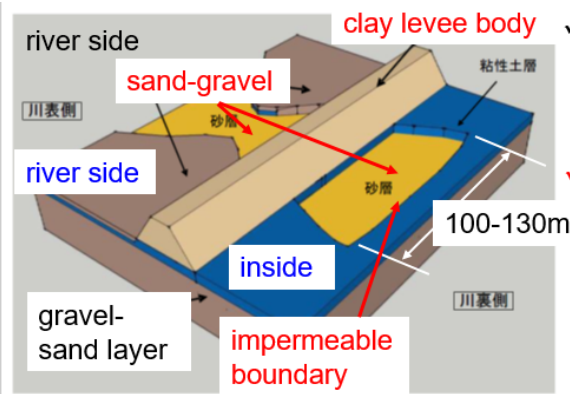
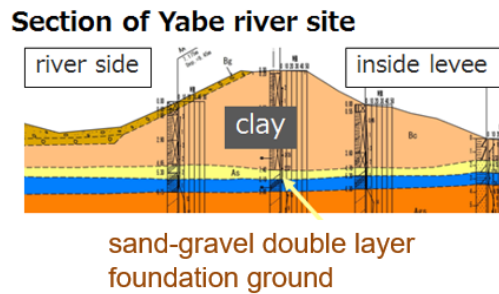
✓ The river water flow was concentrated in sand-gravel base layers during 5 hours. "piping": scouring in base layer, and collapse and fall of levee body.

✓ Levee body is clay. Base layer of levee is almost clay, but in some locations, sand-gravel parts exists in narrow parts of base layers.

Figure 3.28 Example of piping erosion from the presentation 'Picture-Card Show Project' in JGS-JCES', contribution by K. Maeda, M. Ishihara and H. Mori, using materials from the Ministry of Land, Infrastructure, Transport and Tourism in Japan.

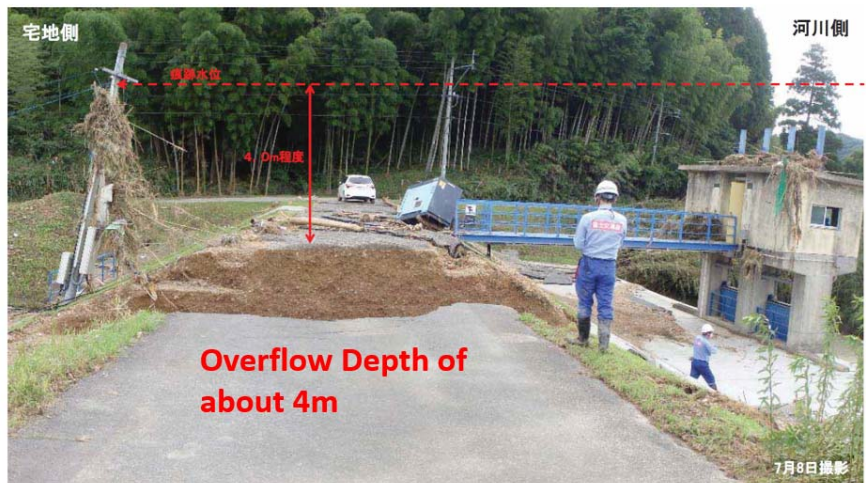
Overtopping Erosion: Kuma river (2020)

The figures below show some sites where overtopping erosion occurred on the Kuma river in 2020.

Figure 3.32 Picture of overtopping from the presentation 'Picture-Card Show Project' in JGS-JCES', contribution by K. Maeda, M. Ishihara and H. Mori, using materials from the Ministry of Land, Infrastructure, Transport and Tourism in Japan.

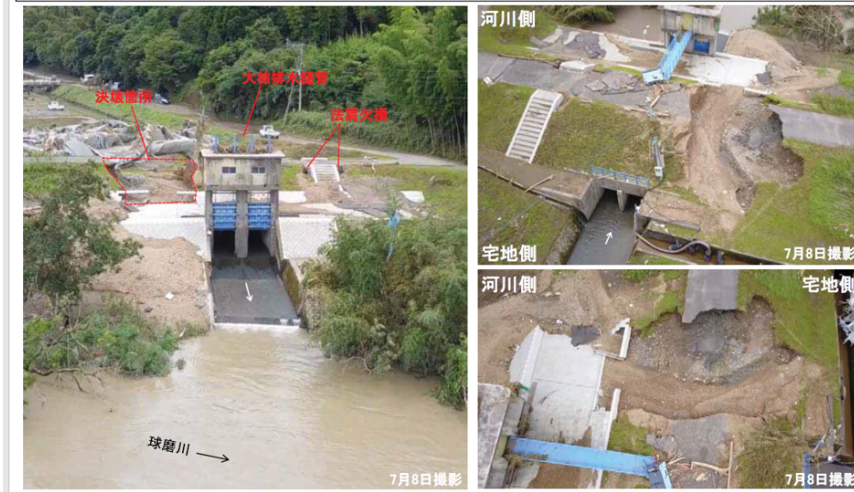
Overtopping Erosion: Kuma river (2020)

Figure 3.33 Example of overtopping from the presentation 'Picture-Card Show Project' in JGS-JCES', contribution by K. Maeda, M. Ishihara and H. Mori, using materials from the Ministry of Land, Infrastructure, Transport and Tourism in Japan.

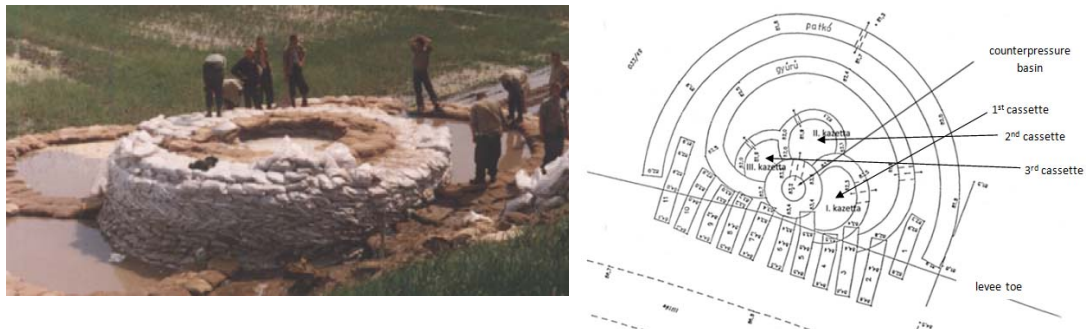
A secondary sand boil arose with a quite strong blow-up under the counter-pressure basin around 3:00 pm. Therefore, the water level in the counter pressure basin, which was already built up, lowered almost by 0.5m in a few minutes. The power of the blow-up was very concerning. Construction of the counter-pressure basin of the first cassette was carried out by soldiers and civils, its walls were 3 sandbags wide and 8 high. The basin of the first cassette fitted the previous semi-circumference shaping. Then, there was a need for building a new counter pressure basin (2nd cassette) in order to prevent another failure (see Figure 3.39).

Figure 3.39 Counterpressure basin for related cassettes (left) and location of sand cassettes (right).

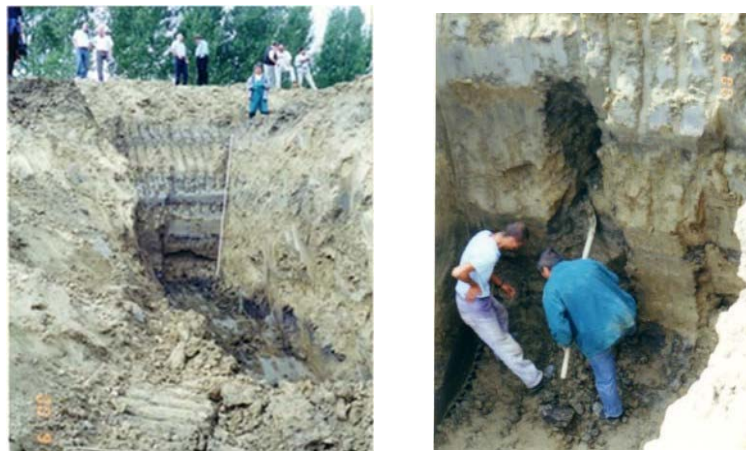
Based on the washout soil, which was more than two cubic meters, a sieve analysis was carried out. The uniformity coefficient of the silty sand was $C_U = 2,74$, $d_{80} = 0.11$ mm. The opening of the sand boil could only take place at the beginning of September. The cut through the levee showed the stratification and the path of the sand boil, which was first deep at the bottom and then it went up the waterside. Figure 3.40 shows the investigation and suggested that the sand boil occurred in a thick silty sand layer, which was covered with arched clay.

Figure 3.40 Opening of the sand boil.

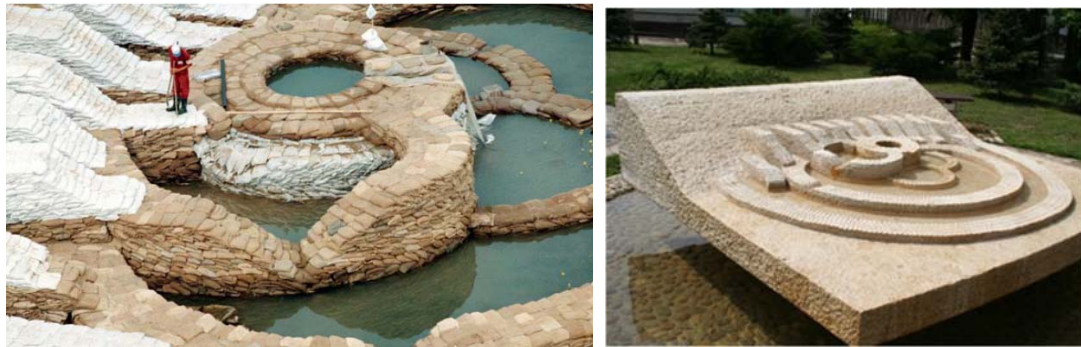
Figure 3.41 Tiszasas sand boil on 1st of May (left) and memorial of Tiszasas sand boil (right).

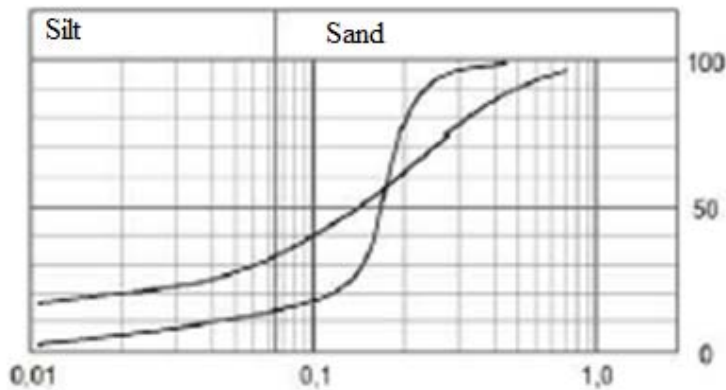
At 6:35 a.m., the guards were about 100 m away when a very strong water geyser spurt was observed. The water, they reported, was "black and thick muddy." The dike burst took about 5 minutes. Width of the tear grew rapidly, reaching a final width of 78 m. This was the first dike failure where detailed soil mechanical exploration was made afterwards. What happened was possibly a dynamic liquefaction of the extremely loose and thick sand lens, at the thickest dimension of the layer. The possible dynamic effect was the tearing off the clay cover layer at the first geyser spot and the sudden displacement of the dike body due to the increased horizontal load.

Figure 3.43 Kettős Körös, Hosszúfok in 1980, fast piping failure, failure location at top from (Szepessy, J.(1983)), with time history of flood. Bottom: grading curves, indicating the very loose sand inclusion with $3 < Cu$ and $e \sim 0.8$.

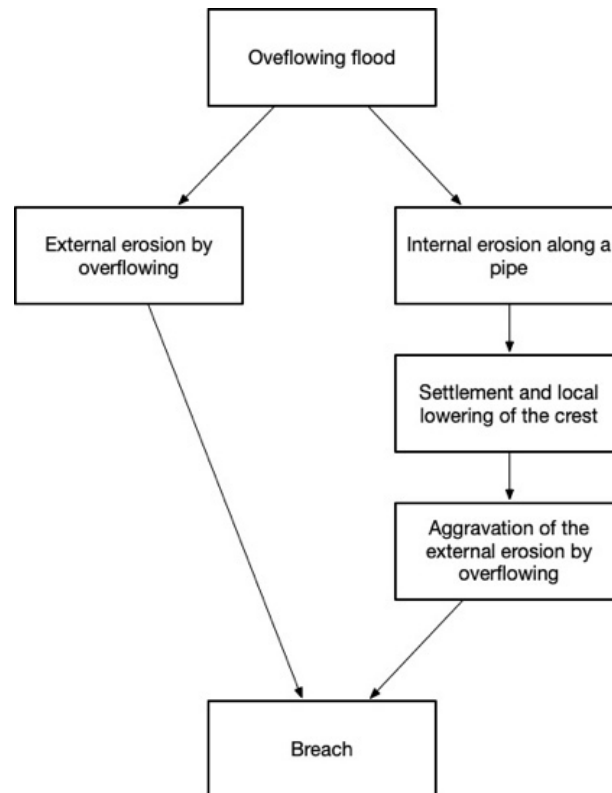
The 1999 breach has been caused by overflow at the location of the waste water treatment plant where internal erosion along a pipe crossing the levee also took place. This pipe probably aggravated the situation, because many other parts of the levee also were damaged by overflow but did not breach. Figure 3.50 shows this in the form of a diagram. It is even possible

Figure 3.50 Failure path for the 1999 Agly breach (Rémy Tourment).

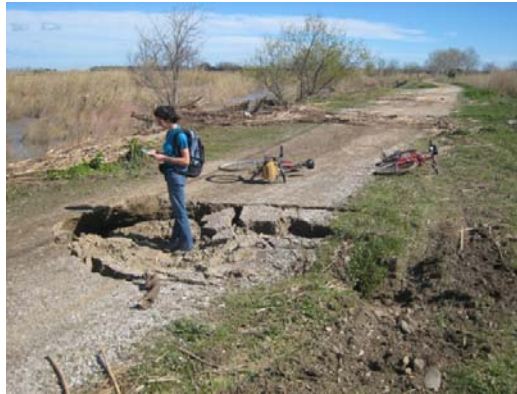
There was internal erosion in some places as well, as shown by some sinkholes and subsidence on the crest or traces of sand boils in the land alongside the levees. These internal erosion problems were mainly in the foundations, but they were also observed in the levees themselves: some seepage through the levee was also observed in areas where there were either intersecting pipes or old structures (rocks, wall) inside the levee.

Figure 3.51 Sinkhole on the levee crest (Photograph by Patrice Mériaux).

Works after the event included repairing the breach, repairing the eroded land slope (with drains and compacted fill) and repairing the damaged toe protection. Some non-exhaustive work also took place to prevent leakage (masonry on the river side) and sand boils (drainage and seepage system) in different places for each of the problems.

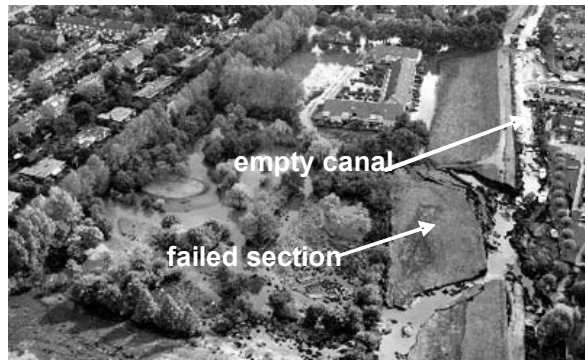
Figure 3.55 Failed canal levee at Wilnis, August 2004.

At the location water was heard or seen running from cracks in the levee’s landward side 0.5 - 1 hour preceding the main failure event. The main failure event was a lateral translation of several meters of a section of the levee, taking less than 15 minutes. The canal emptied through the wide opened lateral cracks resulting in a sheet flood. The flow in the failure’s main bounding cracks eroded peat and a significant amount of sand from the Pleistocene below the peat and clay.

The failure consisted of coherent horizontal translation of about 6 m over a 60 m stretch. Vertical displacement was less than a few decimetres. A planar horizontal basal sliding plane was reconstructed from borehole and excavation data and located to have been at the base of the peat, i.e. at the top of the sand. The failed slices were bound laterally by major linear fractures oriented outward at angles smaller than 45° , indicating the wedge to have been pushed by a force from the canal. Displacement of the slice was accommodated in part by filling a ditch and, mainly, in a subsequent upthrust over the existing terrain surface. A tall poplar tree at the toe of the slide had remained in place with its roots firmly anchored in the underlying sand, cutting the about 4 m thick sliding peat and clay mass.

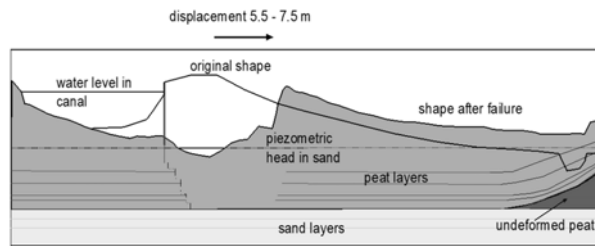
Figure 3.57 Embankment geometry before and after the failure at Wilnis. The various layer boundaries in the subsurface are indicated after failure, as well as the original water level in the canal and the piezometric head in the sand.

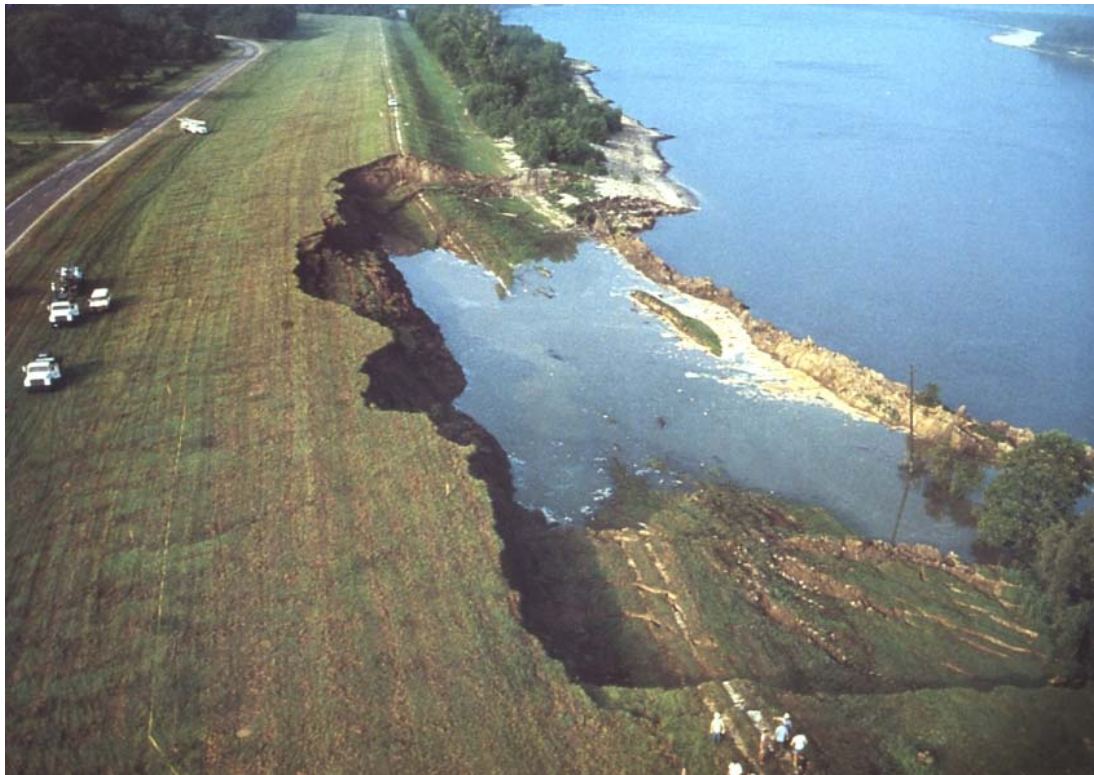
Figure 3.64 Photo: This 210 m section of levee slid into the east side of the Mississippi River on August 23, 1983 at Darrow, in Ascension Parish, Louisiana. The slide occurred shortly after a high-water stage had receded, suggesting that toe undercutting and rapid drawdown likely contributed to the failure.
Source: <https://web.mst.edu/~rogersda/levees/Mississippi%20Delta%20Region.htm>.
