Failure paths for levees

Meindert Van, Esther Rosenbrand, Rémy Tourment, Philip Smith, Cor
Zwanenburg

February 2022

PREPARED BY
Technical Committee on
Geotechnical Aspects of Dikes and Levees
(TC201)

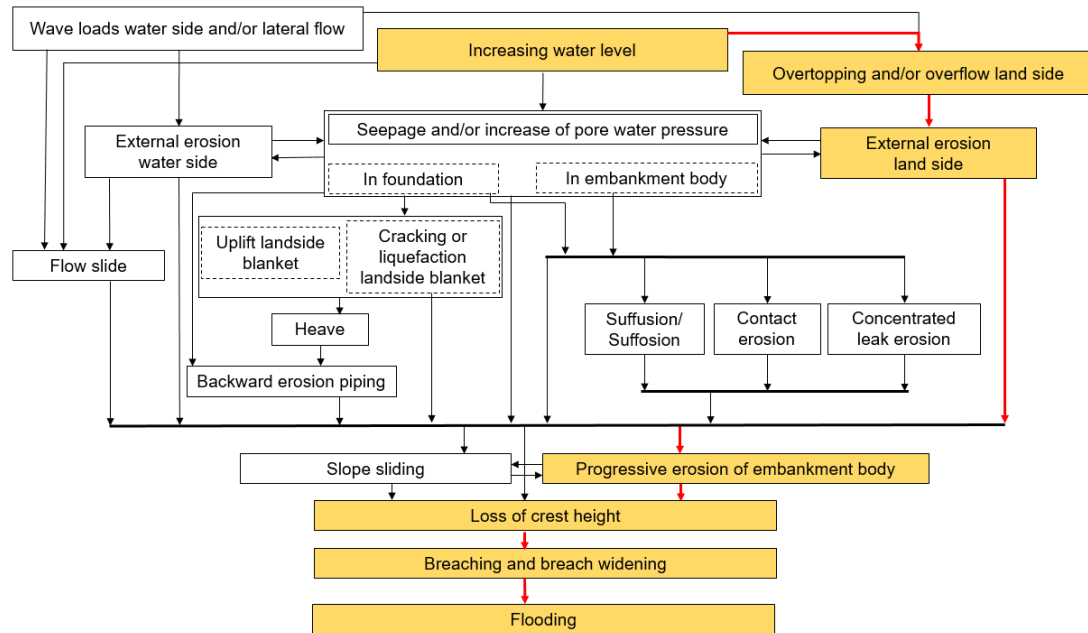
Figure 3.1 Failure tree of the UK breach, 2015.

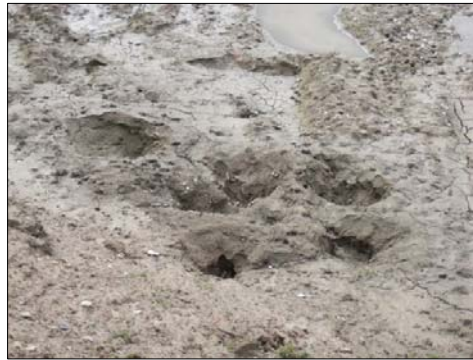
The presence of an old field drain beneath the levee is believed to have influenced the failure. The alignment of the drain can be seen on the LiDAR image and evidence of seepage was found during the post-breach inspections.

Possible evidence of piping failure on landward side of levee at the location of the breach appears to coincide with the location of historic land drain. This seepage may have led to softening of the toe or possibly uplift beneath the landward slope of the embankment.

Figure 3.5 Close-up of the situation.

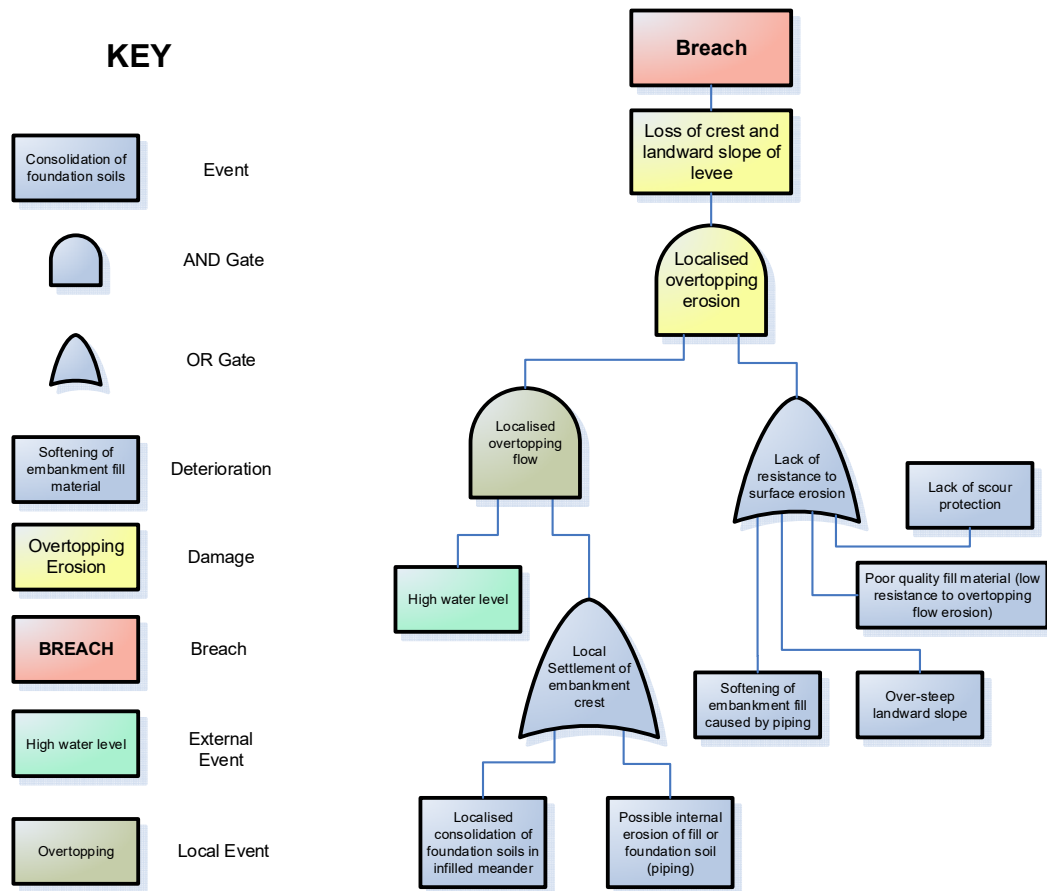
1. Very high-water levels in the river caused by rain associated with a named storm.
2. Localized lower crest levels resulting from historical local settlement of infilled meander and possible internal erosion associated with land drainage. This led to localized overflow.
3. A steep landward slope created turbulent flow at the toe of the landward slope after overflow commenced.
4. The resilience of the landward slope was potentially reduced by seepage and/or uplift at the location of the historic land drain.
5. The relatively poor-quality embankment fill material (locally won and agricultural) meant that the levee had reduced resilience to overflow erosion.

Figure 3.6 indicates how the factors above can be combined into a fault tree to show how these elements can combine to create a situation where a breach occurs. In this case there are several potential influencing factors. As we cannot say for certain what the dominating factor was, or what the contributing percentages were, these are connected by an OR gate.

Figure 3.6 Fault tree UK breach 2015.

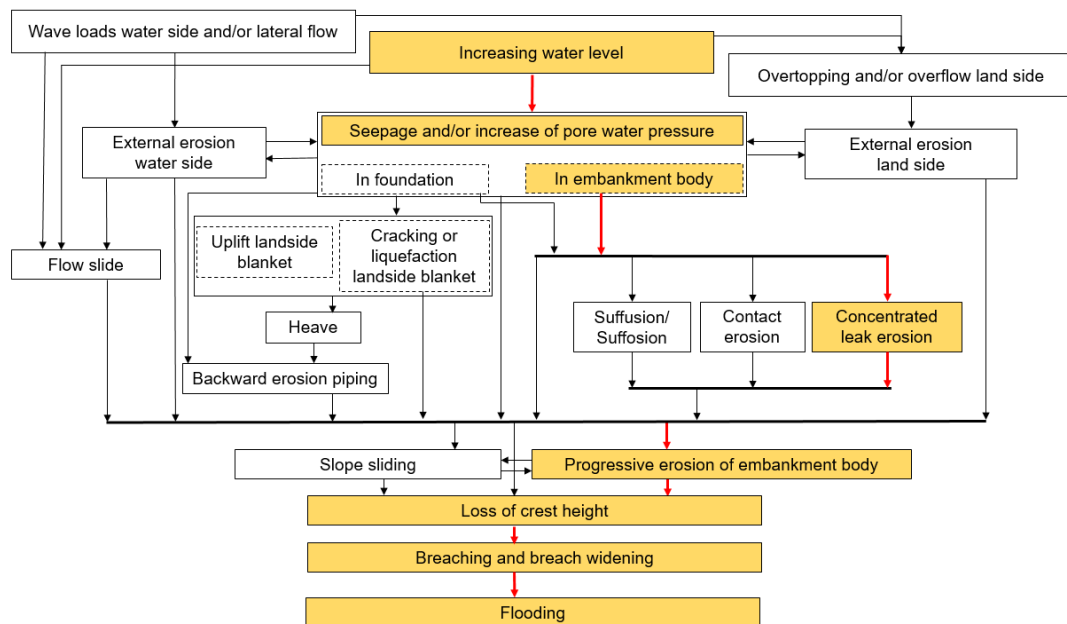
- Water level exceeded design level;
- Previous history of poor performance in the levee system;
- Addition of sandbag wall on levee crest to prevent overtopping;
- Increased pressure on levee leading to through seepage, evidenced by seepage on the land side slope;
- Attempts to put sandbag around the seepage initially worked but eventually became less effective;
- Placement of plastic tarp on the flood side (water side) of the slope of the levee to control seepage inflow;
- Seepage steadily increased with observations of significant fines;
- Reports and observations of rodent holes in levee at location of breach.

Figure 3.7 Failure tree of US Pin Oak levee system breach, Zwanenburg.

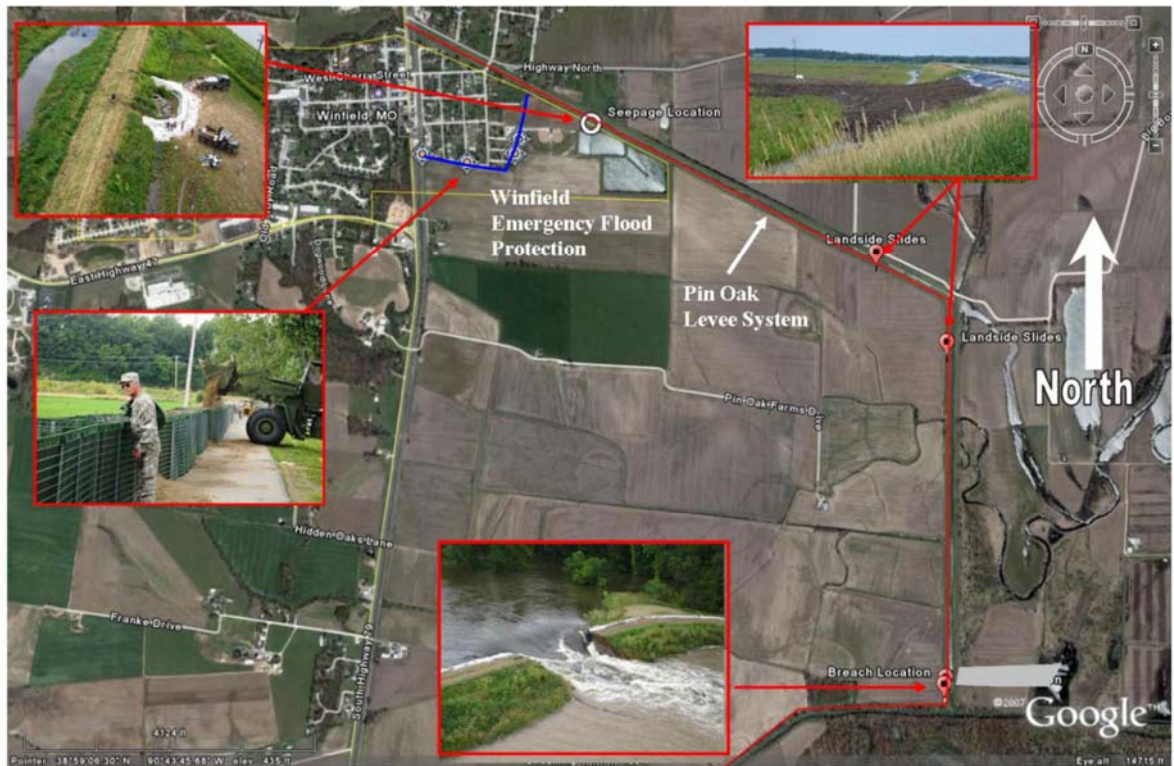
As shown in Figure 3.8, the Pin Oak Levee system experienced significant distress and subsequent breach during the Spring 2008 Flood. The Spring 2008 Flood lasted approximately three weeks and ended in a breach of the system on 27 June. Based on information provided by the USACE St. Louis District, the flood event was considered to be a 50-year event at the Pin Oak Levee system.

At the time of the breach, some portions of the sandbag stack/wall were not loaded while other portions were inundated up to 0.5 m. After the breach occurred, local, state, and federal forces made a heroic effort to protect the city from flooding by constructing an emergency flood protection wall around the city (see Figure 3.8).

Figure 3.8 Aerial view of the Pin Oak Levee system.

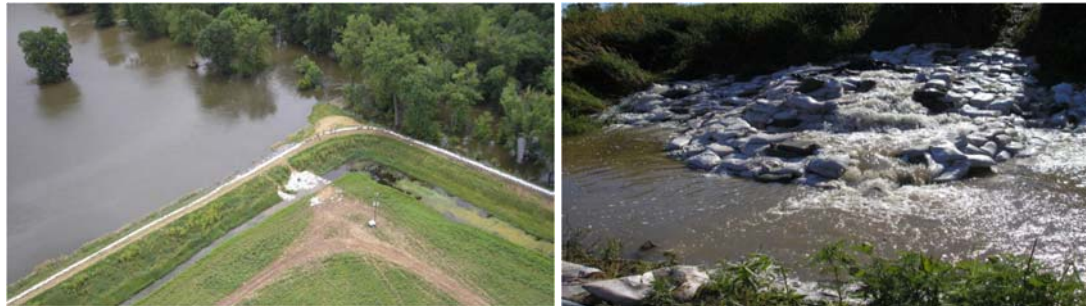
other small mammals were observed diving in the area where the plastic tarp was placed. Several people reported that an animal burrow was located on the flood side of the levee and that the seepage was associated with muskrat or other rodent holes/dens. On 27 June 2008, the levee breached at this site. Figure 3.9 and Figure 3.10 show images of the levee.

Figure 3.9 Seepage occurring at the toe of the levee prior to breach (taken around 0800 hr, 23 June 2008) (left), and Sand bag effort prior to breach (taken around noon on 26 June 2008) (right).

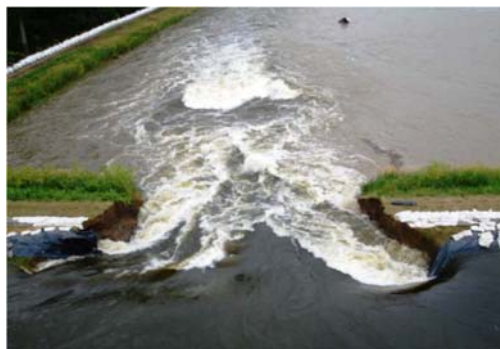
During the site visit, the width of the breach measured approximately 46 m. However, photos taken during the breach show a narrower initial width, indicating that the breach enlarged with continuing flow. The cross section of the embankment was exposed on both sides of the breach allowing the assessment team to inspect the levee embankment materials. Based on the cohesive nature of the soil, the levee embankment materials appear to be clay. A sample of the levee material (taken about mid-height in the levee profile) was removed for laboratory testing for geotechnical properties (e.g., Atterberg limits, sand content, organic content, and soil classification). The results of the tests were used to provide a description of the levee embankment material. The information can also be used to estimate erodibility, cracks, or concentrated leaks in embankments. From these soil properties, the erosion rate of the levee embankment material would be estimated as moderately rapid.

Figure 3.10 Breach occurring (taken around 0700 hr, 27 June 2008).

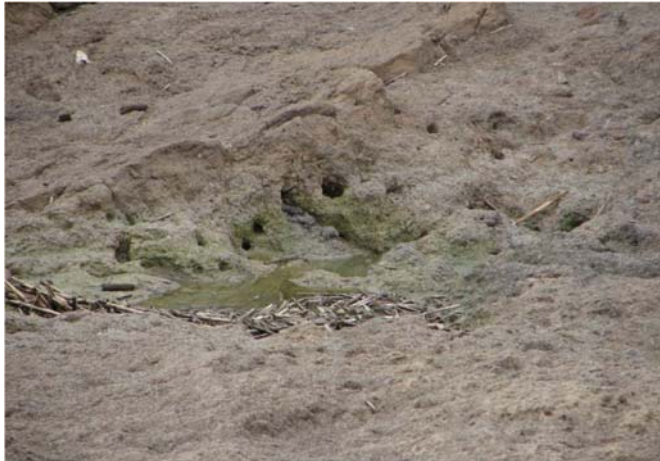
Along the alignment of the levee, the breach scour depth only extended down to the foundation level. However, rodent holes (ranging from 5 to 7 cm in diameter) were found around the perimeter of the levee and at the water side toe of the breached levee section. There were also indications of rodent holes about 1.3 m below the flood side mid-slope near the base of the levee (see Figure 3.11).

Figure 3.11 View of animal burrows beneath water side mid-slope of breach section (22 July 2008).

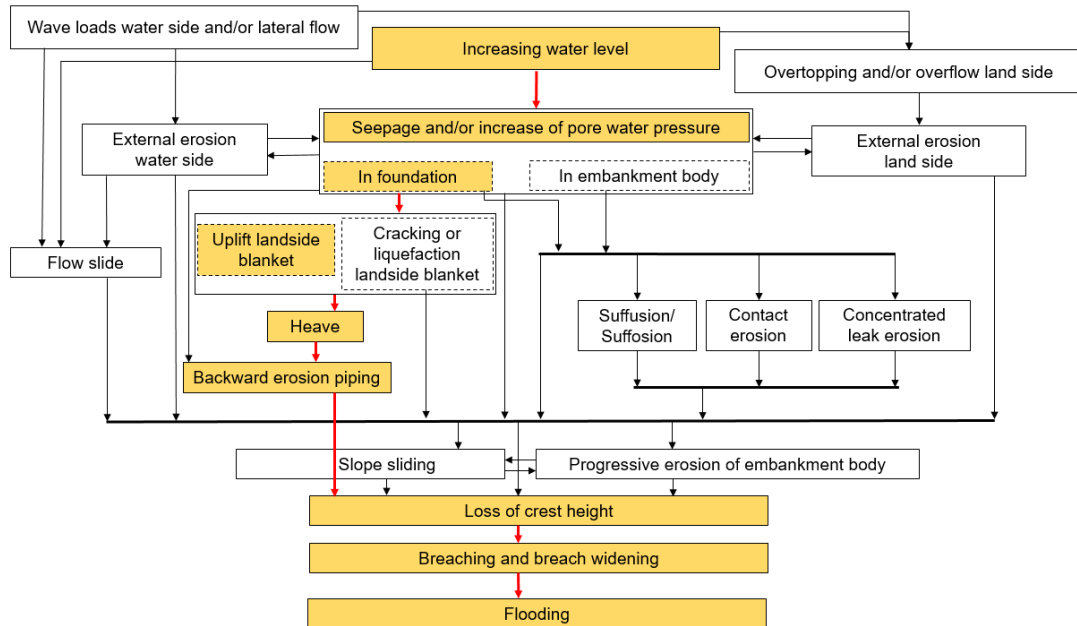
- Water level exceeded design level;
- Increased pressure on levee leading to underseepage evidenced by seepage on the land side slope;
- Numerous observations of collapses in seepage paths on the land side;
- Attempts to stop the seepage unsuccessful;
- Eventual breach of levee.

Figure 3.12 Failure tree of US L-575 levee breach, 2011.

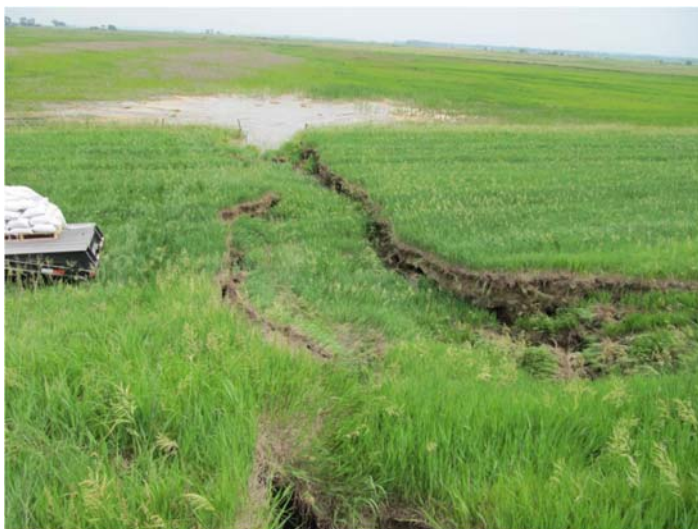
One of the breaches that occurred during the Missouri River flooding of 2011 occurred in the L-575 levee district which protects a large area of agriculture along with the city of Hamburg in southwest Iowa. The breach occurred in an area that had demonstrated several incidents of levee underperformance. Initial distresses, as shown in Figure 3.13 and Figure 3.14, narrowly avoided a full breach as the levee collapsed on itself, sealing off the underseepage path. Emergency repairs were initiated to reinforce this section of levee. The contractor and levee personnel were on site when the next distress appeared. There was a report of a “gurgling” sound, and then the levee collapsed on itself beginning from the protected side (land side) seepage berm and continuing toward the water side. As seen in Figure 3.14, an alluvial fan appeared at the protected side toe of the seepage berm. One additional incident (for 3 total) like this occurred before the final section of the levee breached. For all of these incidents, including the breach, there were a few meters of freeboard on the levee at that time.

Figure 3.14 Initial distress in levee L-575 showing alluvial fan.

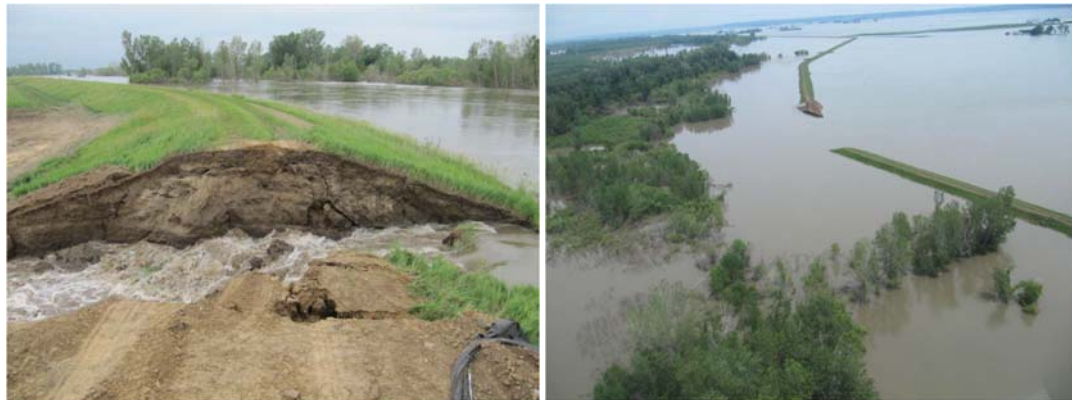
When the fourth incident occurred, the levee was not able to collapse on itself and seal the underseepage path. When Corps personnel arrived on-site several minutes after the breach was reported, the breach was about 3 m wide. While on-site, the breach continued to widen and deepen, Figure 3.15. The protected side continued to flood, eventually equalizing with the river as shown in Figure 3.15. Due to the forecasted water levels and the threat of breach due to the distresses showing up in the main stem levee, a temporary levee was built to protect the city of Hamburg. The temporary levee successfully held back the Missouri flood waters for the duration of the flood.

Figure 3.15 The initial breach of the levee L-575 (left), and the levee breach after complete interior flooding (right).

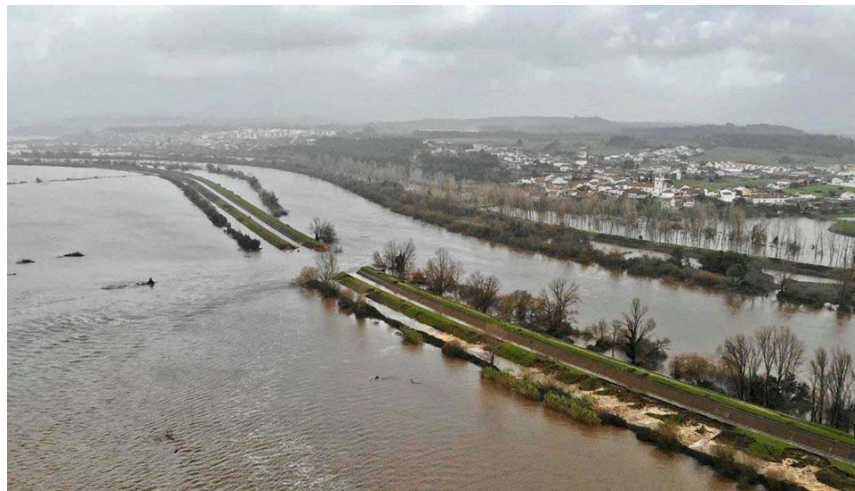
The causes of the failure are still being studied. Available information indicates that there was overtopping before the collapse.

The collapse led to the flooding of the fields in the Central Valley of the Lower Mondego and the cutting of communication routes. Infrastructure was severely damaged, not only the embankment but also the road and the conducting channel at the right bank, for the water supply of agriculture and industries.

Figure 3.21 View of Santo Varão after collapse of the embankment ⁵.

A plan is currently under development to reinforce the Mondego embankments. This plan will consist of integrated solutions, to be implemented in the coming years.

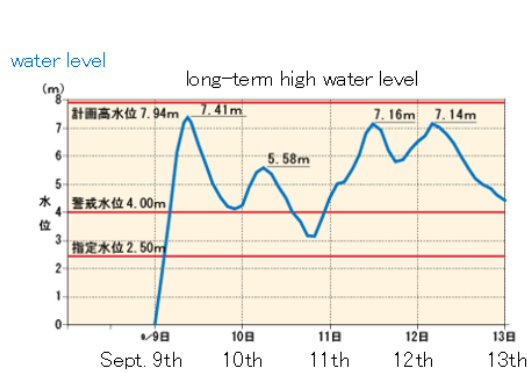
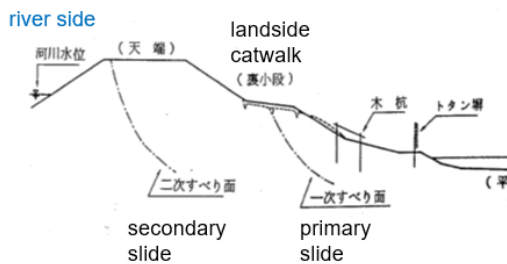
Failure time tree and the process were written down; from cracking to secondary large slide.

- ✓ Sept. 12th, 06:30 --- crack in landside catwalk
- ✓ Sept. 12th, 07:40 --- a crack line in the center of landside catwalk, paralleled to levee
- ✓ Sept. 12th, 08:10 --- two crack lines of landside catwalk: the lengths of 40cm, 60cm and the width of 5-10cm
- ✓ Sept. 12th, 09:10 --- herbicidal works
- ✓ Sept. 12th, 09:30 --- levee protection works with pile driving. Growth of cracks with level difference of 50cm on landside catwalk
- ✓ Sept. 12th, 10:20 --- Primary slide on landside catwalk, and then secondary slide from levee crown in a couple of minutes.
- ✓ Secondary slide and inflow of river water....breach

Figure 3.24 Example of slope slide from the presentation 'Picture-Card Show Project' in JGS-JSCE by K. Maeda, M. Ishihara and H. Mori, using materials from the Ministry of Land, Infrastructure, Transport and Tourism in Japan.

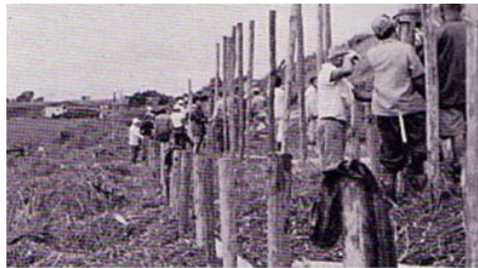
Figure 3.25 illustrates the protection works that were installed as well as the situation following the breach.

Just after
breach

Figure 3.25 Example of slope slide from the presentation 'Picture-Card Show Project' in JGS-JCES', contribution by K. Maeda, M. Ishihara and H. Mori, using materials from the Ministry of Land, Infrastructure, Transport and Tourism in Japan.

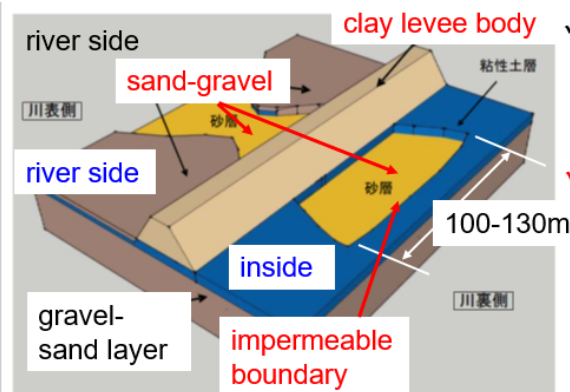
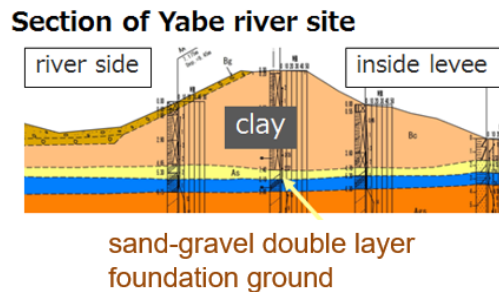
✓ The river water flow was concentrated in sand-gravel base layers during 5 hours. "piping": scouring in base layer, and collapse and fall of levee body.

✓ Levee body is clay. Base layer of levee is almost clay, but in some locations, sand-gravel parts exits in narrow parts of base layers.

Figure 3.28 Example of piping erosion from the presentation 'Picture-Card Show Project' in JGS-JCES', contribution by K. Maeda, M. Ishihara and H. Mori, using materials from the Ministry of Land, Infrastructure, Transport and Tourism in Japan.

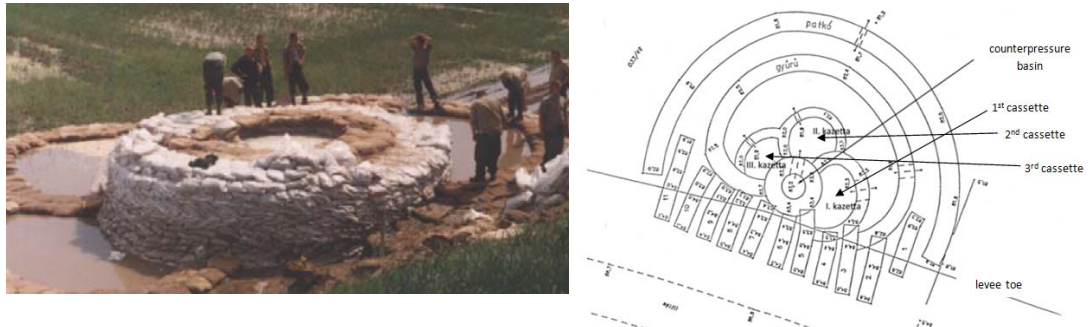
A secondary sand boil arose with a quite strong blow-up under the counter-pressure basin around 3:00 pm. Therefore, the water level in the counter pressure basin, which was already built up, lowered almost by 0.5m in a few minutes. The power of the blow-up was very concerning. Construction of the counter-pressure basin of the first cassette was carried out by soldiers and civils, its walls were 3 sandbags wide and 8 high. The basin of the first cassette fitted the previous semi-circumference shaping. Then, there was a need for building a new counter pressure basin (2nd cassette) in order to prevent another failure (see Figure 3.39).

Figure 3.39 Counterpressure basin for related cassettes (left) and location of sand cassettes (right).

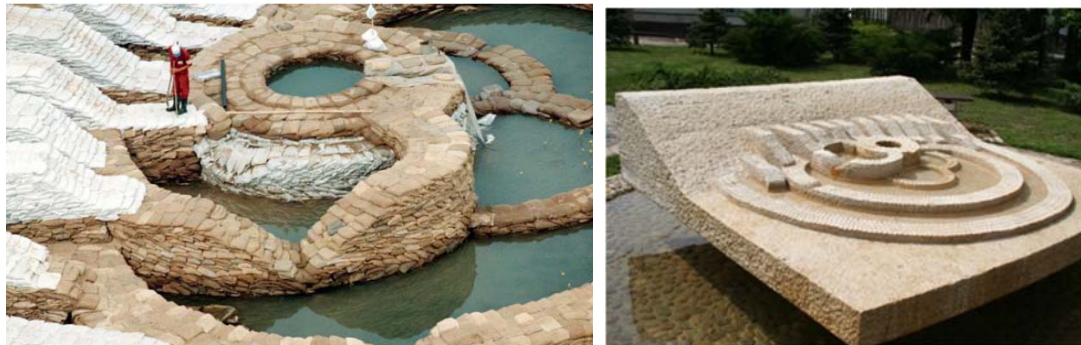
The sand boil of Tizsasas proved that the big as well as the medium-sized sand boils always need to be constantly observed and measured. These measurements must be analysed. A decision can only be made based on the observations. The measurement possibilities are limited regarding the fact that the stability of the levee cannot be endangered. Therefore, possible measurements are: observation of the surface like the blurriness of the water of the counter pressure basin, the temperature and amount of the leaking water, the amount of eroded soil from the counter pressure basin as well as its development in time. The behaviour of the levee must be valued based on these factors. Probably the great sand boil of Tizsasas is the only one in the world which has a Memorial (see Figure 3.41).

Figure 3.41 Tiszasas sand boil on 1st of May (left) and memorial of Tiszasas sand boil (right).

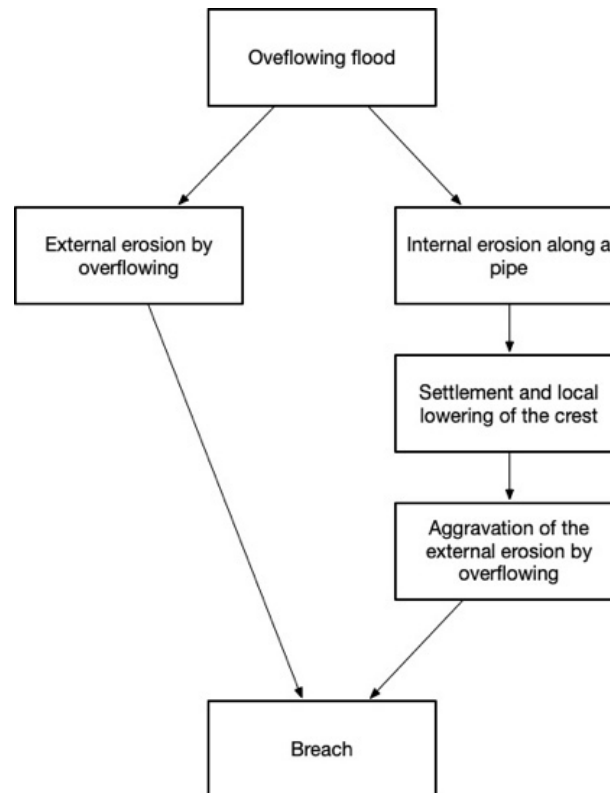
Figure 3.50 Failure path for the 1999 Agly breach (Rémy Tourment).

The 1999 breach has been caused by overflow at the location of the waste water treatment plant where internal erosion along a pipe crossing the levee also took place. This pipe probably aggravated the situation, because many other parts of the levee also were damaged by overflow but did not breach. Figure 3.50 shows this in the form of a diagram. It is even possible

that the two main mechanisms (external erosion and internal erosion) had some interaction and mutually furthered themselves, as both external erosion and internal erosion have a negative effect (saturation) on the remaining part of the levee and so aggravate the vulnerability of the material to the other mechanism.

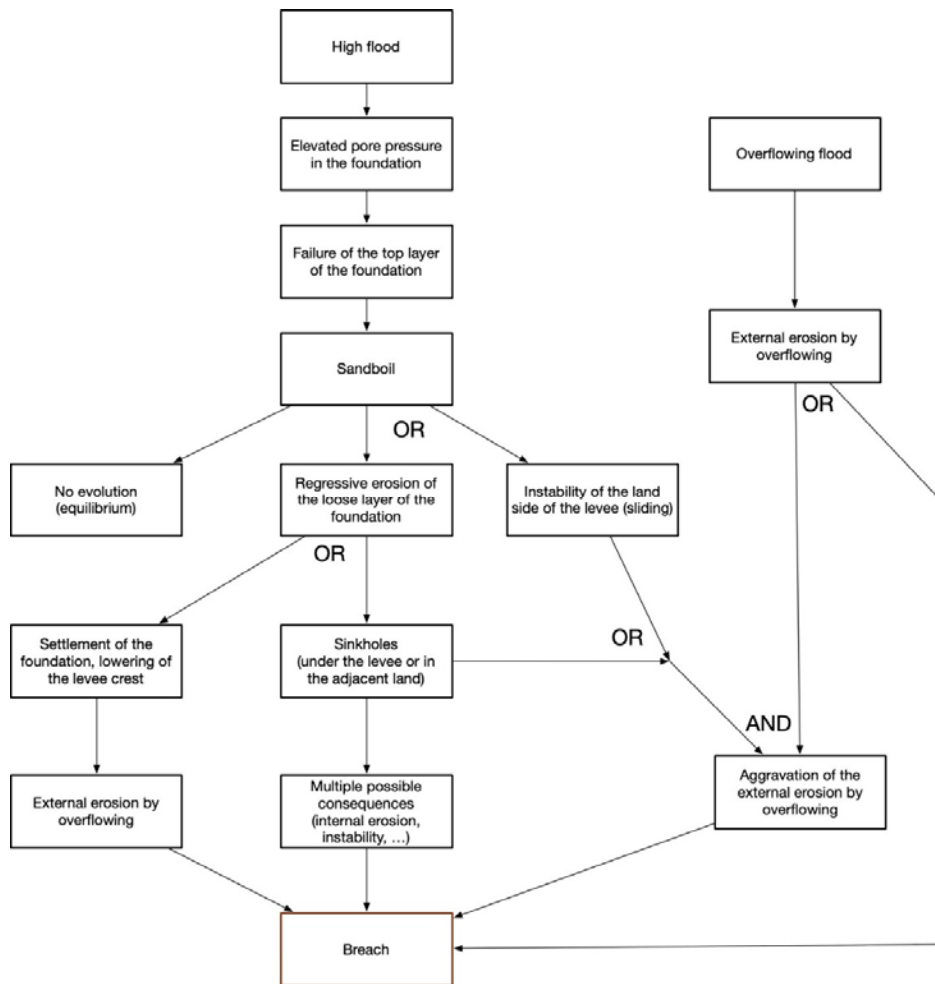
Figure 3.53 Failure tree involving a sand boil (Rémy Tourment).

Figure 3.53 was developed based on the analysis of the various observed damages in relation to the sand boils, using expert analysis. However, for actual cases not all damages lead to the final step of a breach as the condition for continuation to the next step is not always met.

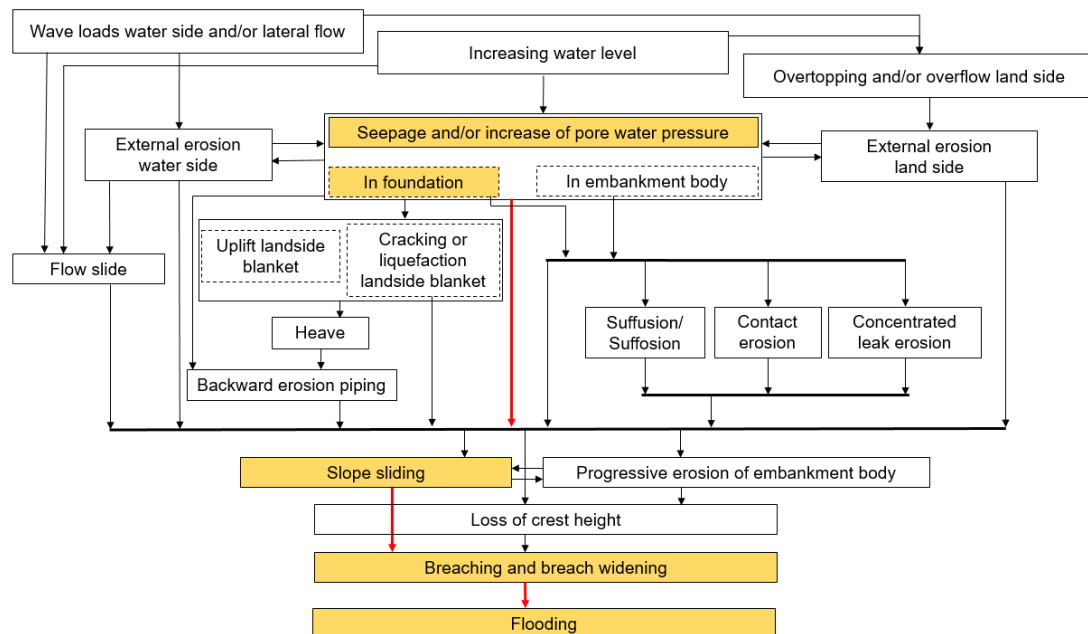
Figure 3.54 Failure tree of Wilnis levee breach, 2003.

- Increase of water pressures in base:
 - In tensile cracks along sheet pile (cracks affected by shrinkage and pore water pressure);
 - Presence of locally more permeable silt layer in foundation peat layers conducting water along cracks to foundation.
- Slope sliding
 - Extremely dry conditions leading to weight loss and shrinkage of peat embankment;
 - Higher pore water pressure in foundation due to shrinkage at sheet pile and enhanced by presence of local silt layer;
 - Discontinuities present from past land use.
