## FIELD TESTING OF THE OVERFLOW EROSION OF RHONE RIVER LEVEES

Key words: Levee, Overflow, Erosion, Field test.

**Summary.** It is important to quantify the soil resistance against erosion caused by the overflow of dikes and levees. Small-scale tests are not recommended, as they do not provide a correct representation of the actual soil in place and do not take into account the geometry of the structure. For this reason, the National Research Institute for Agriculture, Food and Environment (INRAE) developed an on-site overflow device in 2015. The procedure followed is based on ASTM-D6460 standard. Two tests were performed in May 2022 on a Compagnie Nationale du Rhône (CNR) dike near Avignon (France). The dike is 6.2 m high; the core is mainly made of sandy silts. The toe is covered by a gravel shoulder which forms a berm. The first test was carried out on the intact soil: the core covered by a natural grass on the upper part, and the gravel fill without grass in the lower part of the slope. The test consisted of carrying out a flow in a channel of 1 m wide and 25 m long, in 12 steps of 30 min (6 hours of flow in total). The second test was carried out on the soil stripped of the

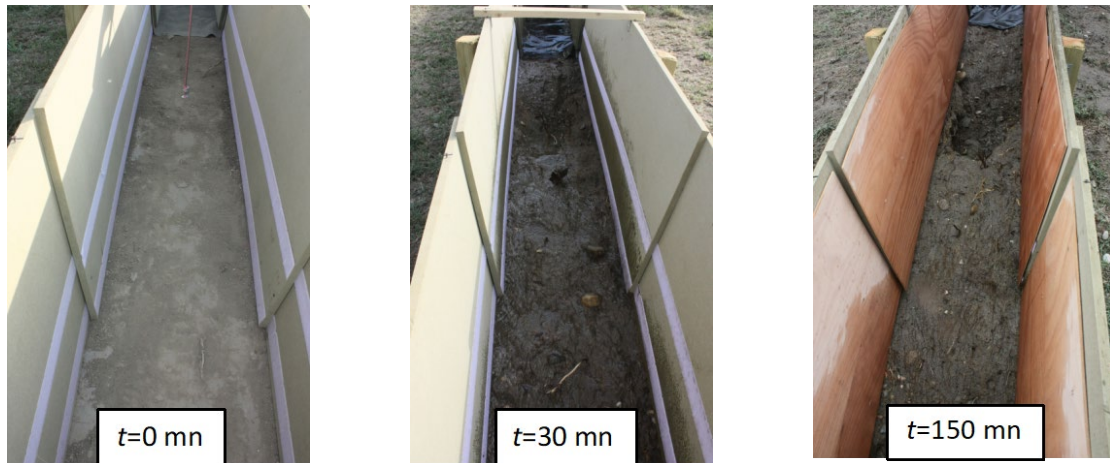
The soil before testing is visible in Figure 11. After 30 minutes of flow at  $q=24.0$  l/s/m and  $h_0 = 5.7$  cm, the visible erosion corresponds to that of the surface soil, which is not significant. The initiation of a scouring (Figure 11) is probably due to the fact that the flow has a locally high velocity at the outlet of the geomembrane. This result will allow to quantify the erosion threshold from the velocity measurements at this location. After 90 min of flow at  $q=24.0$  l/s/m and  $h_0 = 5.7$  cm, and 60 min of flow at  $q=43$  l/s/m and  $h_0 = 11.8$  cm, surface erosion is a few cm and scouring is more significant (Figure 11).

**Figure 11.** Erosion of compacted sandy silt, between  $t = 0$  and  $t = 150$  min (channel 1).

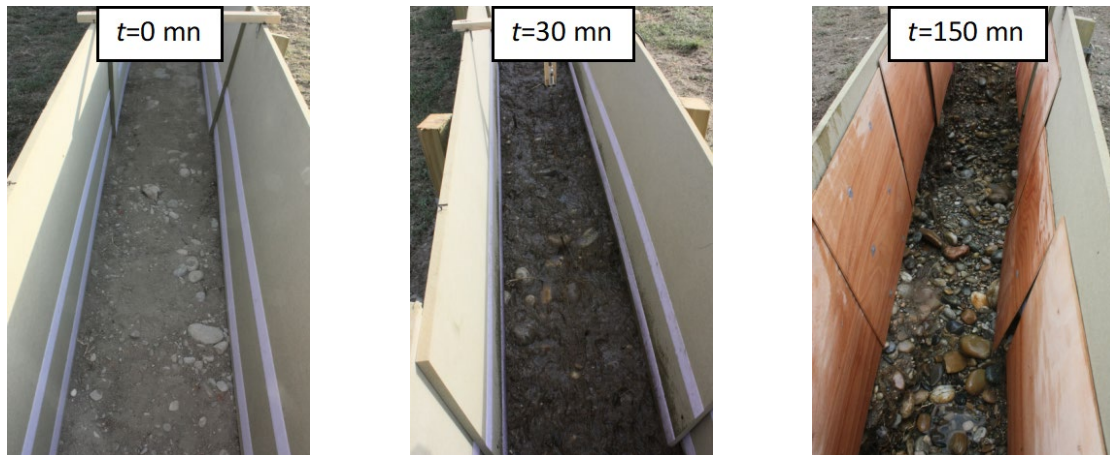
This analysis concerns channel 2. The soil before testing is visible in Figure 12. Significant surface erosion was observed from the first flow stage, corresponding to  $q=24.0$  l/s/m, and  $h_0 = 5.7$  cm (Figure 12). After 90 min of flow at  $q=24.0$  l/s/m and  $h_0 = 5.7$  cm, and 60 min of flow at  $q=43$  l/s/m and  $h_0 = 11.8$  cm, surface erosion reaches 20 to 30 cm (Figure 12). The visible soil corresponds to the coarse fraction, the fines having been washed away.

**Figure 12.** Erosion sandy gravel, between  $t = 0$  and  $t = 150$  min (channel 1).

Erosion of the sandy gravel formed a step with the sandy silt, located 8.70 m from the crest at  $t=30$  min. This step then regressed to 3.20 m from the crest. This evolution is probably more responsible for the departure of the sandy silt (by mechanical instability), than the surface erosion of the silt itself.
