Field testing of the overflow erosion of Rhone river levees

Christophe Picault, Fabrice Crampette, Stéphane Bonelli, Sylvie Nicaise, Naïm Chaouch, et al.. Field testing of the overflow erosion of Rhone river levees. 4th Int Seminar on Dam Protections against Overtopping, Nov 2022, Madrid, Spain. pp.1-13. hal-03924594

FIELD TESTING OF THE OVERFLOW EROSION OF RHONE RIVER LEVEES

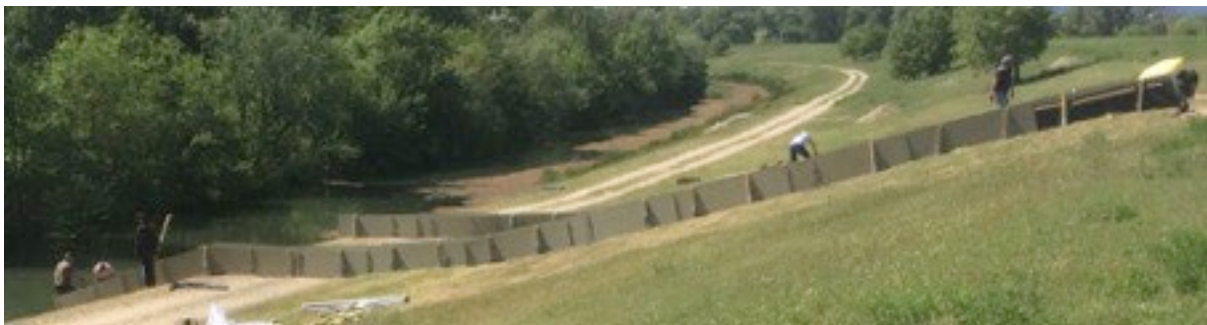
Figure 3. View of the two test channels. Channel 1 is in the foreground.

Two hydraulic channels were built. Channel 1 is laid out on the intact ground. It is 0.60 m high, 1.00 m wide and 25.00 m long (Figure 2a). This channel allows flow to be applied to the vegetal cover and the gravel fill. Channel 2 is laid out on the soil previously stripped of the vegetal cover to a depth of 20 to 25 cm. It is 0.60 m high, 0.60 m wide and 20.00 m long (Figure 2a). This channel allows flow to be applied to the constitutive soil of the dike, especially the compacted silt and the sandy gravel. A buffer tank is located on the crest between the discharge point of the pumping system and the inlet of each channel. The test channels lead to the counter-channel (at the toe of the embankment) that houses the pumps, which makes it possible to operate in a closed circuit.
