Field testing of the overflow erosion of Rhone river levees

Christophe Picault, Fabrice Crampette, Stéphane Bonelli, Sylvie Nicaise, Naïm Chaouch, et al.. Field testing of the overflow erosion of Rhone river levees. 4th Int Seminar on Dam Protections against Overtopping, Nov 2022, Madrid, Spain. pp.1-13. hal-03924594

FIELD TESTING OF THE OVERFLOW EROSION OF RHONE RIVER LEVEES

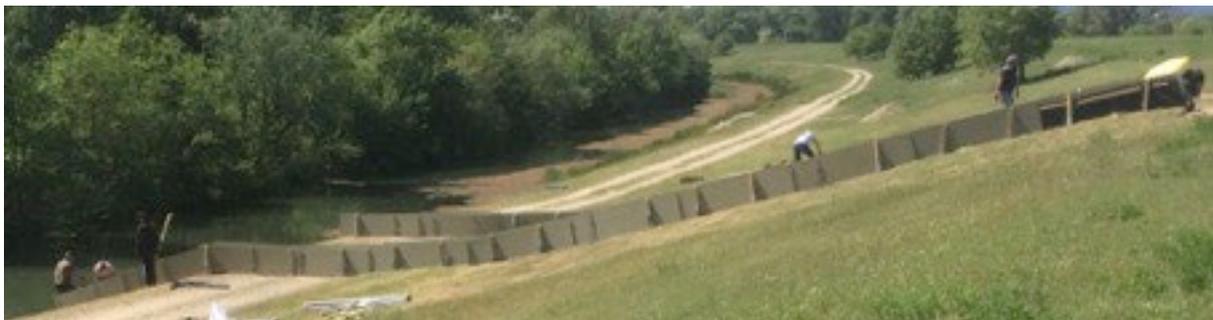
Figure 3. View of the two test channels. Channel 1 is in the foreground.

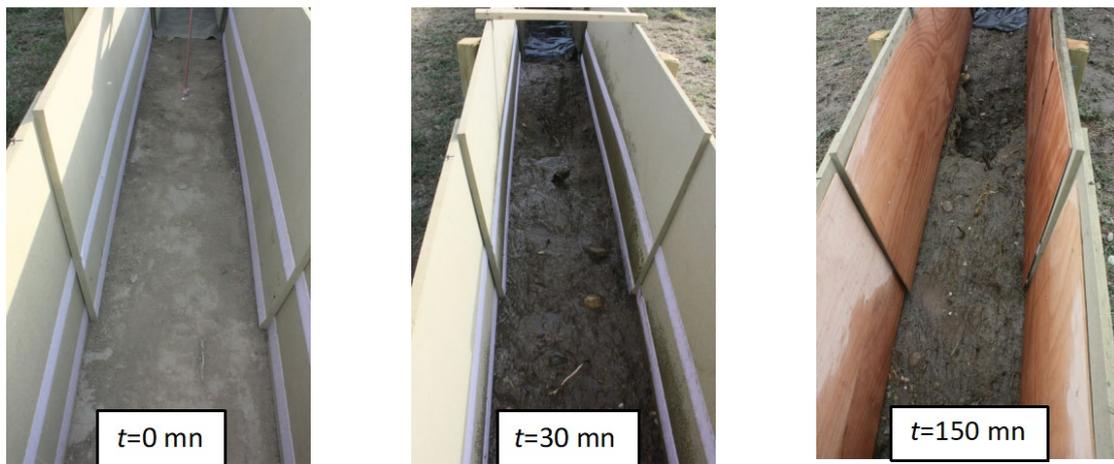
Figure 11. Erosion of compacted sandy silt, between $t = 0$ and $t = 150$ min (channel 1).

The soil before testing is visible in Figure 11. After 30 minutes of flow at $q=24.0$ l/s/m and $h_0 = 5.7$ cm, the visible erosion corresponds to that of the surface soil, which is not significant. The initiation of a scouring (Figure 11) is probably due to the fact that the flow has a locally high velocity at the outlet of the geomembrane. This result will allow to quantify the erosion threshold from the velocity measurements at this location. After 90 min of flow at $q=24.0$ l/s/m and $h_0 = 5.7$ cm, and 60 min of flow at $q=43$ l/s/m and $h_0 = 11.8$ cm, surface erosion is a few cm and scouring is more significant (Figure 11).
