## **Influence of Fe content on the damage mechanism in A319 aluminum alloy: Tensile tests and digital image correlation**

Zaidao Li, Nathalie Limodin, Amina Tandjaoui, Philippe Quaegebeur,  
Jean-François Witz, David Balloy

**Abstract:** In order to study the role of Fe content on the damage mechanisms of Al–Si–Cu alloy on a microstructural level, a Digital Image Correlation (DIC) method has been developed and performed on two Al–Si–Cu alloys: a high-Fe alloy (0.1 wt.% Fe) and a low-Fe alloy (0.8 wt.% Fe). Tensile tests on flat specimens have been performed, and a Questar long distance microscope has been used for the in-situ observation during tensile tests. The field measurements allow to identify and track the development and localization of deformation, and the fracture surfaces of the tensile specimens are analyzed using Scanning Electron Microscopy and Energy-Dispersive X-ray spectrometry (SEM-EDX) to identify the damage mechanisms. The results show that crack initiation occurs through the fracture of hard inclusions, i.e. Si particles, iron-intermetallics and Al<sub>2</sub>Cu particles in the high stress concentration region. Cracks often propagate through the fracture of

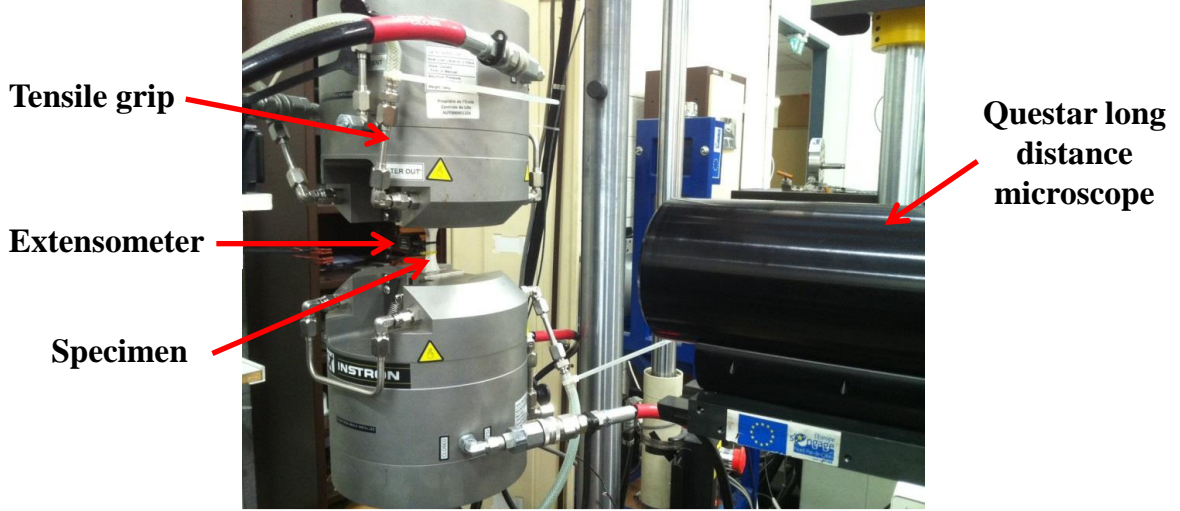
Figure 2: Experimental set-up with Questar microscope.

In order to record the deformation images during the tensile tests, the test was interrupted at different loading steps. The images were taken using a JAI 500 CCD camera with a resolution of 2048 $\times$ 2048 pixels and fitted with a long-distance microscope (Questar QM100). The camera was mounted on a translation stage perpendicular to the tensile test set-up. Digital pictures were taken in several adjacent zones of the ROI with a pixel size of about 0.23/0.27  $\mu\text{m}$  in order to cover the area of interest (see Figure 1). Stitching of the images acquired at each loading step was performed using the plugin MosaicJ in Image J software [16] which allows rigid registration of images. An appropriate overlap between
