Managing erosion of mangrove-mud coasts with permeable dams – lessons learned

Johan Winterwerp, Thorsten Albers, Edward J. Anthony, Daniel Friess, Alejandra Gijón Mancheño, et al.. Managing erosion of mangrove-mud coasts with permeable dams – lessons learned. Ecological Engineering, 2020, 158, pp.106078. 10.1016/j.ecoleng.2020.106078 . hal-03222423

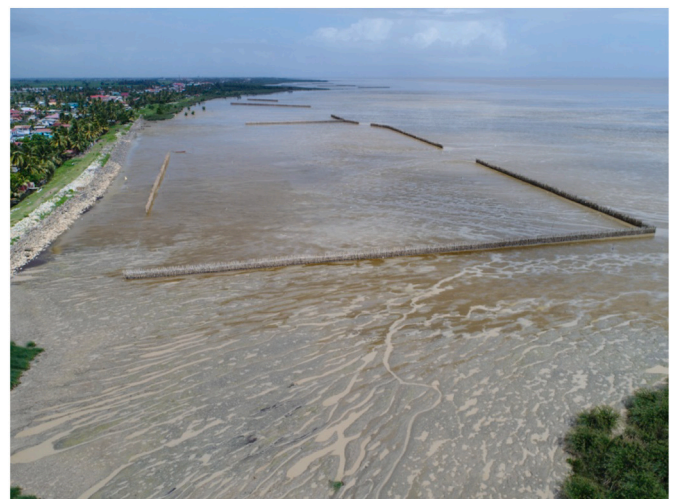
Fig. 4. Mangrove recolonization along Guyana coast, east of Georgetown, 2019.

was similar to the descriptions in Section 4. Figure 4 shows an aerial photo of some of the dams erected near Georgetown. The dams near Georgetown did not have durable results. However, along the left bank of the Essequibo River (Anna Regina and Devonshire Castle, west of Georgetown) 1.5 – 2 m siltation was monitored behind a 100 m long dam between 2013 and 2016. The higher siltation rate yielded bed levels a bit higher than the optima for mangrove rehabilitation. Part of the mangrove planting took place on these deposits.

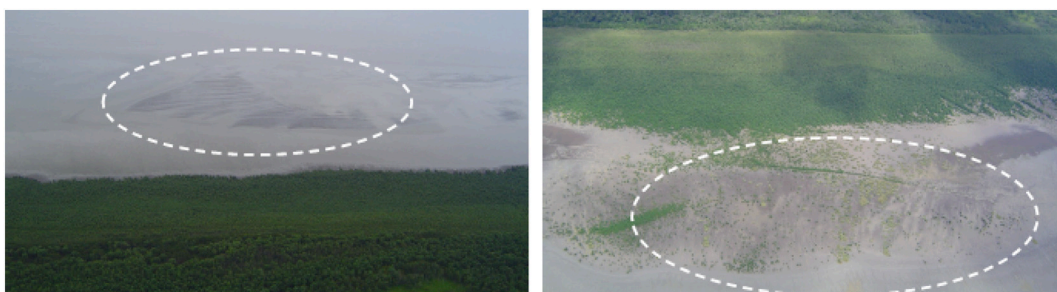
Fig. 3. Mangrove recolonization along the Guyana coast synchronizing with a migrating mudbank (dotted white ellipse).

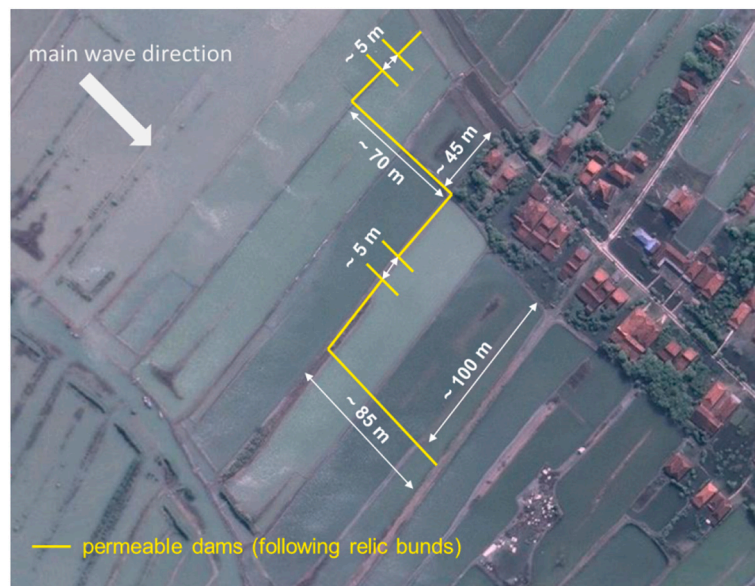
Fig. 5. First permeable dam pilot project in Indonesia in 2013, Bogorame, Demak.

Two sedimentation basins were created by erecting permeable dams on the lost lands at the head of Bogorame, as this part of the village was severely at risk to erosion and flooding. Fig. 5 shows the remnants of the bunds previously forming the now-lost aquaculture ponds. The

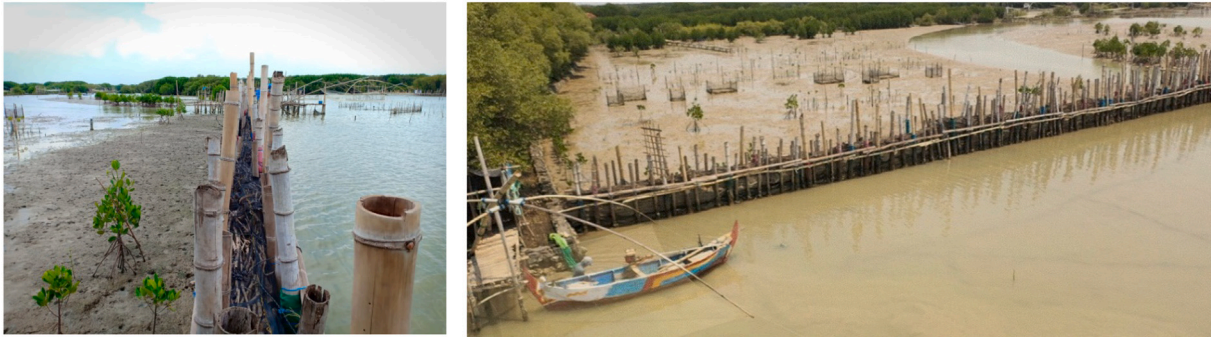
Fig. 7. 2019 sedimentation patterns, Bogorame, Demak, Java, Indonesia, photos December 2019 and January 2020.

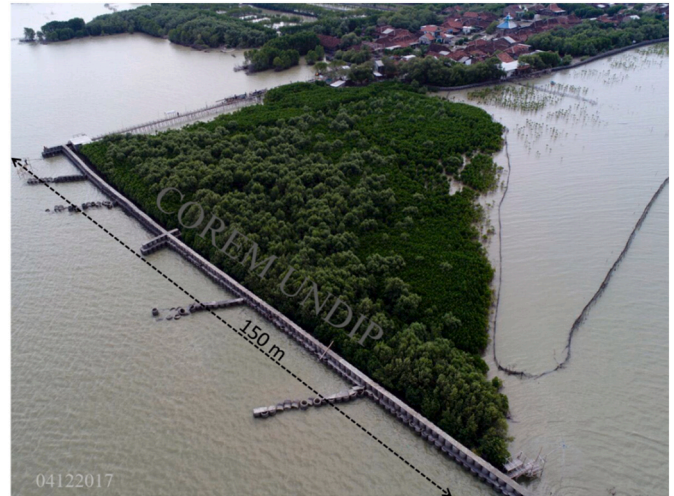
Fig. 9. APO, concrete seawall at Timbul Sloko, Demak, Indonesia (courtesy COREM-UNDIP) with natural colonization by *Avicennia* (high vegetation) and planted *Rhizophora* (low vegetation).

Prior to the construction of permeable structures, a 150 m long seawall was built in Timbul Sloko using concrete cylinders. This seawall is locally known as the APO (Fig. 9), located along the original, pre-erosion coastline. Sedimentation behind the APO up to MSL took place in about two years, and one year later the first *Avicennia* seedlings were

observed. After that, the local community planted *Rhizophora* as well. In 2020, a mature, many meter high mangrove canopy has developed with both species, as shown in Fig. 9. As the APO is highly reflective, considerable scour took place in front, prohibiting seaward extension of the mangrove forest. Moreover, the APO is becoming unstable over time and some of its supporting structures have already collapsed. It is however a question whether a complete collapse of the APO would be problematic. The pile of concrete rubble would continue to dissipate wave energy, and the mangroves behind may well survive. If integrated with the coast behind, the construction of temporary hard structures, collapsing in a managed way, may therefore form an option in heavily degraded coastal systems, where waters are too deep for the application of permeable dams. Seaward extension of the coastline would then, of course, no longer be possible.

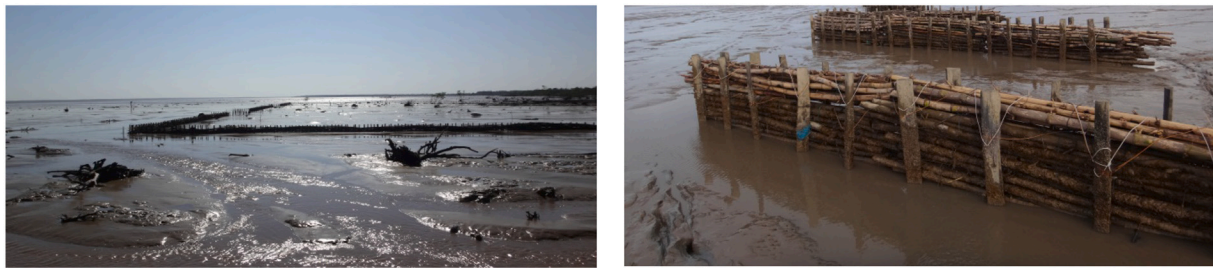
Fig. 11. Permeable dams constructed near Weg naar Zee, north of Paramaribo, Suriname (photos by E. Van Lavieren).

series of permeable dams were constructed, as shown in Fig. 11, the locations of which are indicated in Fig. 10. Next to these constructions, a small-scale mangrove replanting program was executed in 2018. This work was mainly aimed at involving local stakeholders in mangrove rehabilitation efforts, and no systematic monitoring program was executed.

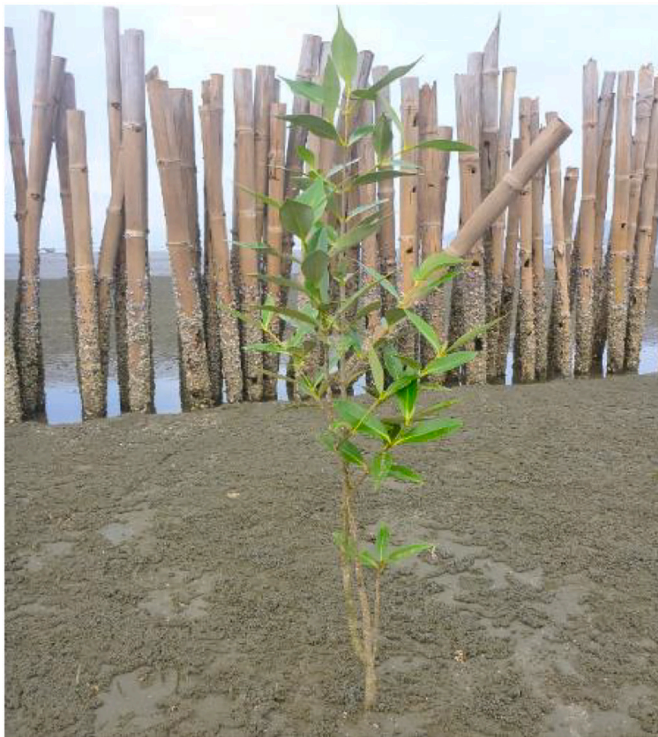
Fig. 14. Sedimentation and *Avicennia marina* behind the bamboo fence on Klang Island, Thailand.

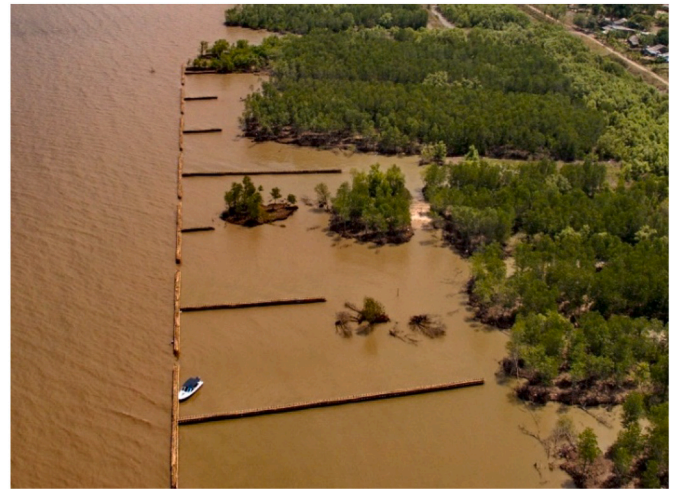
Fig. 16. Wave dampening effect of bamboo T-dams in Ca Mau Province, Viet Nam (courtesy R. Sorgenfrei, 2016).

Two designs were tested in Soc Trang, a double row of bamboo fences filled with soft and another filled with stiff brushwood bundles. Wave measurements to quantify wave transmission through the permeable dams were carried out over a period of approximately six months to cover various storm and tidal conditions. Pressure transducers were used to measure wave heights at two positions on the seaward and landward side of the bamboo dam, each about 5 m from the dam. The wave data were analysed and summarised in significant wave heights of 15-min periods (Schmitt et al., 2013), see Section 3.3 for the results. Flexible bundles were found more efficient in damping waves than stiff bundles; these can induce up to 80% reduction of the incoming wave height.

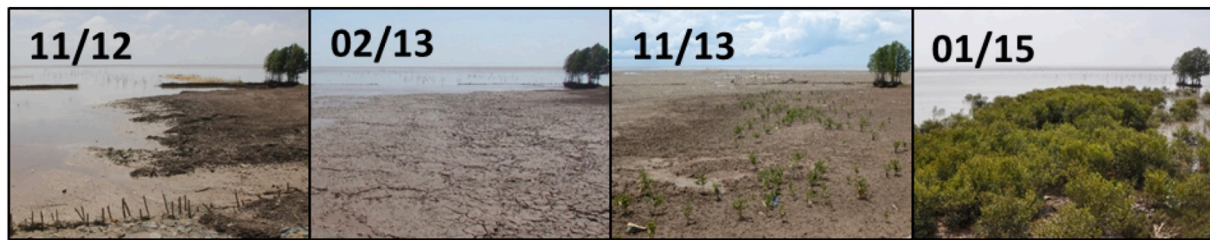
Fig. 17. Natural regeneration of *Avicennia* on restored floodplains in Soc Trang Province from the construction of the T-fences in October 2012 until January 2015 (Photos: GIZ Soc Trang, R. Sorgenfrei).

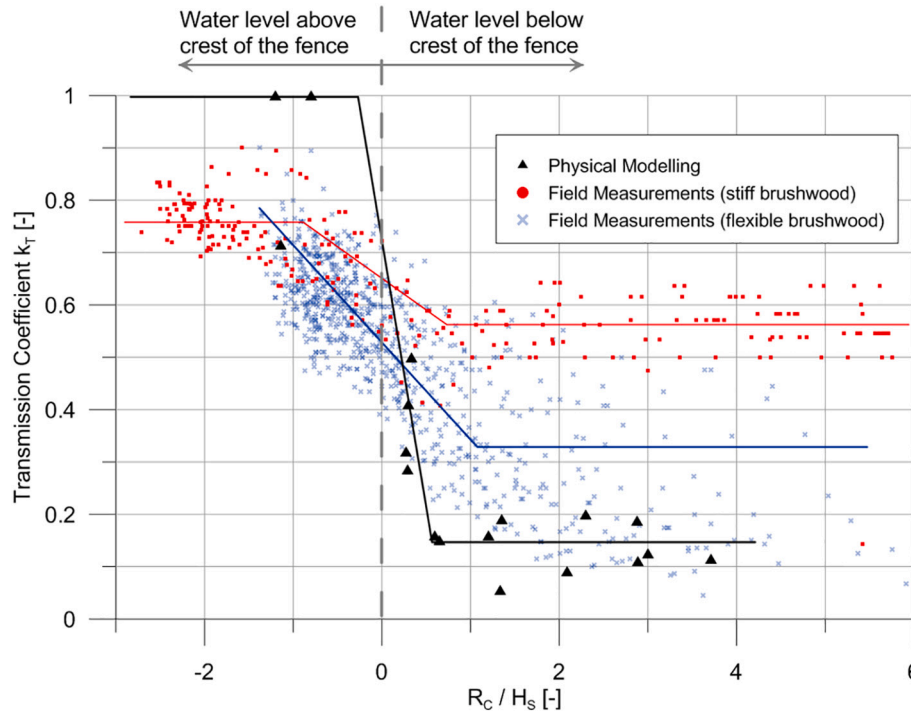
Fig. 19. Wave transmission coefficients of bamboo fences under various hydrological conditions (modified after Albers et al., 2013).

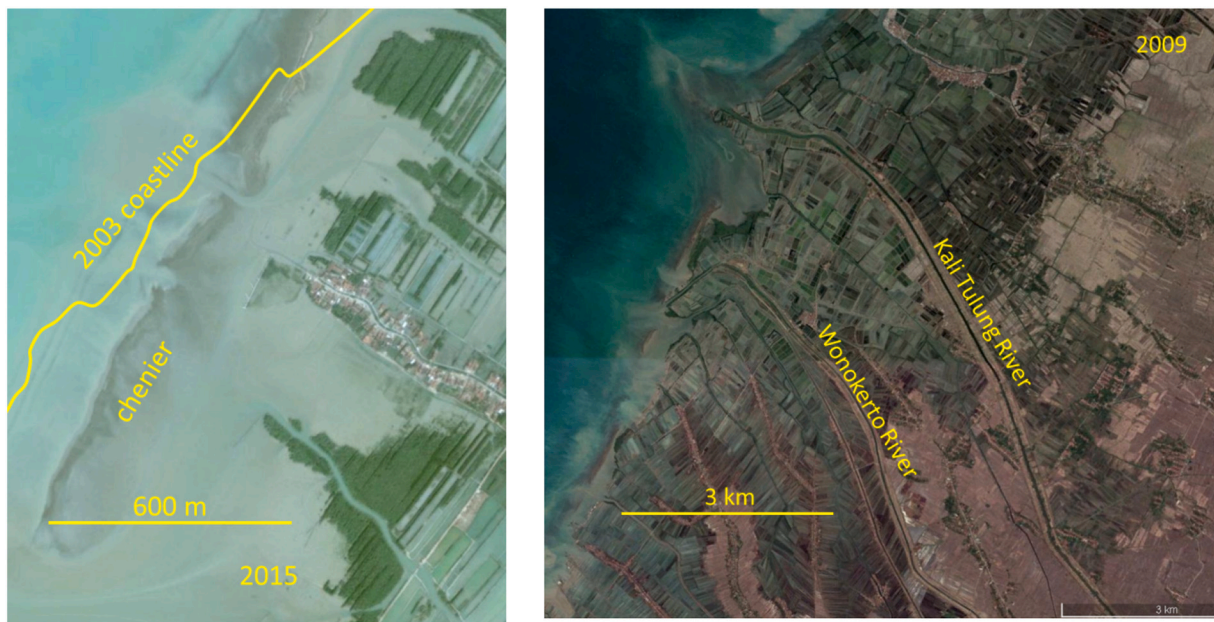
Fig. 26. Example of chenier formation Demak, Indonesia (Google Earth image) by (a) self-organization of eroded coastal sediment and (b) riverine sand input.

The formation and dynamics of cheniers and their migration are largely unknown. Tas et al. (2020) collected data on chenier dynamics, mainly under quiet hydrodynamic conditions (0.2 m waves). They tested some hypotheses with mathematical models, and it is postulated that the large tidal volume behind this chenier presumably augments its dynamics largely. However, no data could be collected during storm conditions. Fig. 27 exhibits the importance of such storm conditions, showing how a cheniers moved about 100 m onshore within one to two weeks. Likely, its further migration is blocked by the permeable dam.

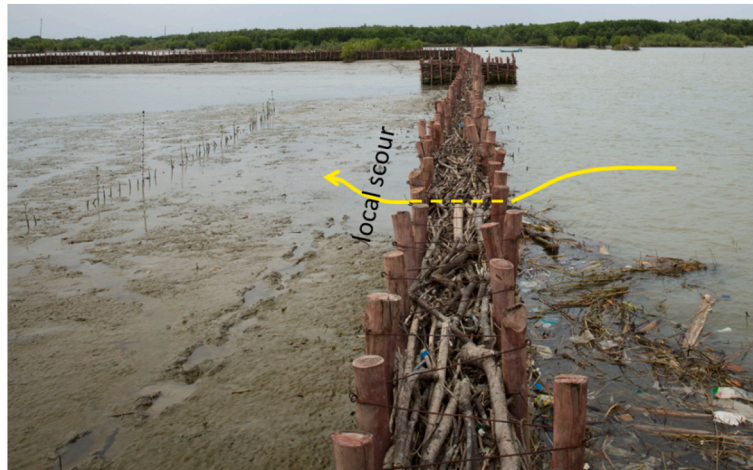
Fig. 29. Example of local scour by near-bed currents underneath loose brushwood, coastal restoration works in Bogorame, Demak, Indonesia.

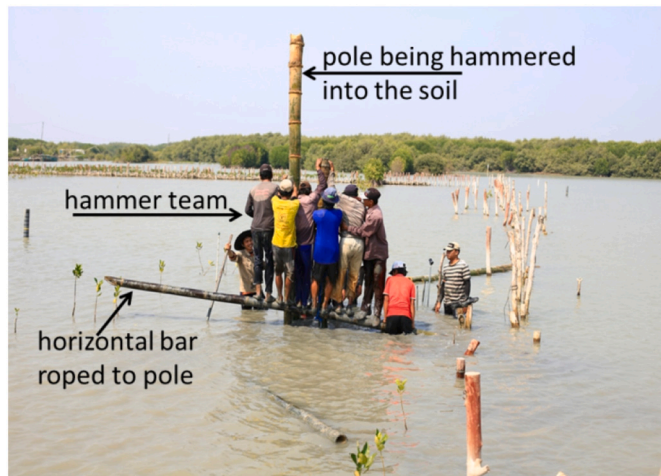
Fig. 32. Hammer team at work to place bamboo pole, Bogorame, Demak, Indonesia.

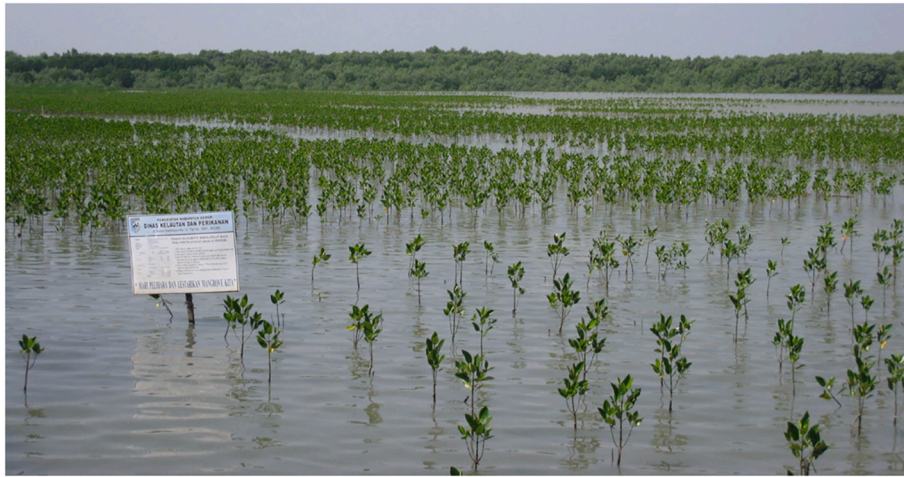
Fig. 33. *Rhizophora* planted on mud flat.

Overall, mangrove replanting is often done with red mangrove propagules, irrespective of habitat suitability (Fig. 33). As a

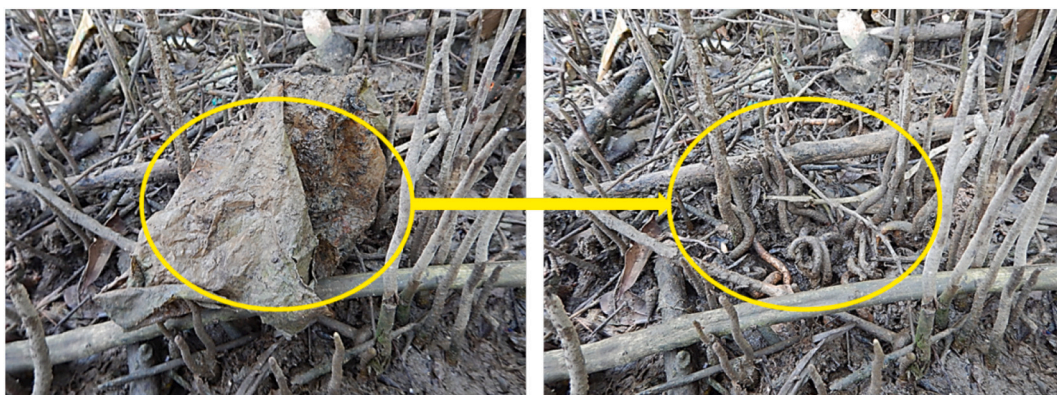
Fig. 34. Example of root degeneration/deformation in response to suffocation by plastic (Demak, photo C. Van Bijsterveldt).
