Managing erosion of mangrove-mud coasts with permeable dams – lessons learned

Johan Winterwerp, Thorsten Albers, Edward J. Anthony, Daniel Friess, Alejandra Gijón Mancheño, et al.. Managing erosion of mangrove-mud coasts with permeable dams – lessons learned. *Ecological Engineering*, 2020, 158, pp.106078. 10.1016/j.ecoleng.2020.106078 . hal-03222423

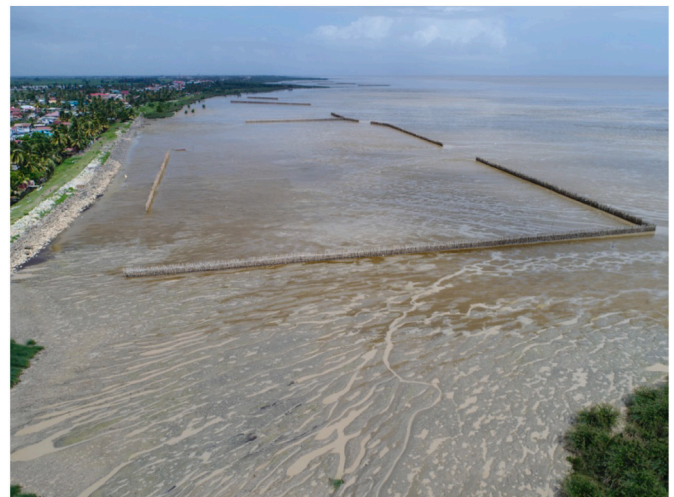
Fig. 4. Mangrove recolonization along Guyana coast, east of Georgetown, 2019.

was similar to the descriptions in Section 4. Figure 4 shows an aerial photo of some of the dams erected near Georgetown. The dams near Georgetown did not have durable results. However, along the left bank of the Essequibo River (Anna Regina and Devonshire Castle, west of Georgetown) 1.5 – 2 m siltation was monitored behind a 100 m long dam between 2013 and 2016. The higher siltation rate yielded bed levels a bit higher than the optima for mangrove rehabilitation. Part of the mangrove planting took place on these deposits.

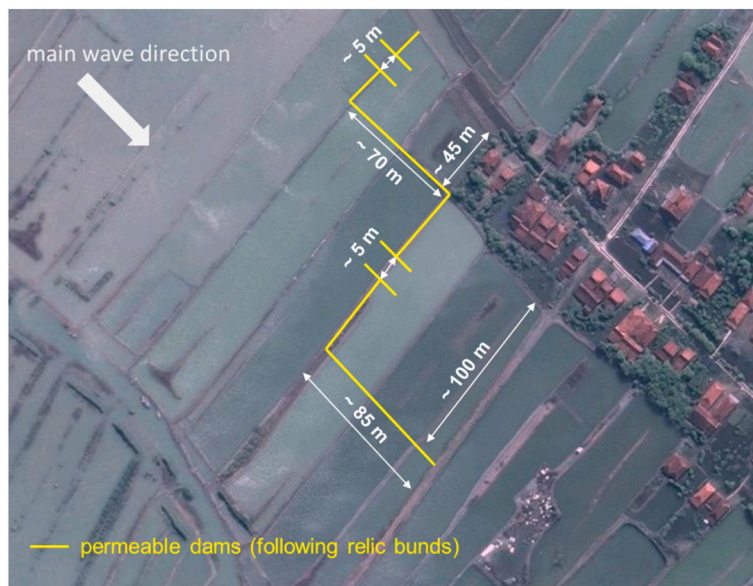
Fig. 5. First permeable dam pilot project in Indonesia in 2013, Bogorame, Demak.

Two sedimentation basins were created by erecting permeable dams on the lost lands at the head of Bogorame, as this part of the village was severely at risk to erosion and flooding. Fig. 5 shows the remnants of the bunds previously forming the now-lost aquaculture ponds. The

permeable dams were placed on top of these remnants, as they form a stable underground, reducing the risks of local scour. Construction of the dams was finished in November 2013. Fig. 6 presents the measured sedimentation volumes in the two sedimentation basins, showing a mean sedimentation rate of about 0.5 m in the four most dynamic months, whereas elsewhere erosion continued. Based on these promising results, many more dams were constructed in Demak coastal area with a total length of more about 13.5 km, built and funded by various partners, with slightly modified designs, while still based on best engineering practices. Simultaneously, an extensive monitoring and basic research program was set up, in conjunction with a socio-economic development program with the local stakeholders (see Section 5).

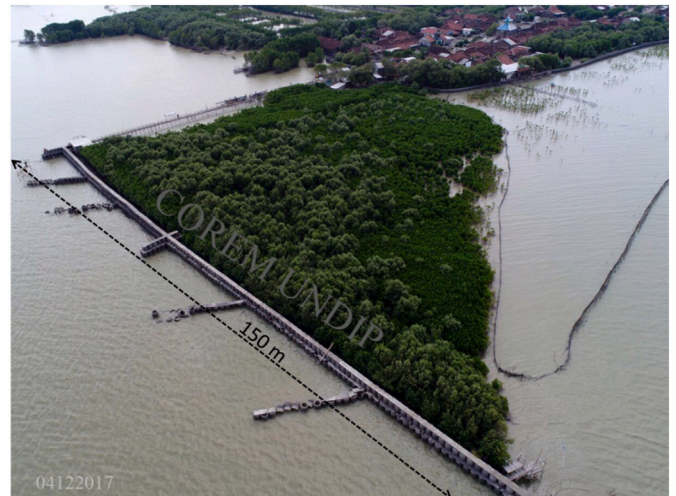
Fig. 9. APO, concrete seawall at Timbul Sloko, Demak, Indonesia (courtesy COREM-UNDIP) with natural colonization by *Avicennia* (high vegetation) and planted *Rhizophora* (low vegetation).

Prior to the construction of permeable structures, a 150 m long seawall was built in Timbul Sloko using concrete cylinders. This seawall is locally known as the APO (Fig. 9), located along the original, pre-erosion coastline. Sedimentation behind the APO up to MSL took place in about two years, and one year later the first *Avicennia* seedlings were

observed. After that, the local community planted *Rhizophora* as well. In 2020, a mature, many meter high mangrove canopy has developed with both species, as shown in Fig. 9. As the APO is highly reflective, considerable scour took place in front, prohibiting seaward extension of the mangrove forest. Moreover, the APO is becoming unstable over time and some of its supporting structures have already collapsed. It is however a question whether a complete collapse of the APO would be problematic. The pile of concrete rubble would continue to dissipate wave energy, and the mangroves behind may well survive. If integrated with the coast behind, the construction of temporary hard structures, collapsing in a managed way, may therefore form an option in heavily degraded coastal systems, where waters are too deep for the application of permeable dams. Seaward extension of the coastline would then, of course, no longer be possible.

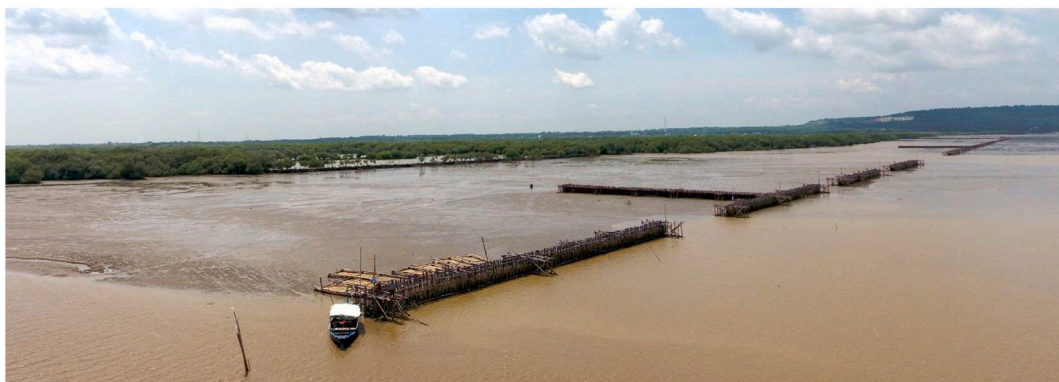
Fig. 8. Example of permeable dams in Gresik Regency, close to Solo River, Java, Indonesia (photo by MMAF early 2019).

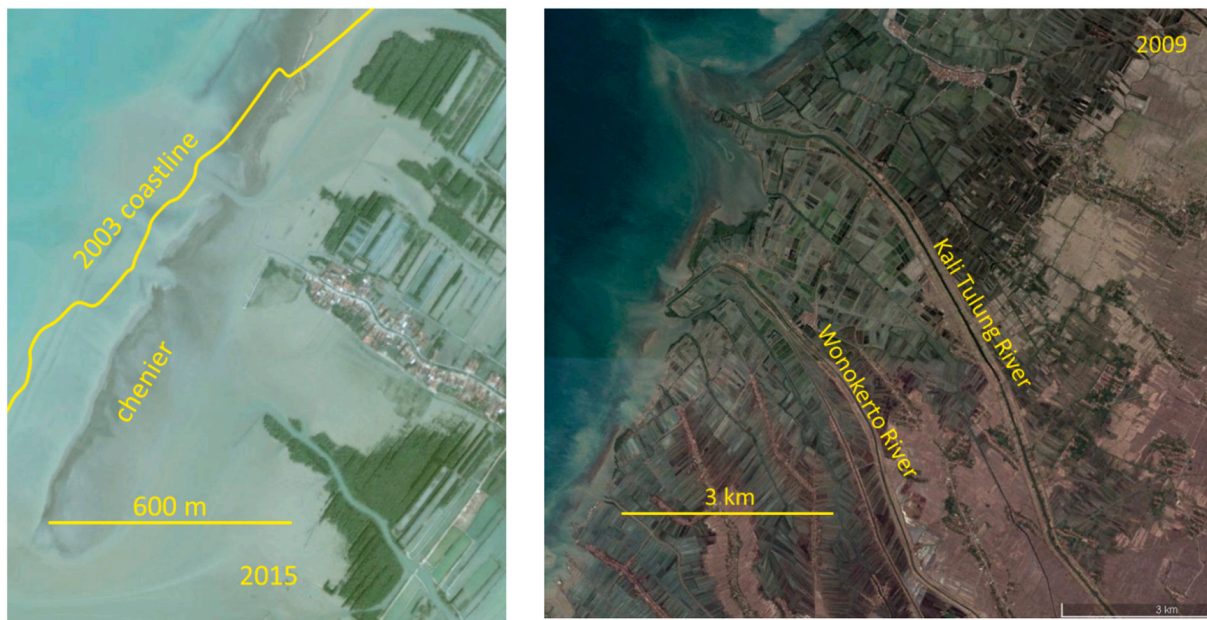
Fig. 26. Example of chenier formation Demak, Indonesia (Google Earth image) by (a) self-organization of eroded coastal sediment and (b) riverine sand input.

The formation and dynamics of cheniers and their migration are largely unknown. Tas et al. (2020) collected data on chenier dynamics, mainly under quiet hydrodynamic conditions (0.2 m waves). They tested some hypotheses with mathematical models, and it is postulated that the large tidal volume behind this chenier presumably augments its dynamics largely. However, no data could be collected during storm conditions. Fig. 27 exhibits the importance of such storm conditions, showing how a cheniers moved about 100 m onshore within one to two weeks. Likely, its further migration is blocked by the permeable dam.

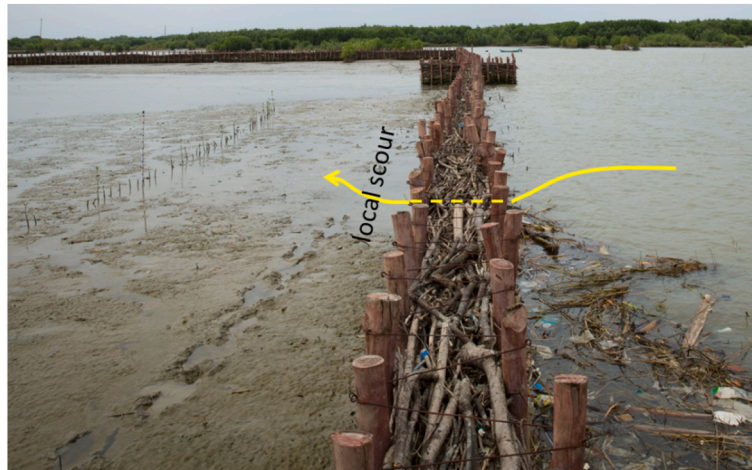
Fig. 29. Example of local scour by near-bed currents underneath loose brushwood, coastal restoration works in Bogorame, Demak, Indonesia.

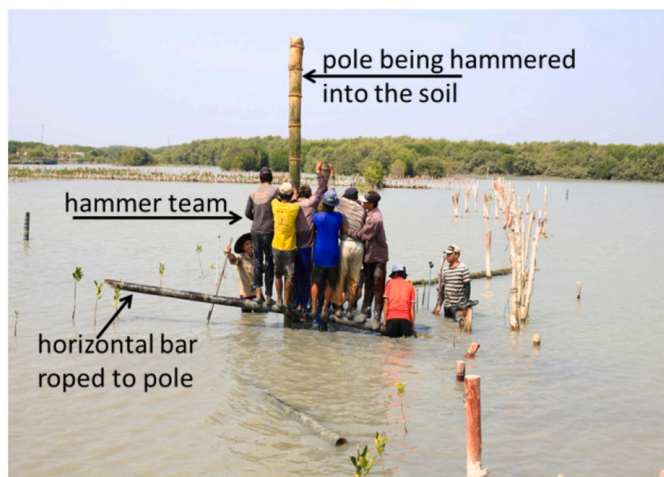
Fig. 32. Hammer team at work to place bamboo pole, Bogorame, Demak, Indonesia.

Though no heavy equipment is used, safety is an issue, as the bamboo poles are long and heavy, and hammering implies considerable forces on the poles and horizontal bars. Also weather conditions, in particular storm conditions and lightening are important safety issues.

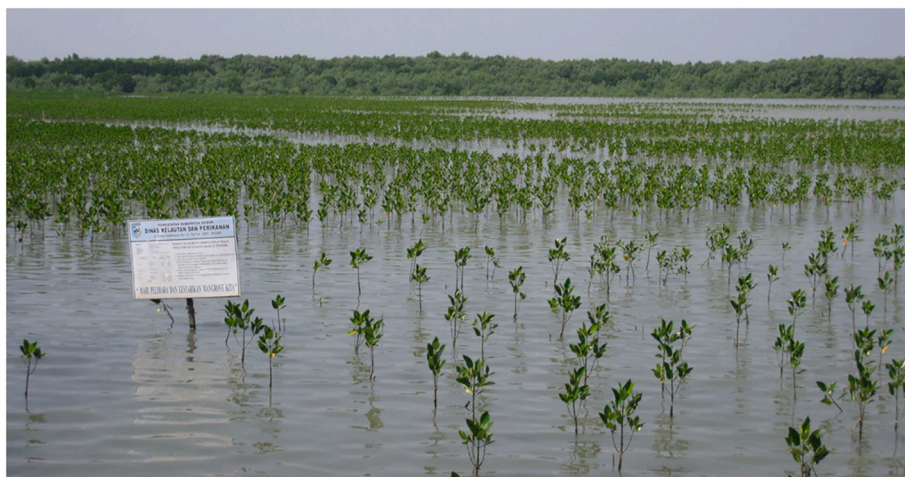
Fig. 33. *Rhizophora* planted on mud flat.

Overall, mangrove replanting is often done with red mangrove propagules, irrespective of habitat suitability (Fig. 33). As a

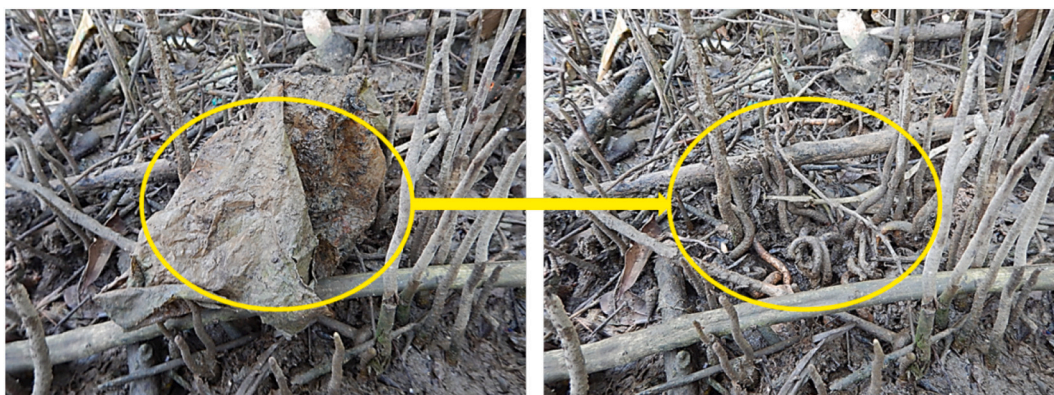
Fig. 34. Example of root degeneration/deformation in response to suffocation by plastic (Demak, photo C. Van Bijsterveldt).
