Managing erosion of mangrove-mud coasts with permeable dams – lessons learned

Johan Winterwerp, Thorsten Albers, Edward J. Anthony, Daniel Friess, Alejandra Gijón Mancheño, et al.. Managing erosion of mangrove-mud coasts with permeable dams – lessons learned. *Ecological Engineering*, 2020, 158, pp.106078. <10.1016/j.ecoleng.2020.106078>. <hal-03222423>

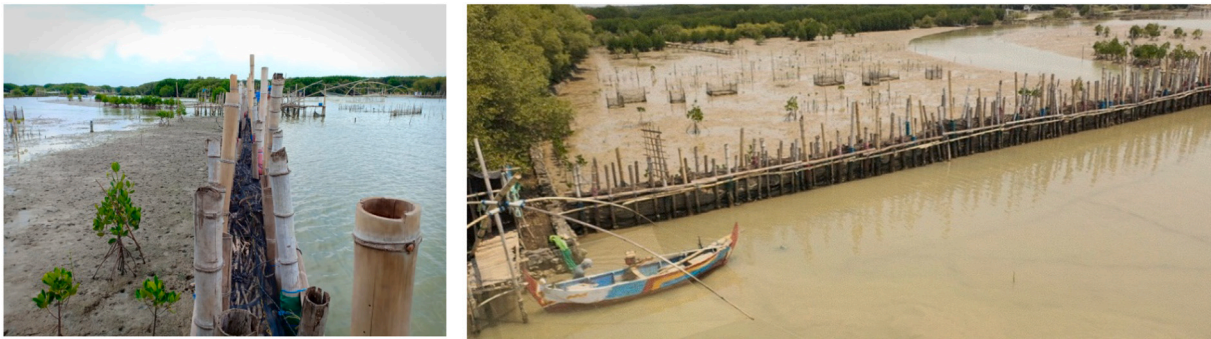
Fig. 7. 2019 sedimentation patterns, Bogorame, Demak, Java, Indonesia, photos December 2019 and January 2020.

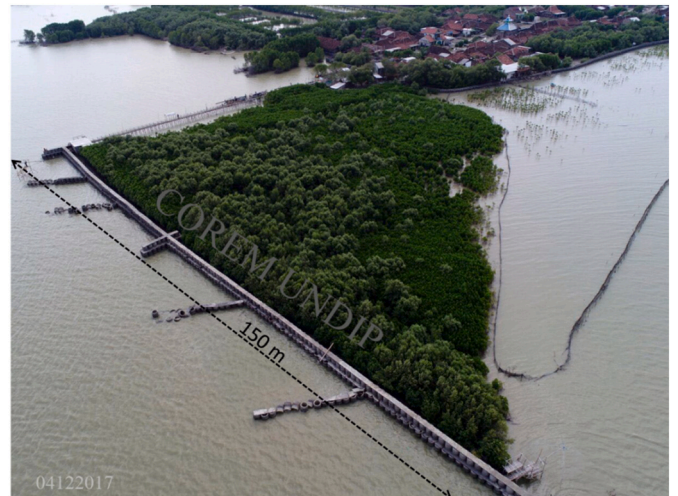
Fig. 9. APO, concrete seawall at Timbul Sloko, Demak, Indonesia (courtesy COREM-UNDIP) with natural colonization by *Avicennia* (high vegetation) and planted *Rhizophora* (low vegetation).

Prior to the construction of permeable structures, a 150 m long seawall was built in Timbul Sloko using concrete cylinders. This seawall is locally known as the APO (Fig. 9), located along the original, pre-erosion coastline. Sedimentation behind the APO up to MSL took place in about two years, and one year later the first *Avicennia* seedlings were

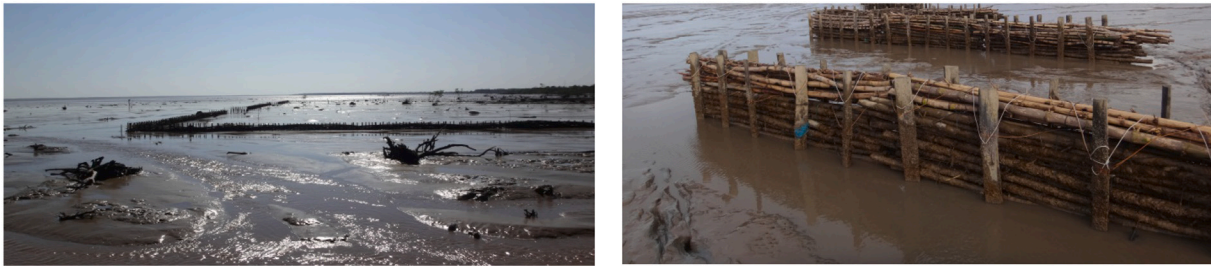
Fig. 11. Permeable dams constructed near Weg naar Zee, north of Paramaribo, Suriname (photos by E. Van Lavieren).

series of permeable dams were constructed, as shown in Fig. 11, the locations of which are indicated in Fig. 10. Next to these constructions, a small-scale mangrove replanting program was executed in 2018. This work was mainly aimed at involving local stakeholders in mangrove rehabilitation efforts, and no systematic monitoring program was executed.

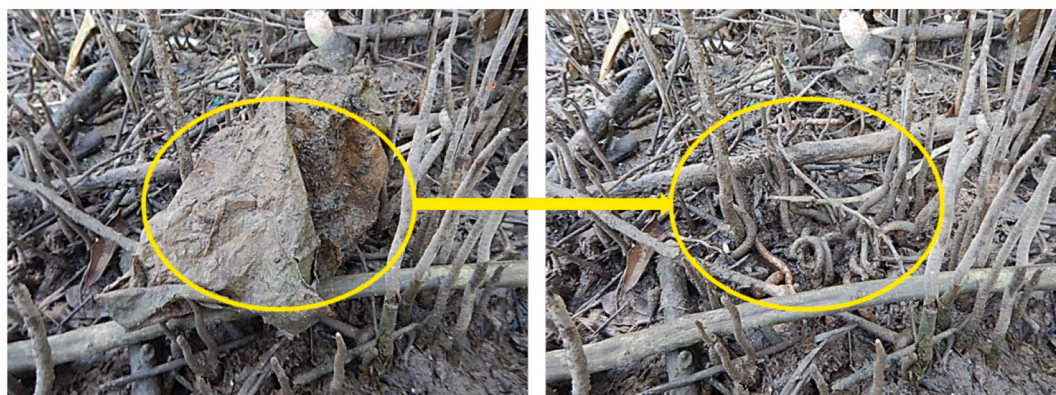
Fig. 34. Example of root degeneration/deformation in response to suffocation by plastic (Demak, photo C. Van Bijsterveldt).
