Managing erosion of mangrove-mud coasts with permeable dams – lessons learned

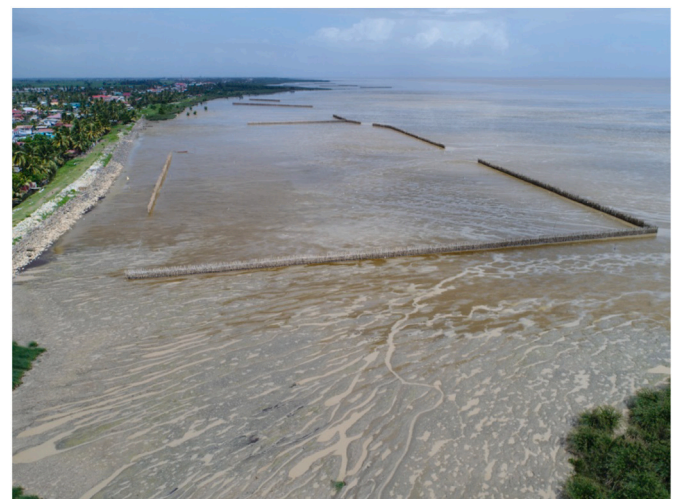
Fig. 4. Mangrove recolonization along Guyana coast, east of Georgetown, 2019.

was similar to the descriptions in Section 4. Figure 4 shows an aerial photo of some of the dams erected near Georgetown. The dams near Georgetown did not have durable results. However, along the left bank of the Essequibo River (Anna Regina and Devonshire Castle, west of Georgetown) 1.5 – 2 m siltation was monitored behind a 100 m long dam between 2013 and 2016. The higher siltation rate yielded bed levels a bit higher than the optima for mangrove rehabilitation. Part of the mangrove planting took place on these deposits.

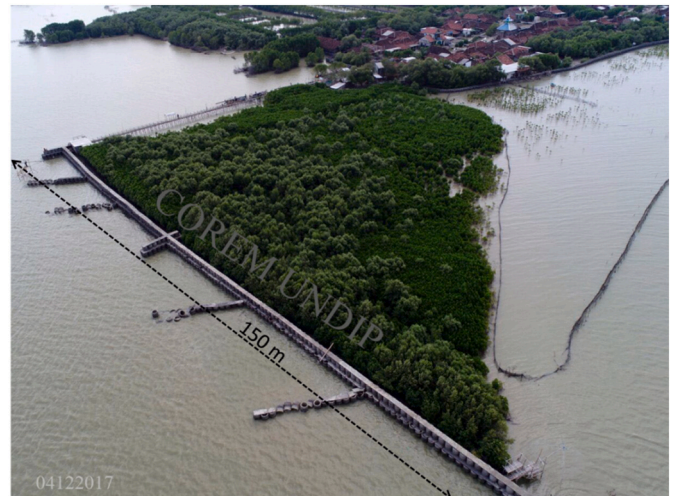
Fig. 9. APO, concrete seawall at Timbul Sloko, Demak, Indonesia (courtesy COREM-UNDIP) with natural colonization by *Avicennia* (high vegetation) and planted *Rhizophora* (low vegetation).

Prior to the construction of permeable structures, a 150 m long seawall was built in Timbul Sloko using concrete cylinders. This seawall is locally known as the APO (Fig. 9), located along the original, pre-erosion coastline. Sedimentation behind the APO up to MSL took place in about two years, and one year later the first *Avicennia* seedlings were

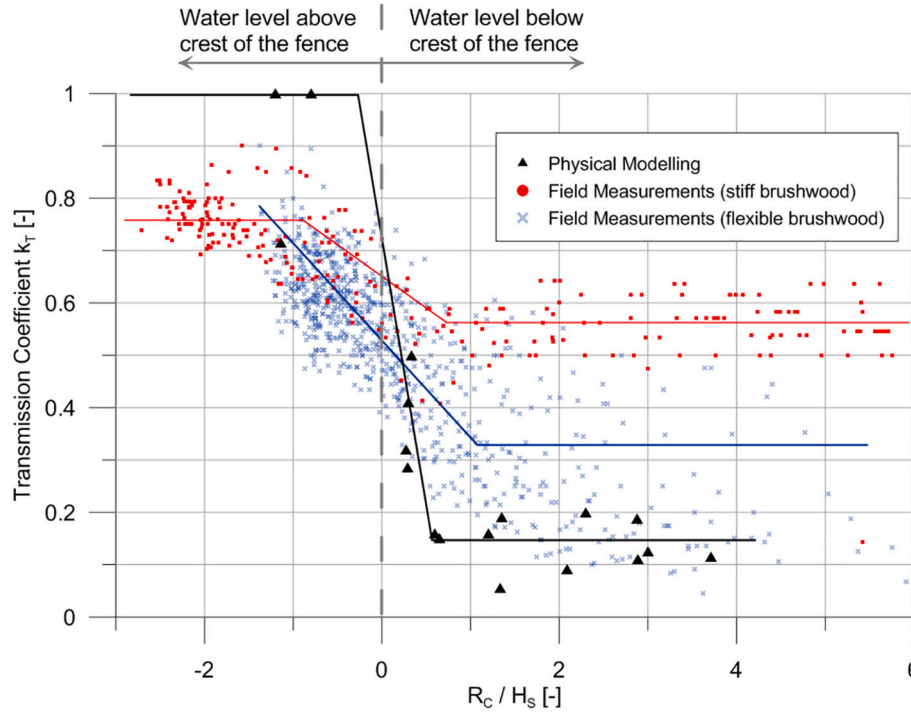
Fig. 19. Wave transmission coefficients of bamboo fences under various hydrological conditions (modified after Albers et al., 2013).

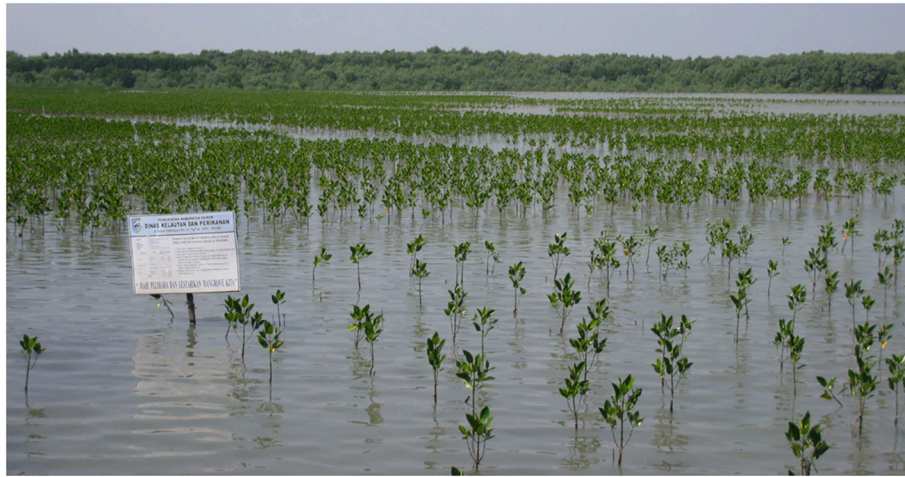
Fig. 33. *Rhizophora* planted on mud flat.

Overall, mangrove replanting is often done with red mangrove propagules, irrespective of habitat suitability (Fig. 33). As a
